KINSMEN PEDESTRIAN BRIDGE

EVALUATION REPORT

**ENHANCED OSIM INSPECTION,
LOAD LIMIT ANALYSIS,
& OPTIONS EVALUATION**

FOR
THE CORPORATION OF
THE TOWN OF TILLSONBURG

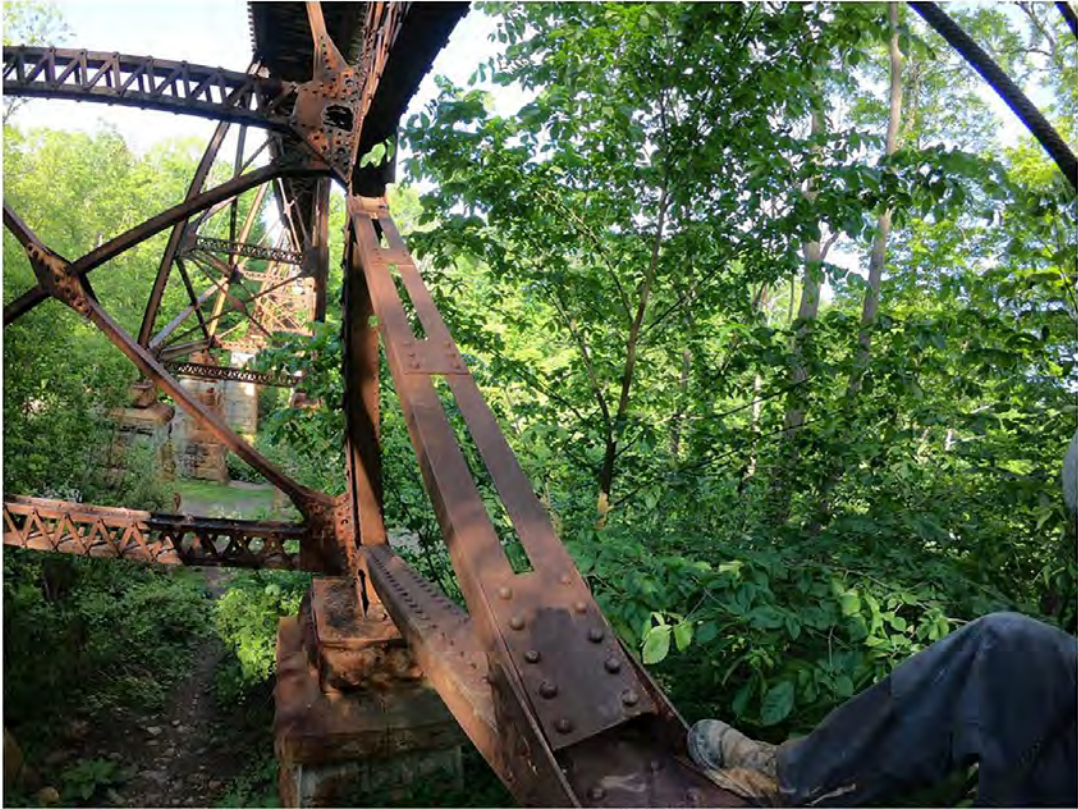
7. Surface Corrosion on Diagonal Bracing, Typical

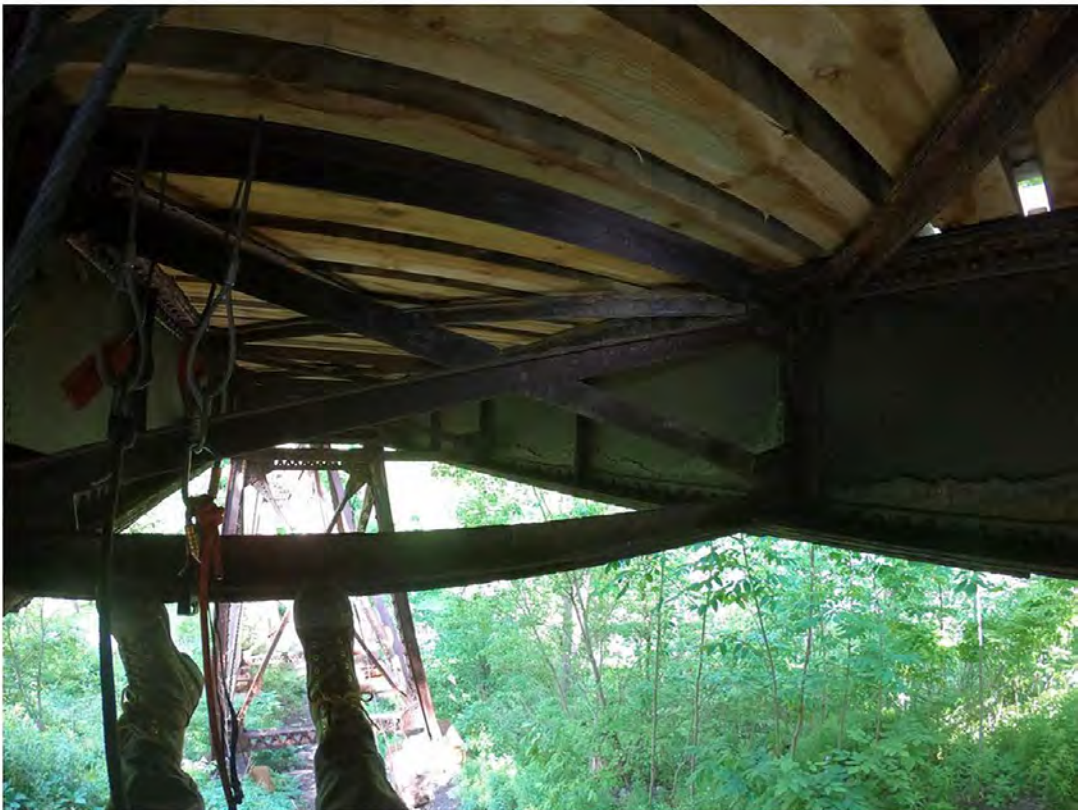
8. Severe Corrosion and Delamination on Girder and Diaphragm

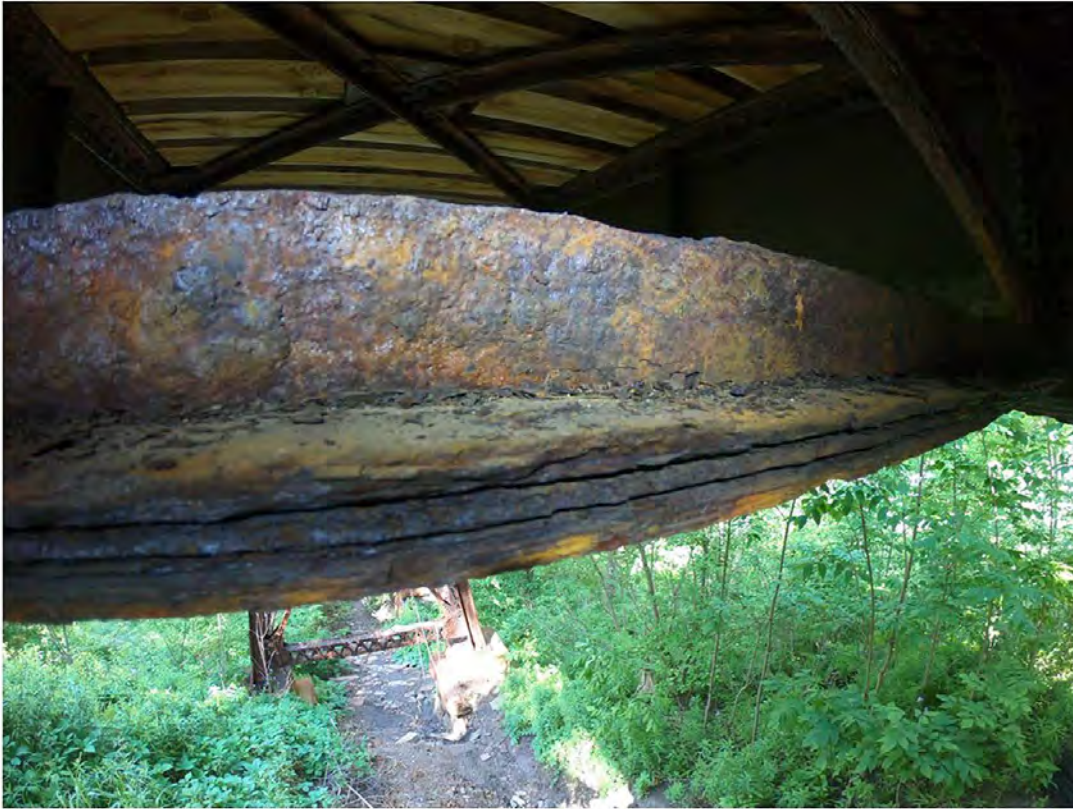
9. Severe Corrosion and Delamination on Horizontal Component of Diaphragm

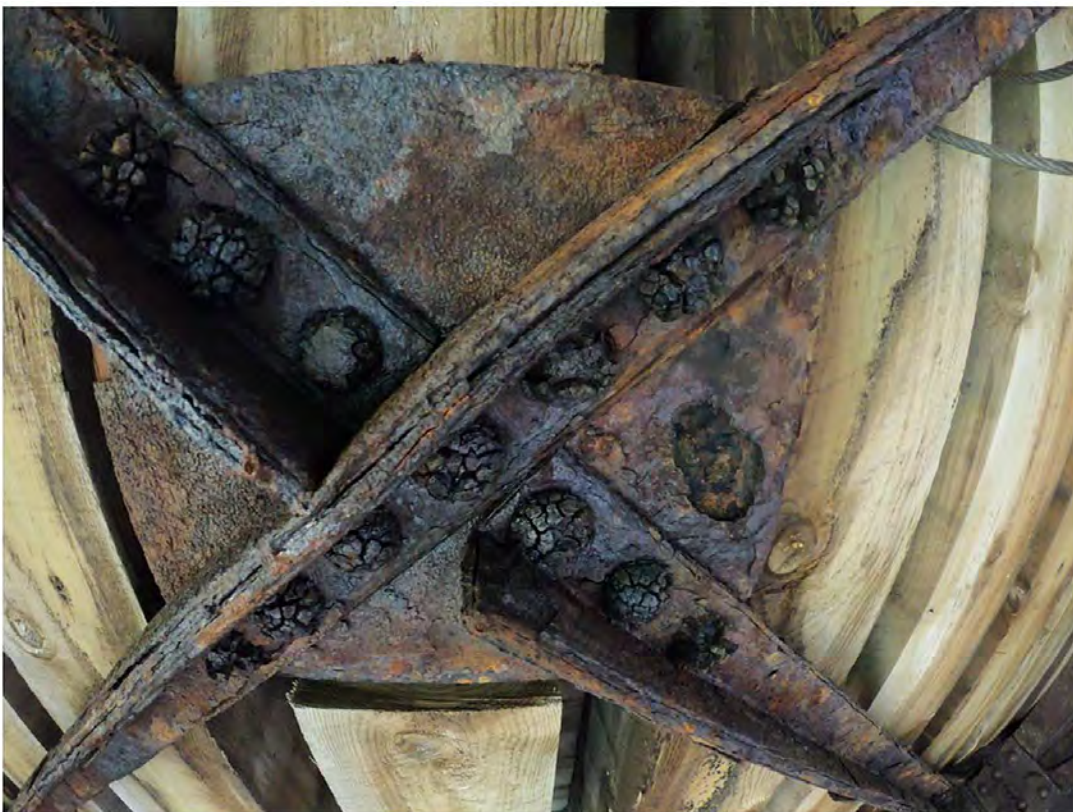
10. Severe Corrosion and Rivet Cracking on Lateral Bracing on Soffit

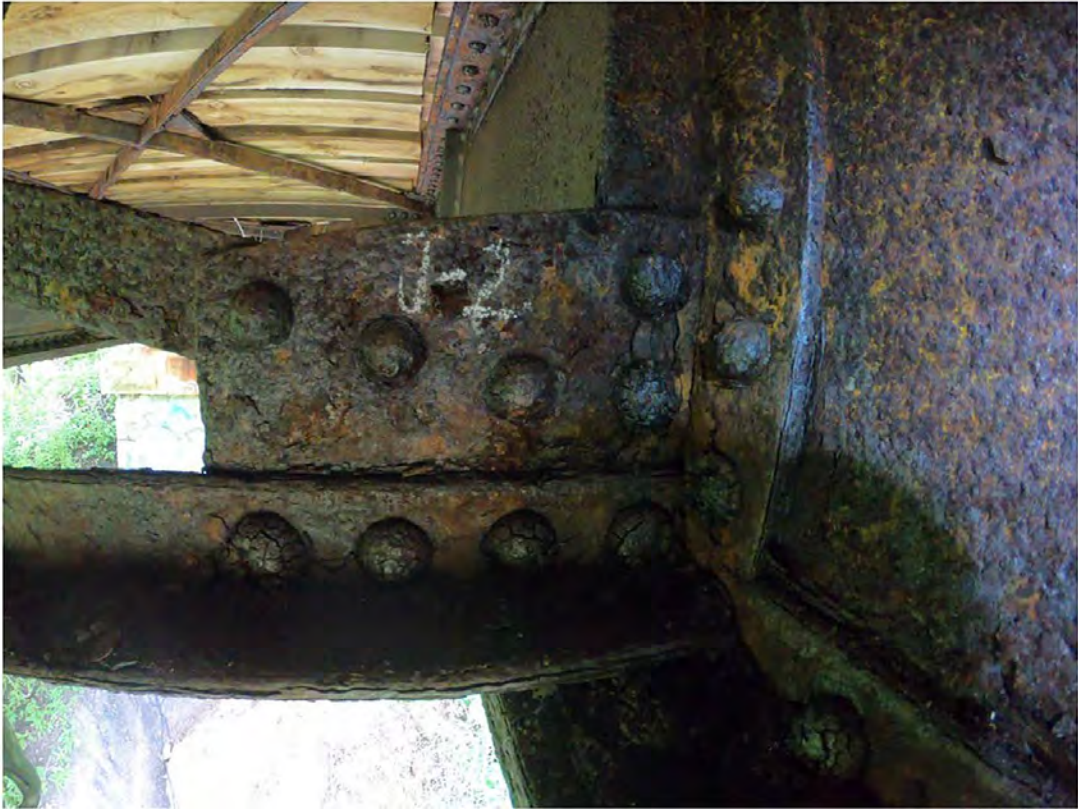
11. Medium Corrosion and Delamination of Diaphragm and Girder Connection

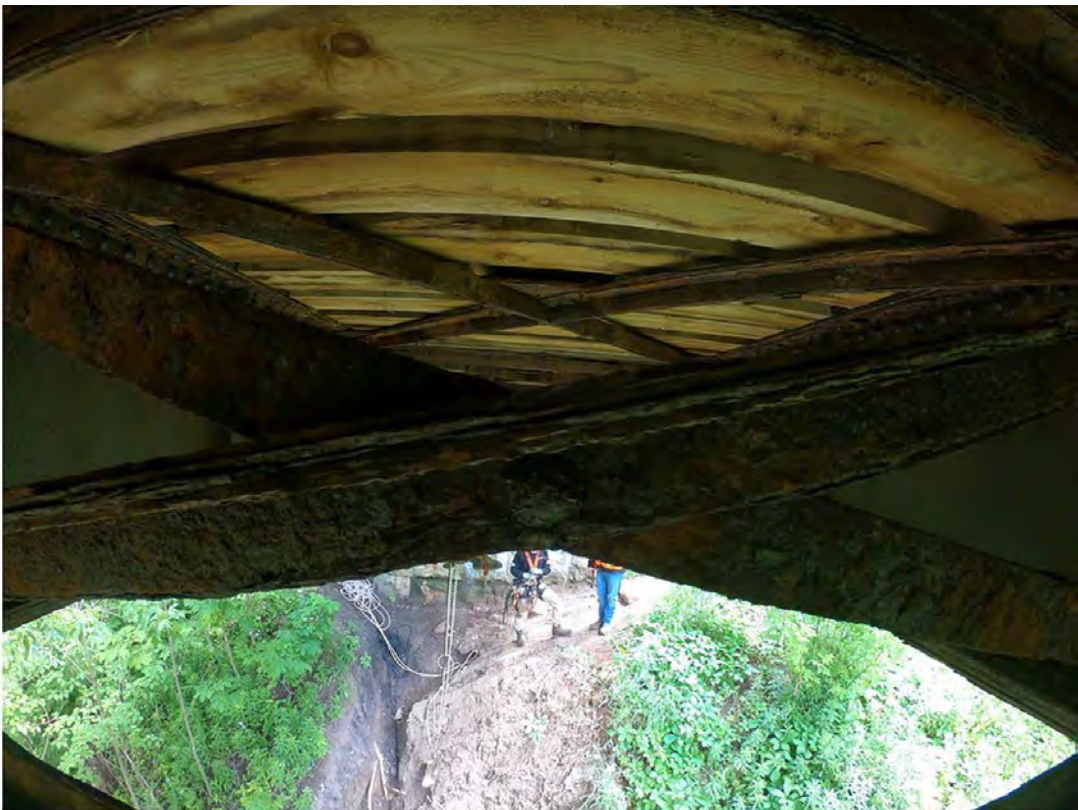
12. Severe Corrosion and Delamination of Diagonal Components of Diaphragm

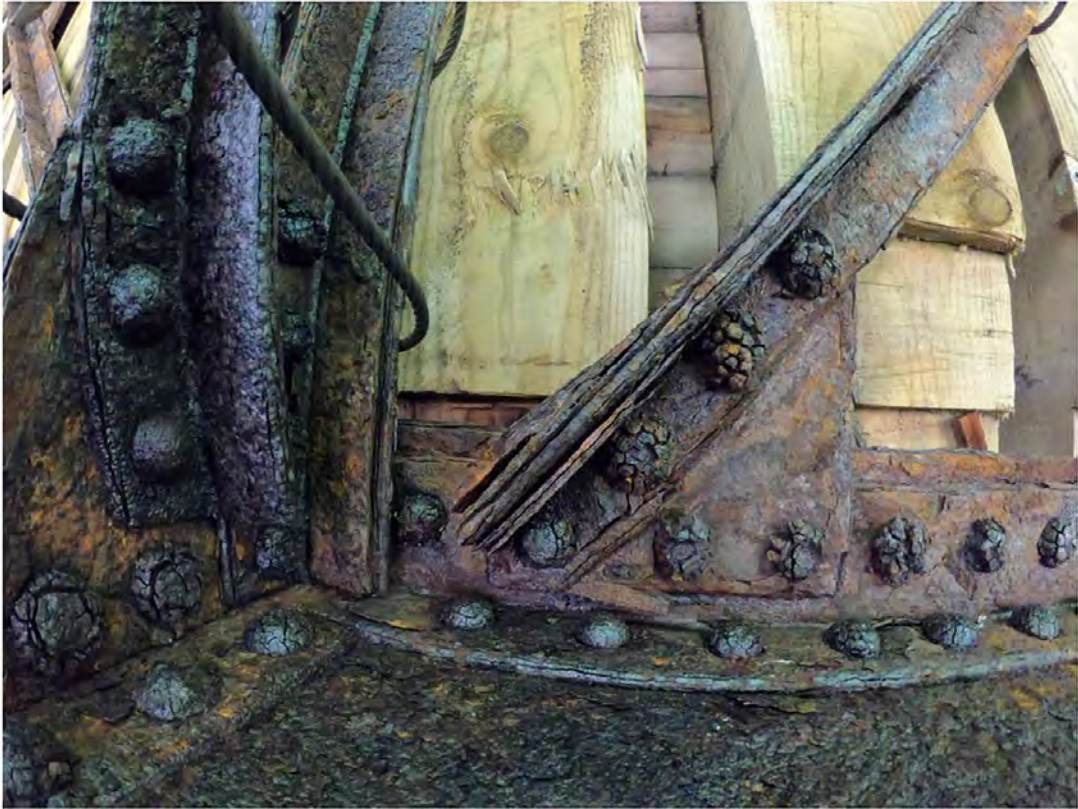
13. Severe Corrosion, Delamination, and Cracking of Rivets at Lateral Bracing and Girder

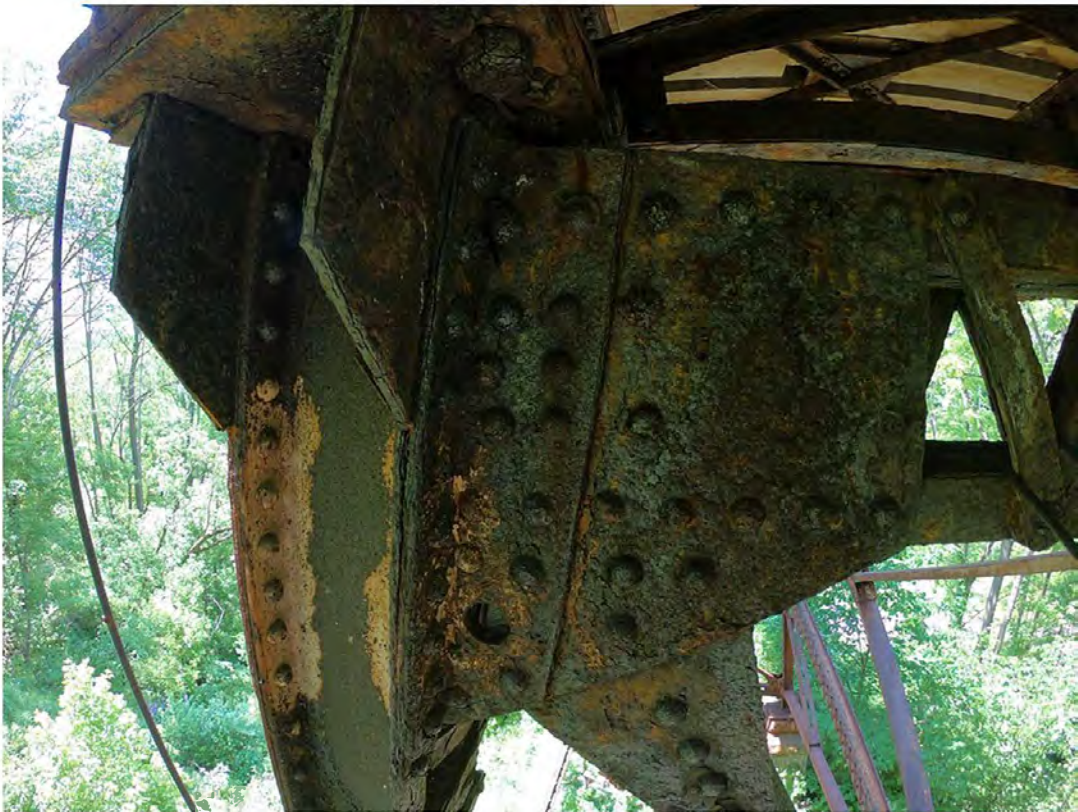
14. Severe Corrosion and Delamination on Columns

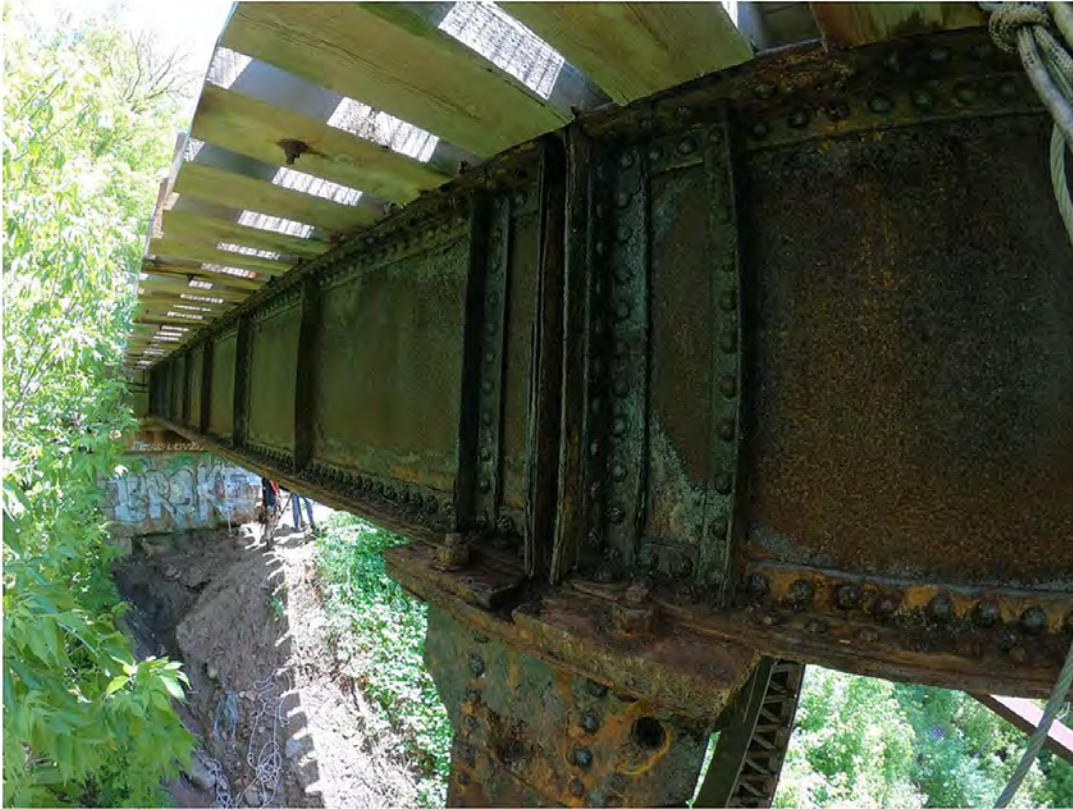
15. Severe Corrosion and Delamination on Girder

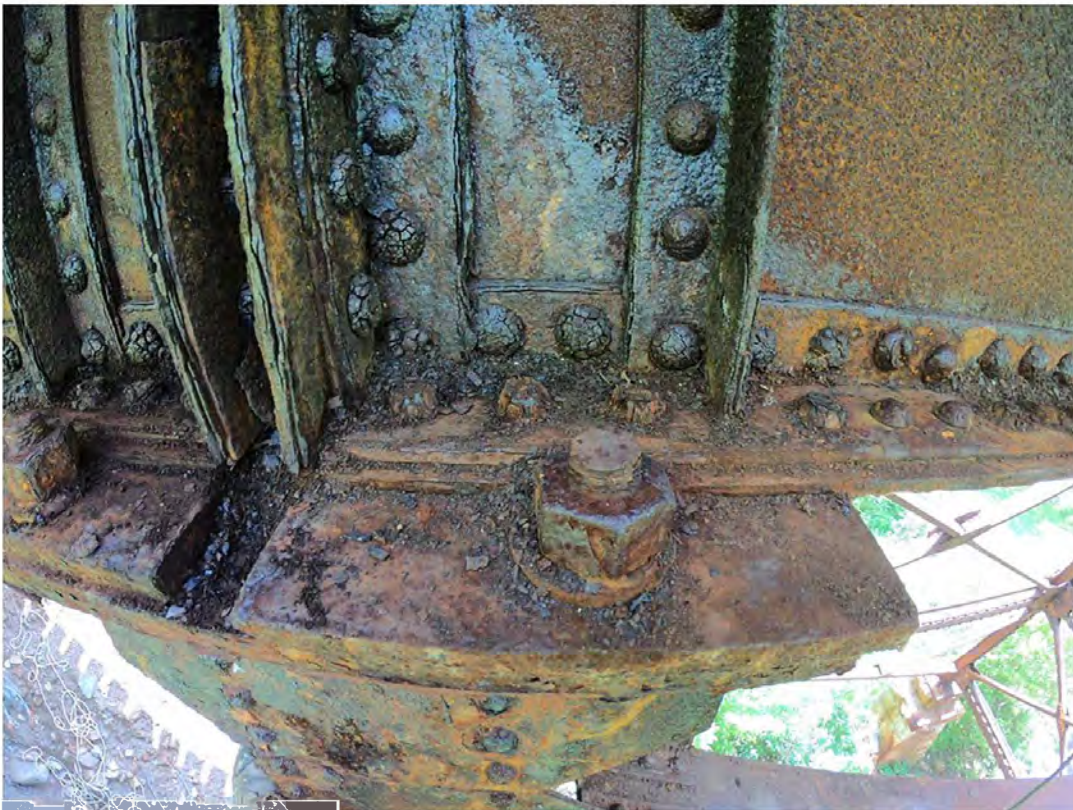
16. Medium Corrosion of Bearing Plate

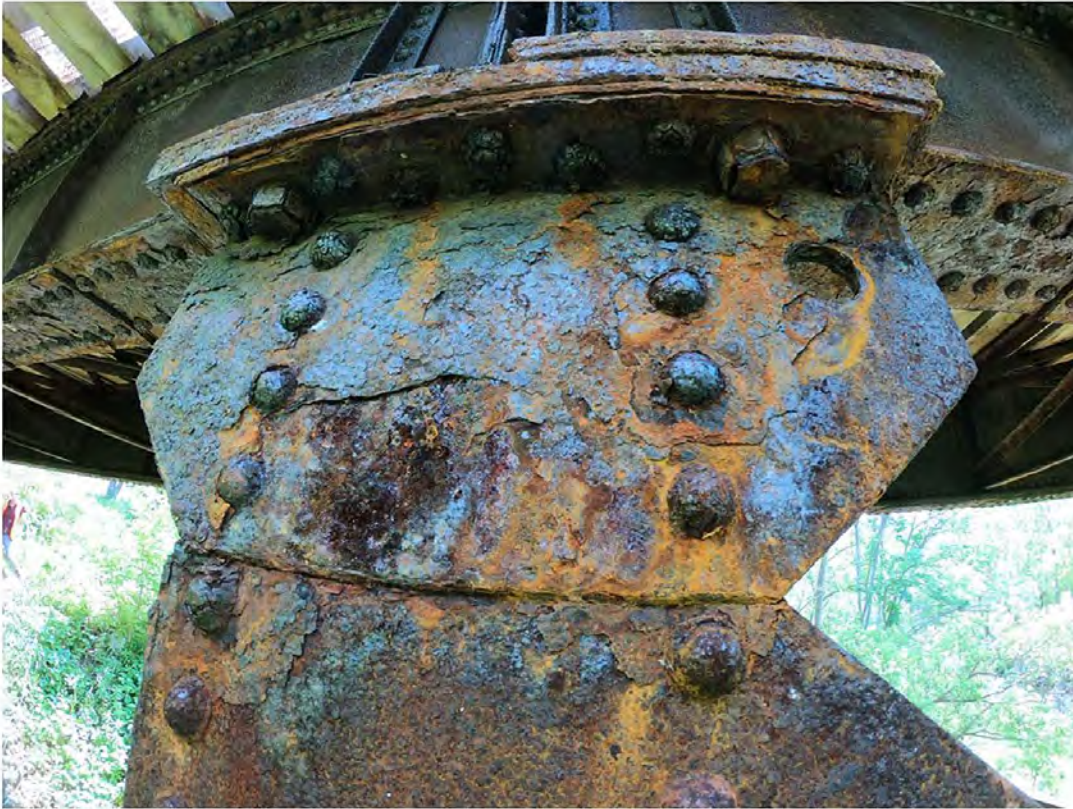
17. Medium Corrosion and Delamination of Connection Plate at Column End

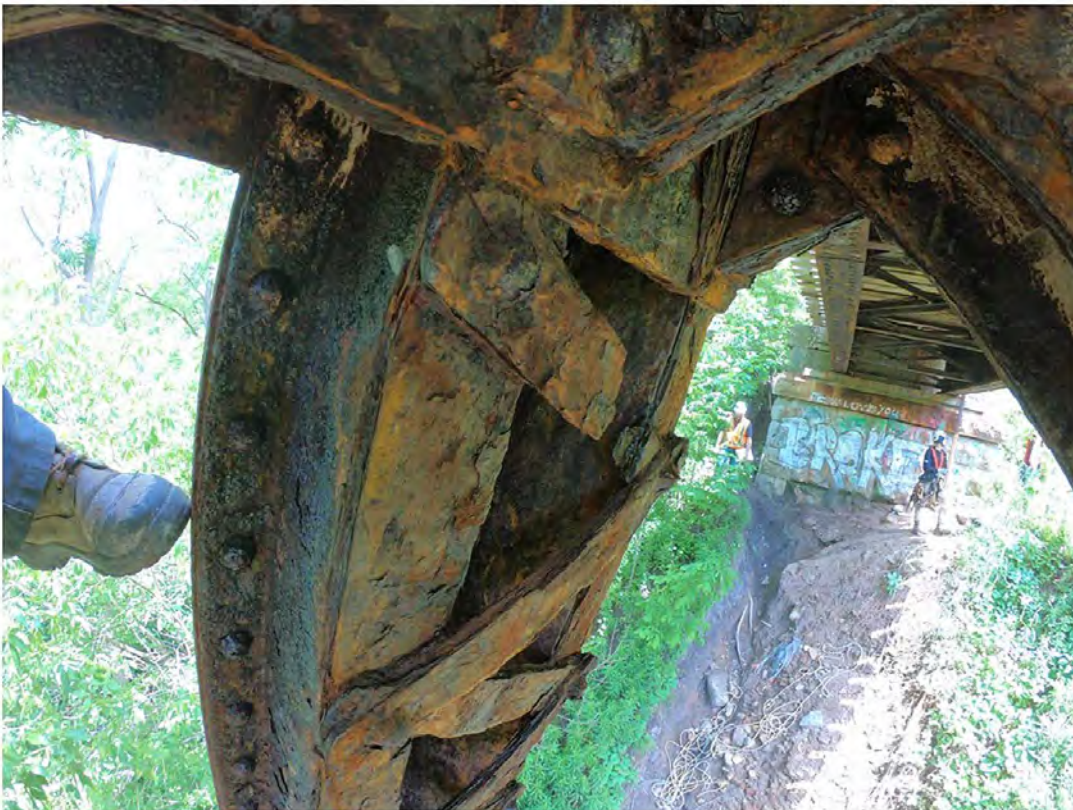
18. Very Severe Corrosion and Delamination with Complete Section Loss on Column Brace

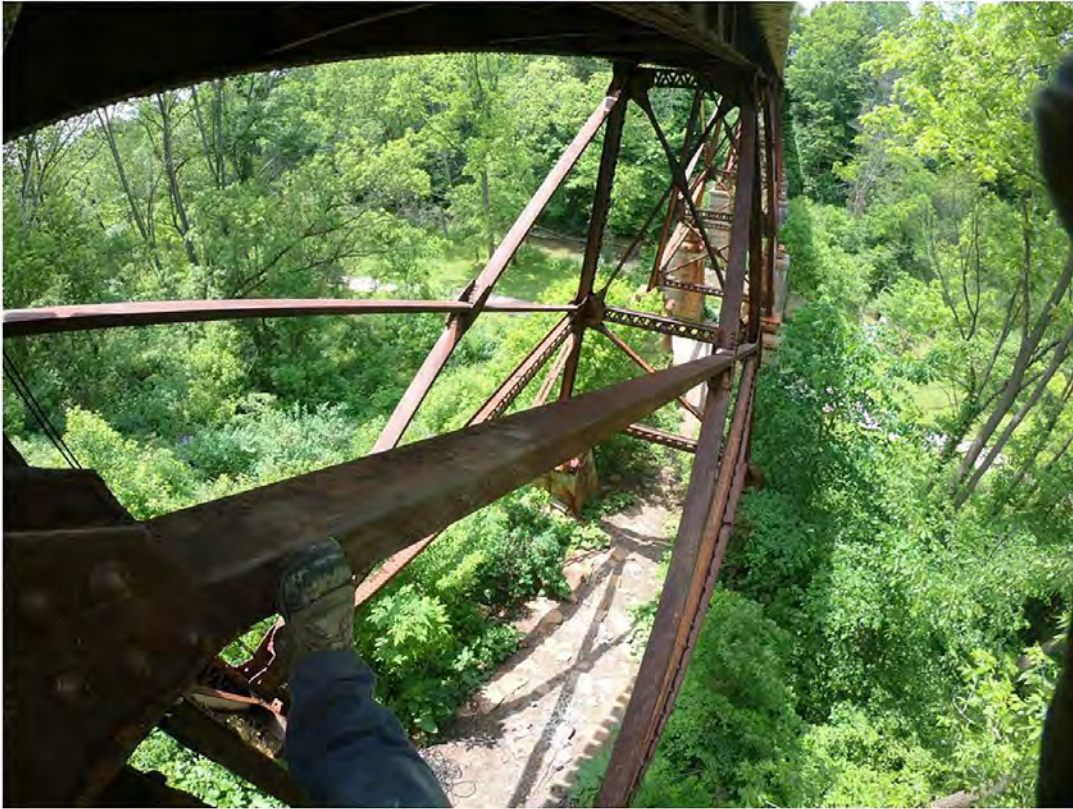
19. Surface Corrosion on Diagonal Bracing

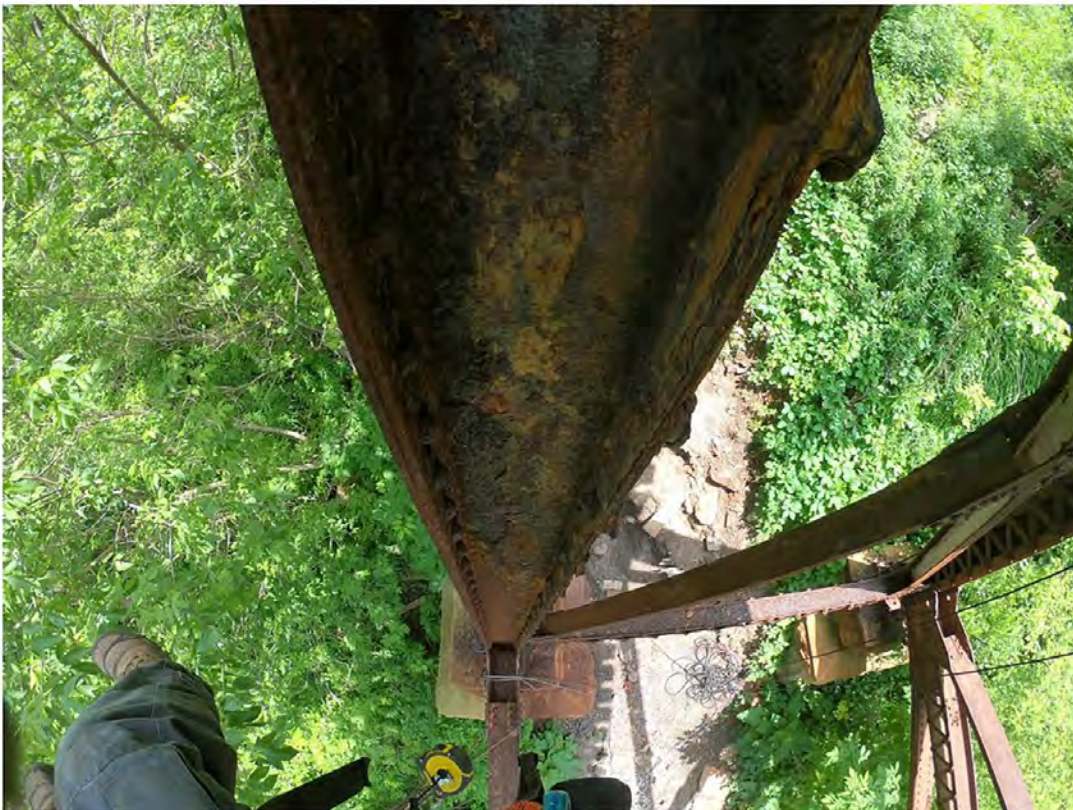
20. Medium Corrosion and Delamination on Column

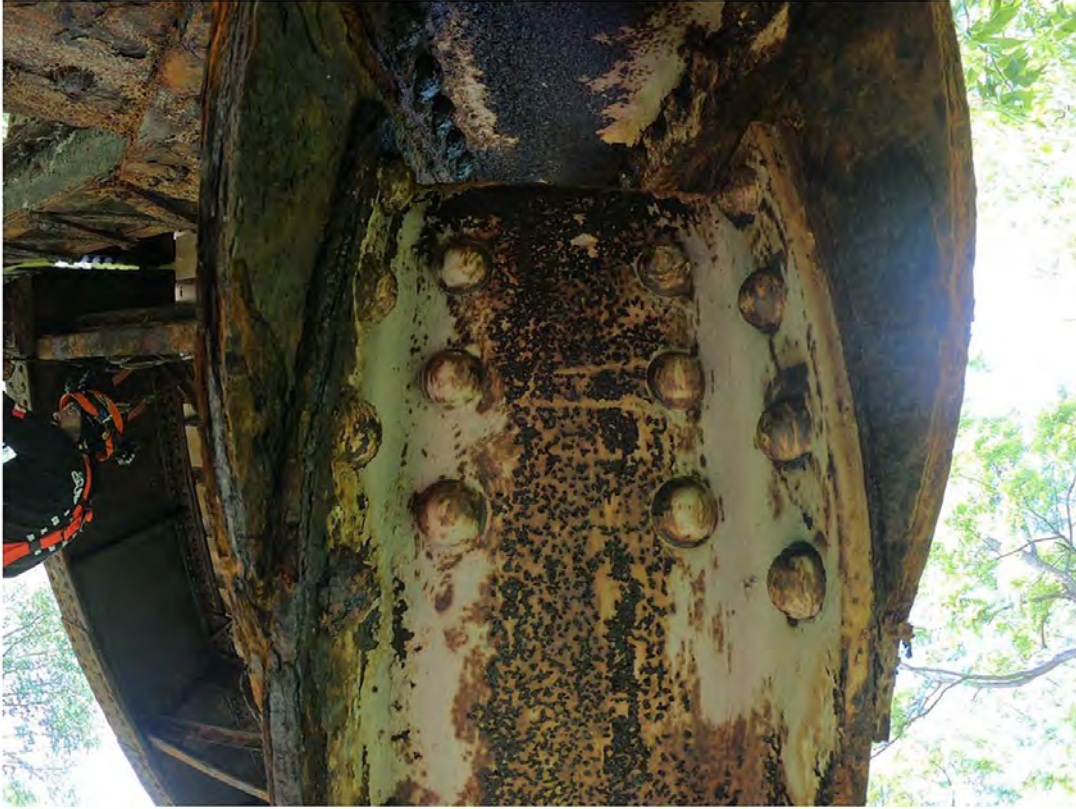
21. Medium Corrosion of Column at Girder

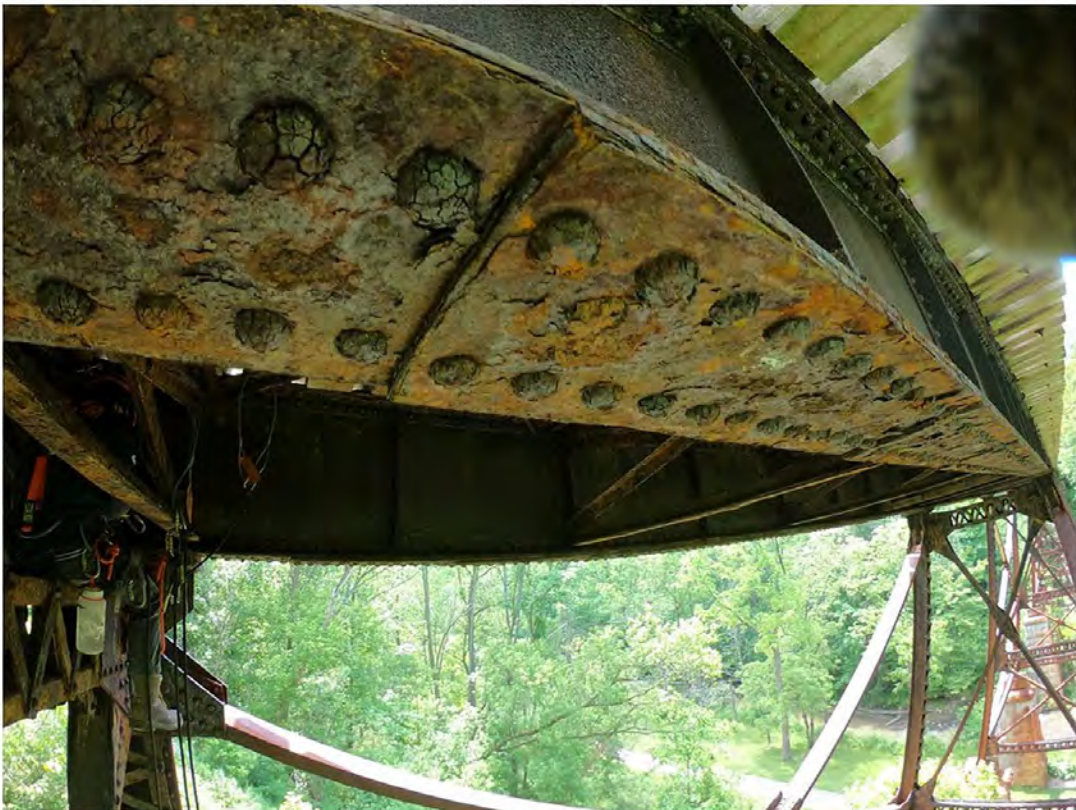
22. Medium Corrosion, Delamination, and Cracking of Rivets at Connection Plates on Girder

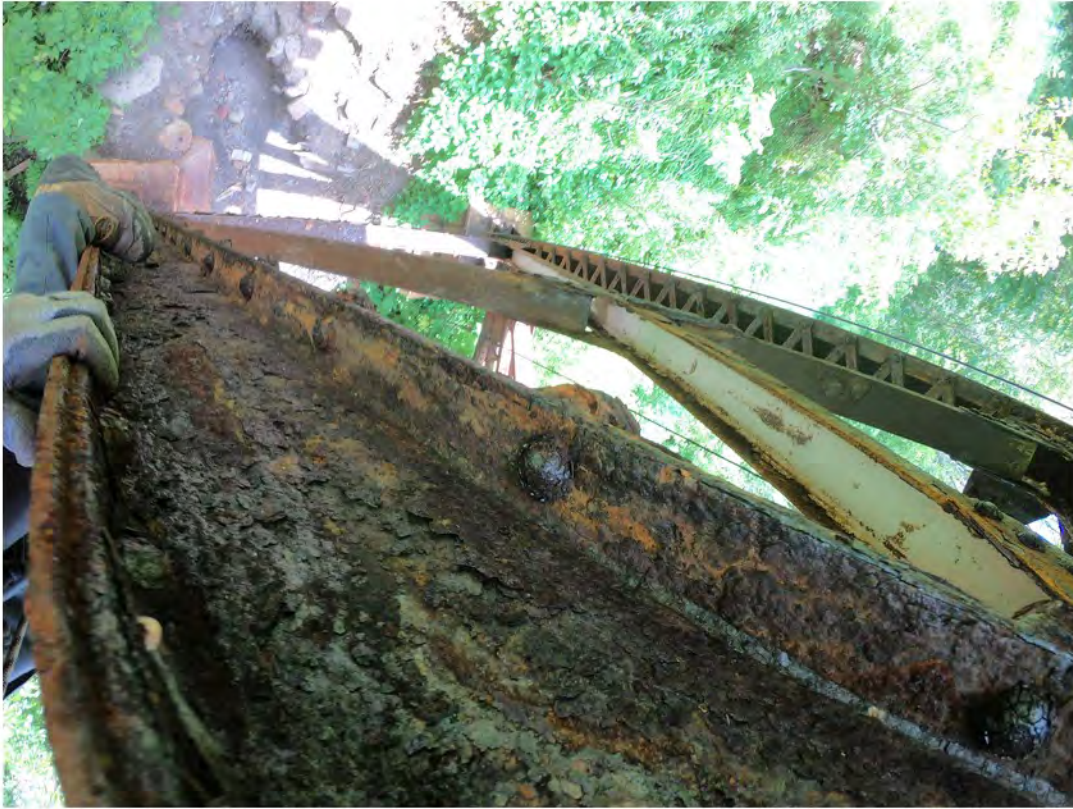
23. Severe Corrosion and Delamination of Column

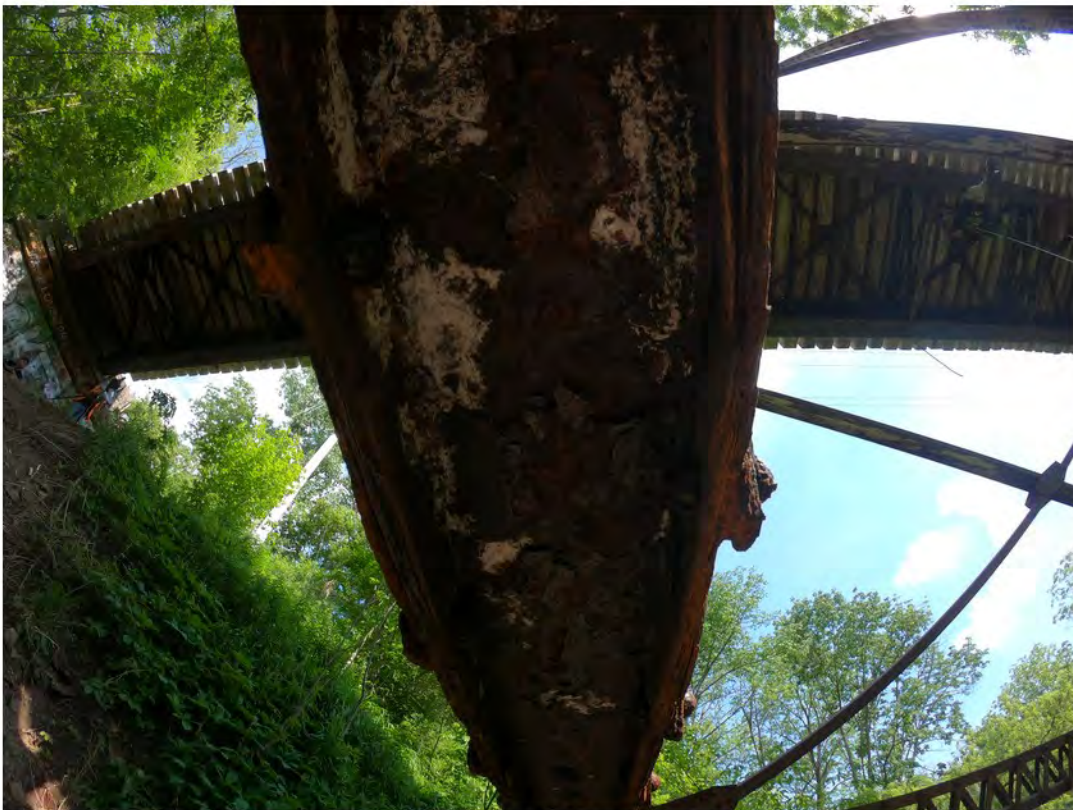
24. Severe Corrosion and Delamination of Bottom Horizontal Chord

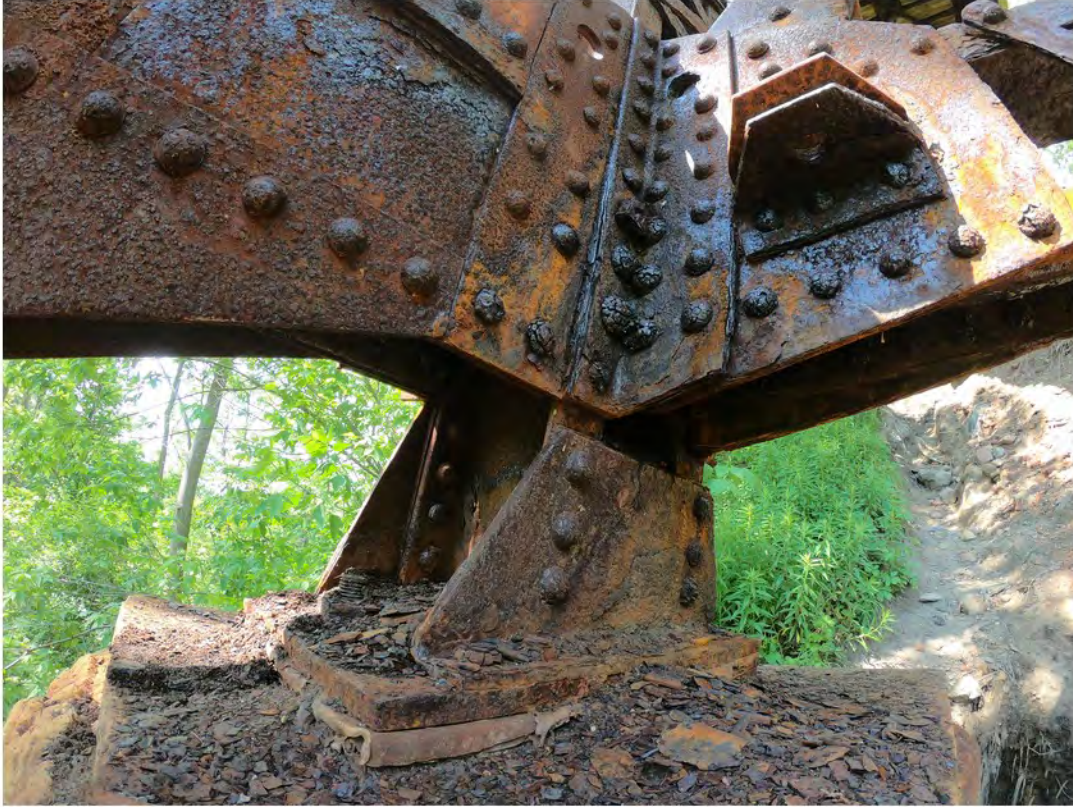
25. Medium Corrosion on Bearing Plate, and Surrounding Members; Cracking of Rivets

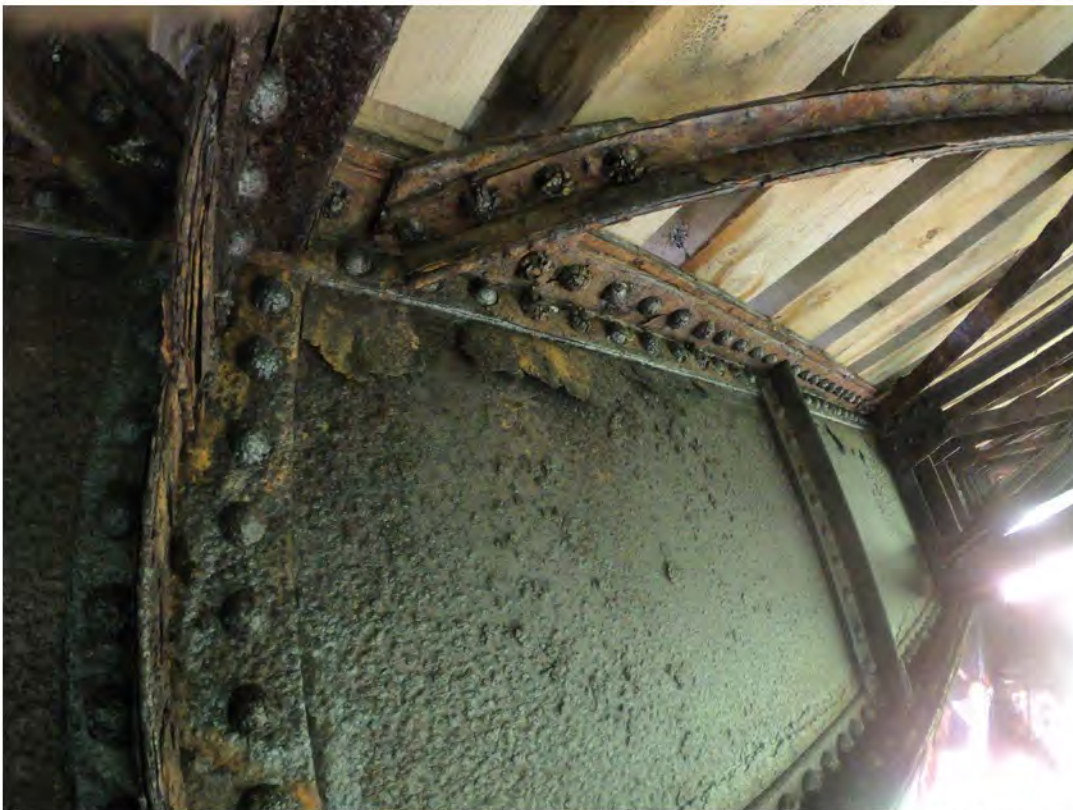
26. Medium Corrosion and Delamination on Girder at Soffit; Severe Corrosion of Lateral Bracing

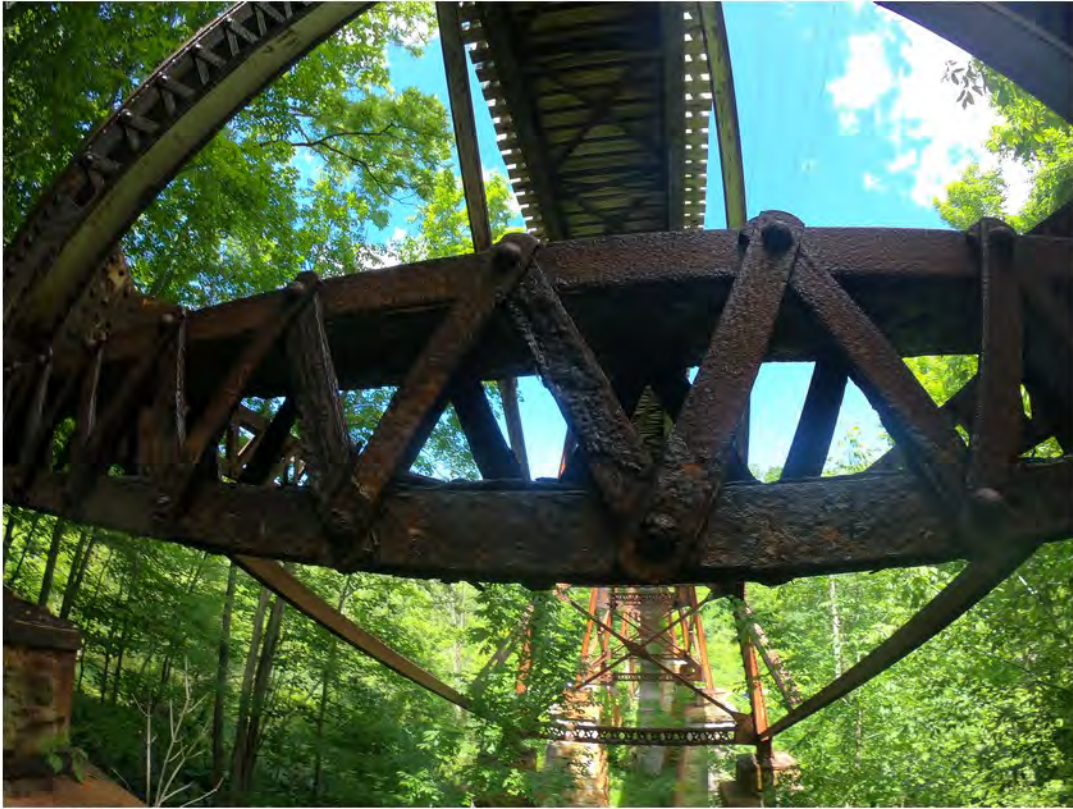
27. Very Severe Corrosion of Bracing on Lateral Support

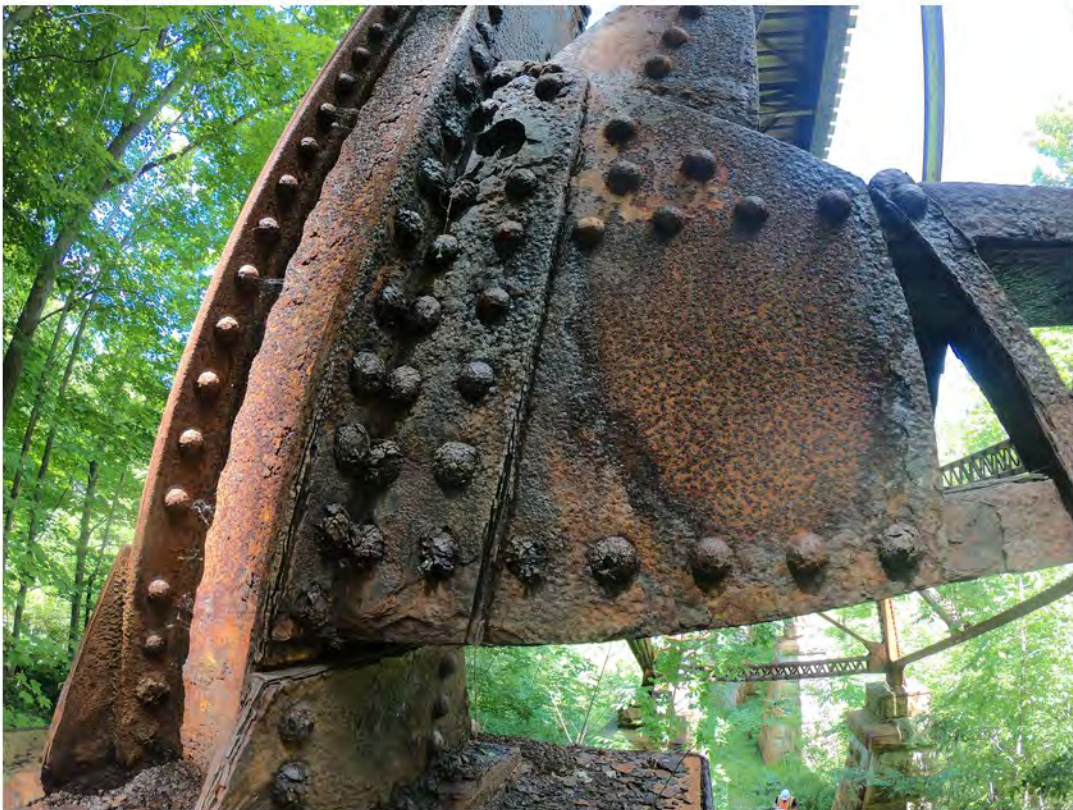
28. Very Severe Corrosion and Delamination at Connection of Column and Lateral Support

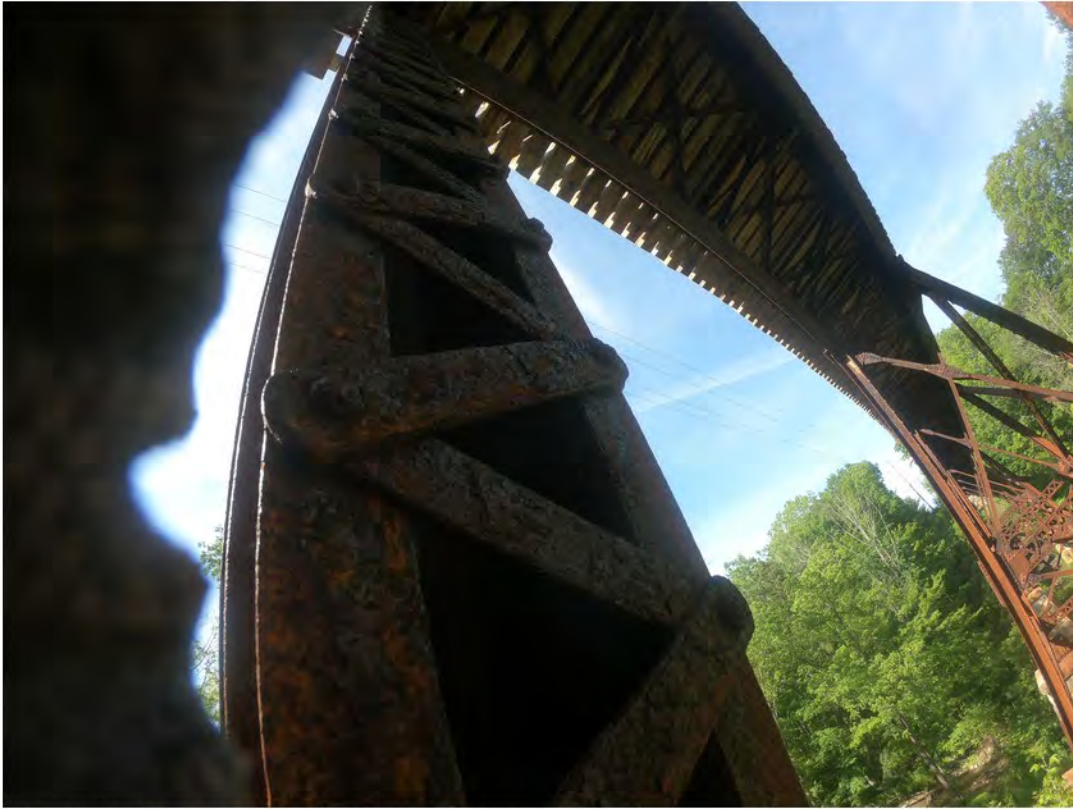
29. Severe Corrosion and Delamination on Column Bracing

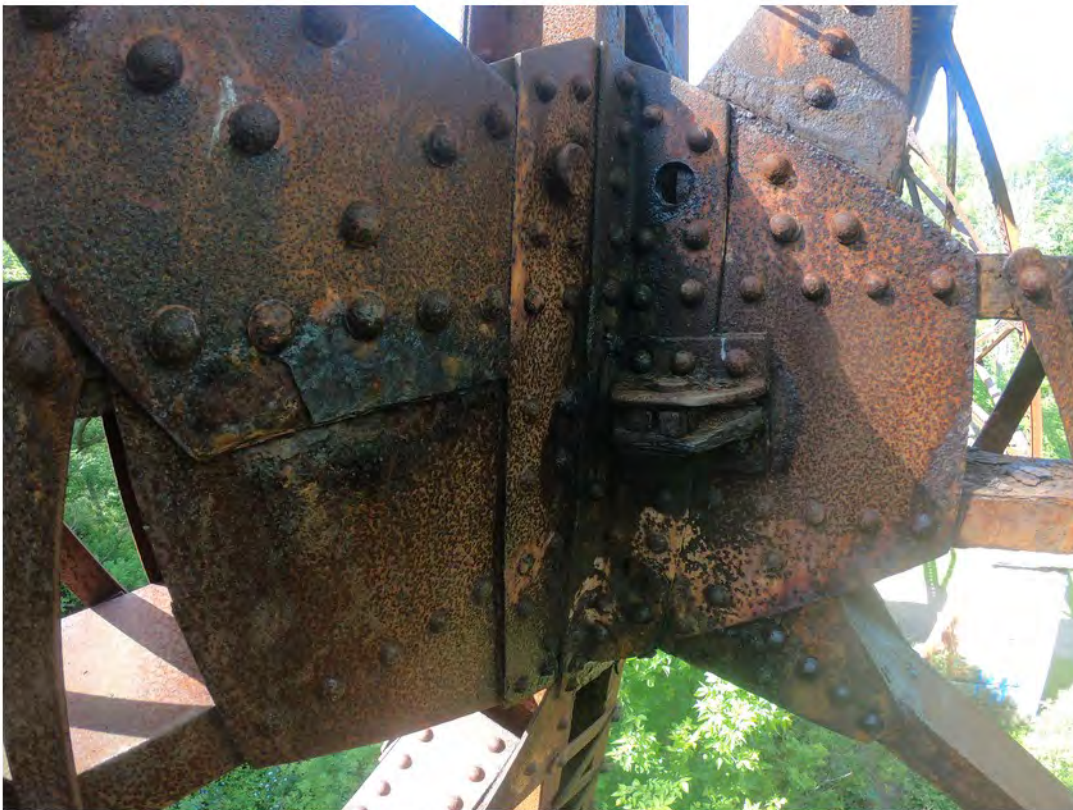
30. Medium Corrosion and Delamination of Connection at Middle of Column

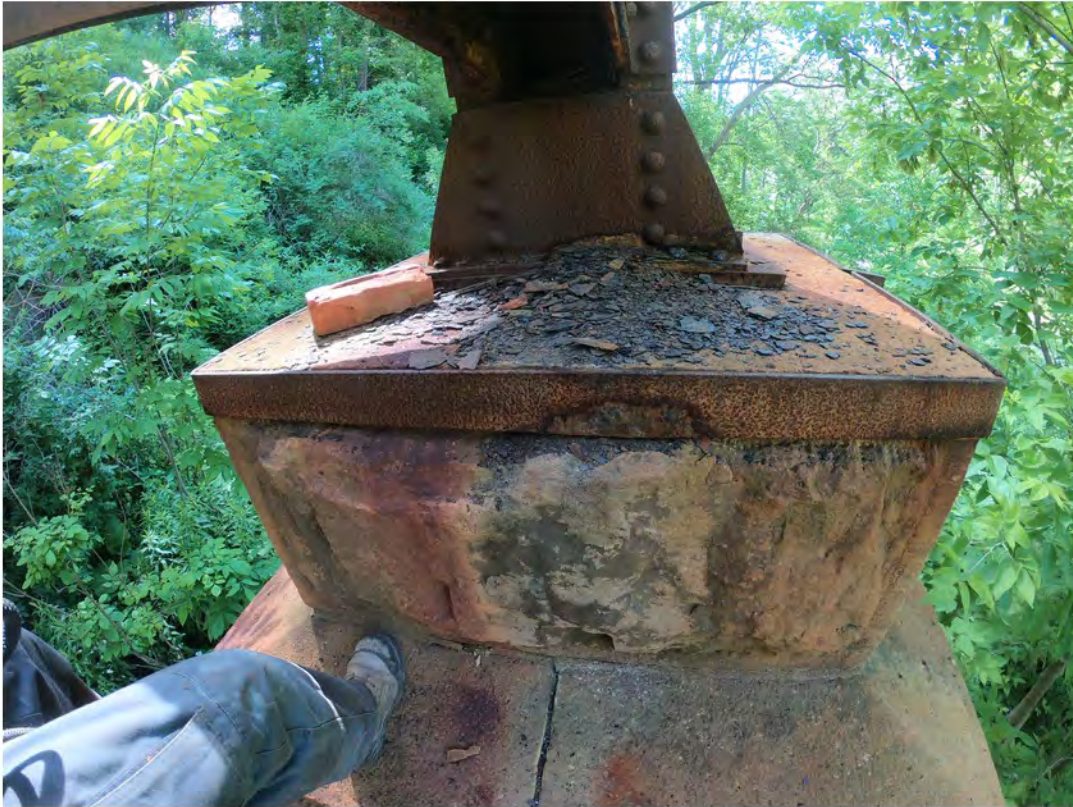
31. Medium Corrosion of Bearing Plate; Staining of Pier Cap

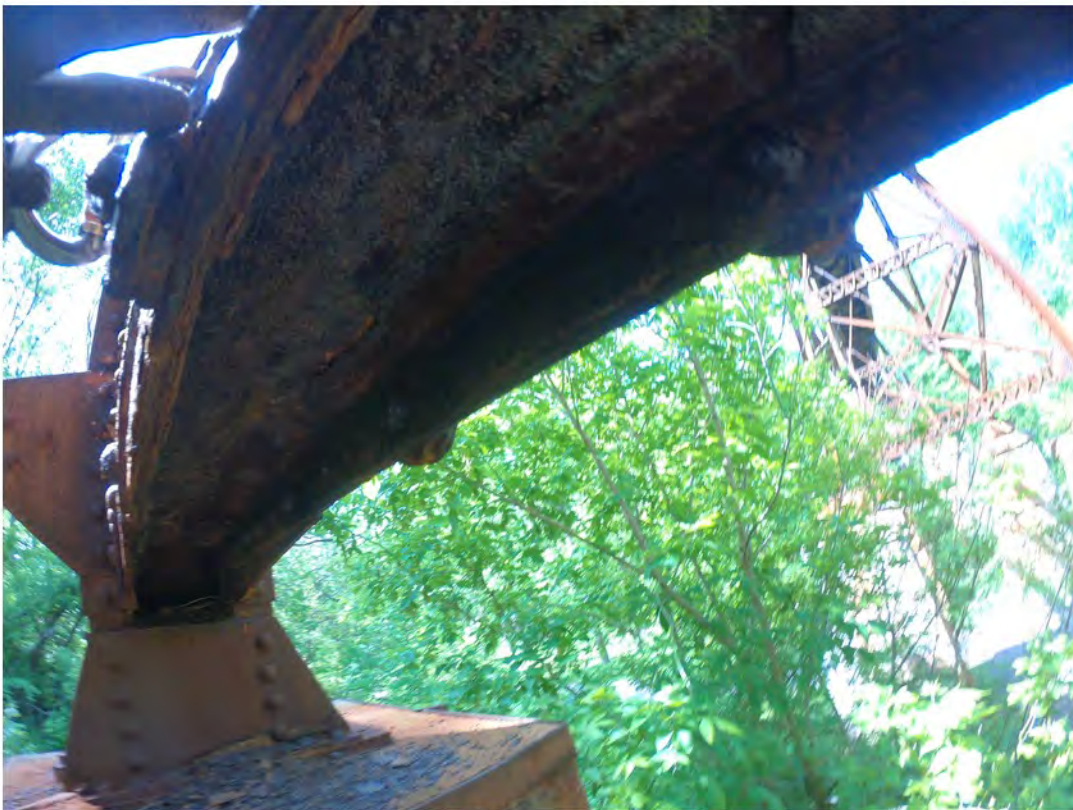
32. Severe Corrosion and Delamination of Bottom Horizontal Chord of Lateral Support
