KINSMEN PEDESTRIAN BRIDGE

EVALUATION REPORT

**ENHANCED OSIM INSPECTION,
LOAD LIMIT ANALYSIS,
& OPTIONS EVALUATION**

FOR
THE CORPORATION OF
THE TOWN OF TILLSONBURG

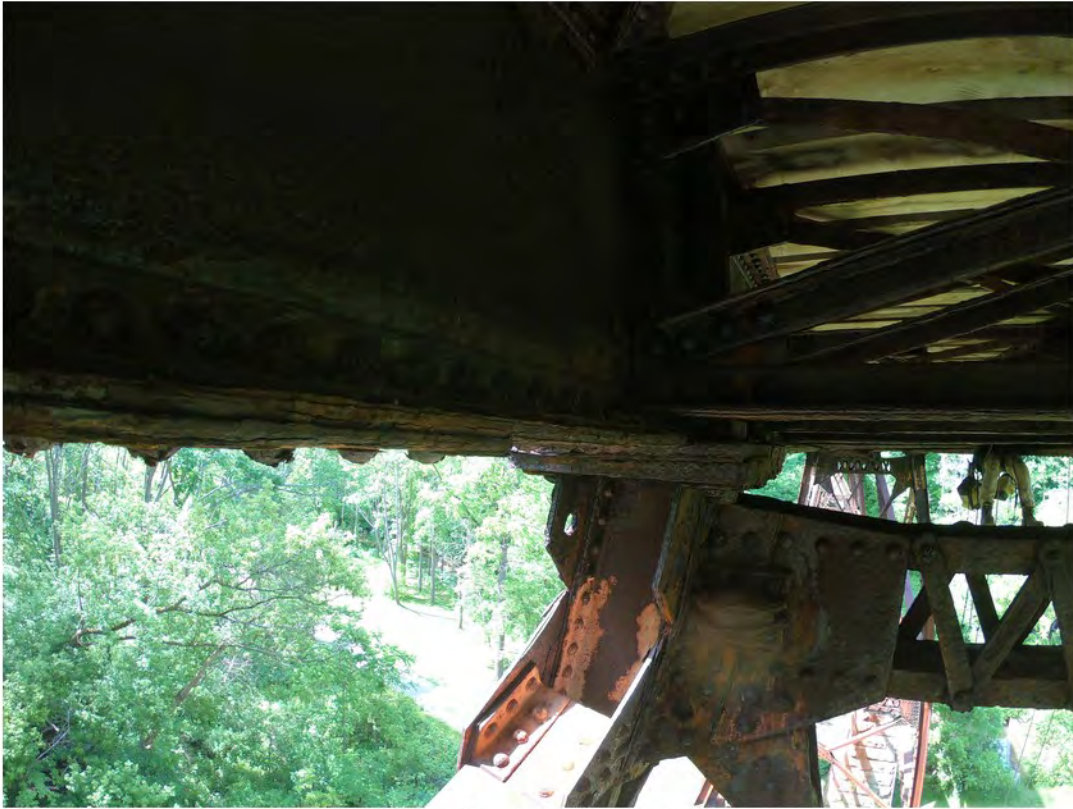
33. Medium Corrosion of Girder; Cracking of Rivets and Delamination of Bottom Flange

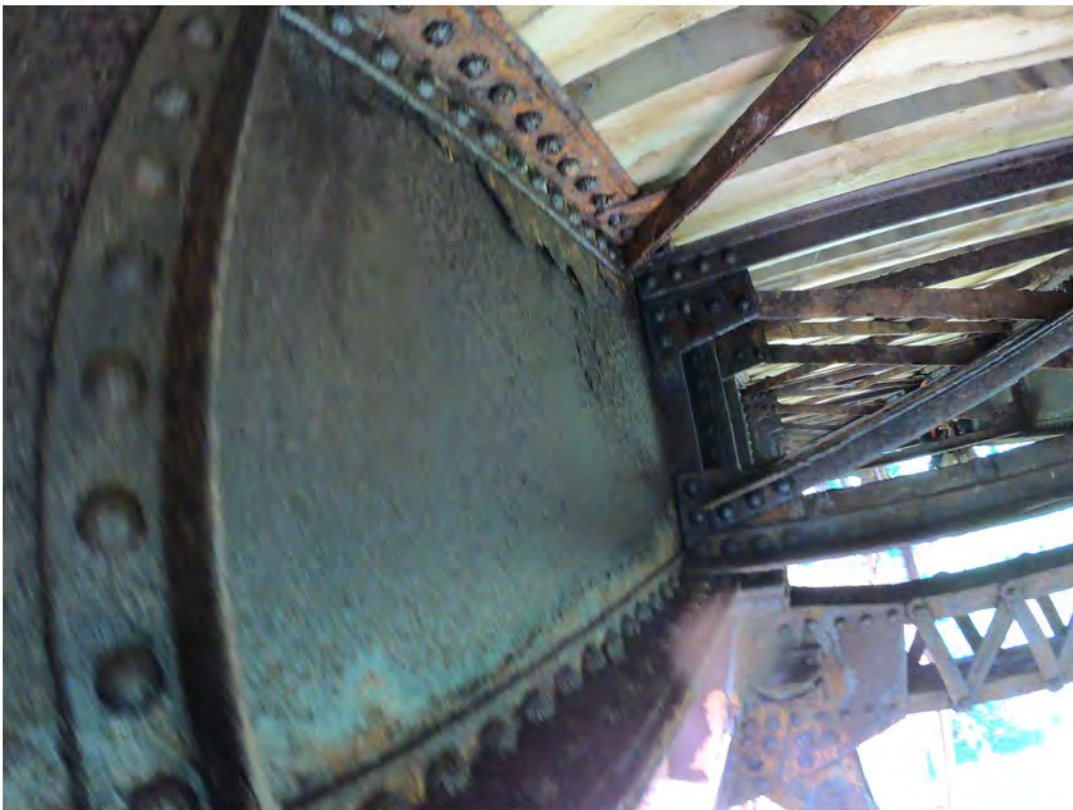
34. Medium Corrosion and Delamination of Girder

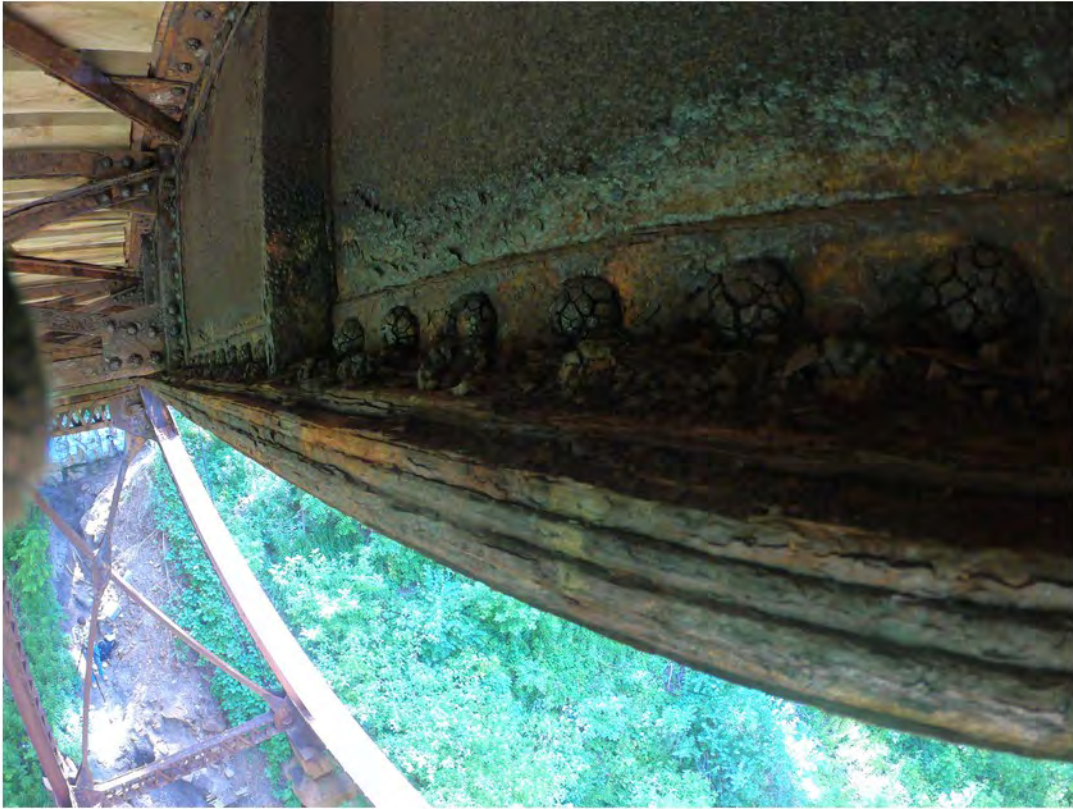
35. Severe Corrosion on Bottom Flange of Girder; Cracked Rivets

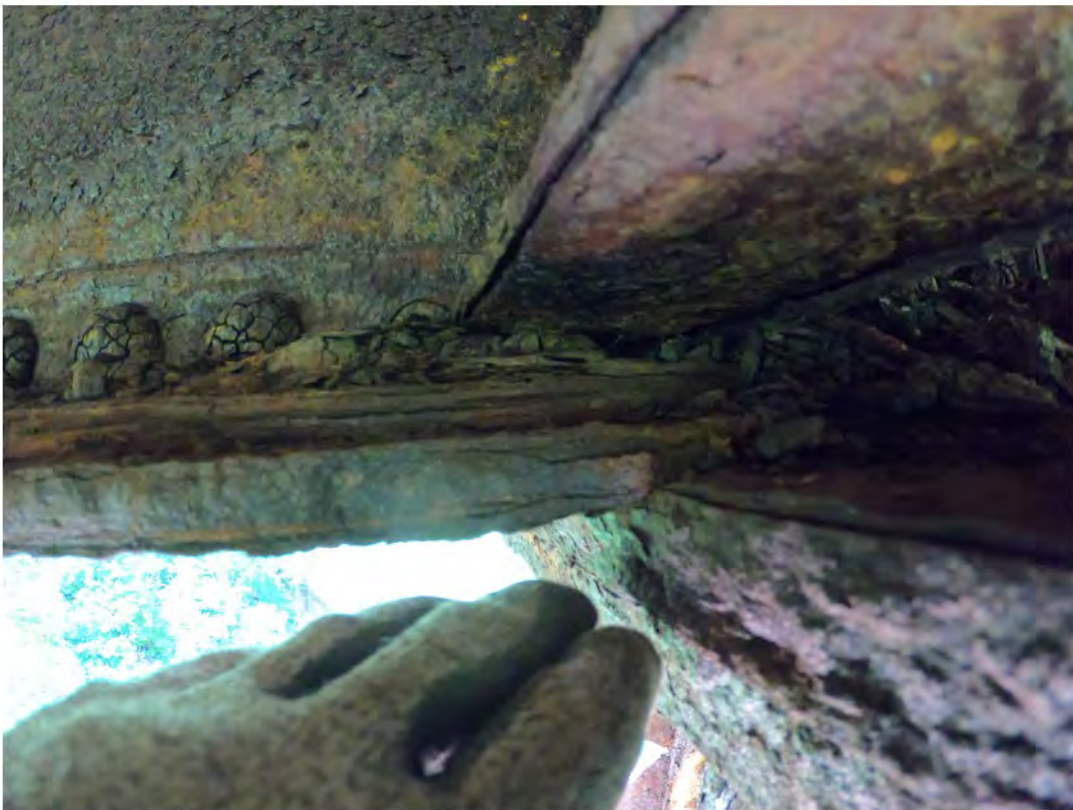
36. Deterioration of the Girder Flange at the South H Column

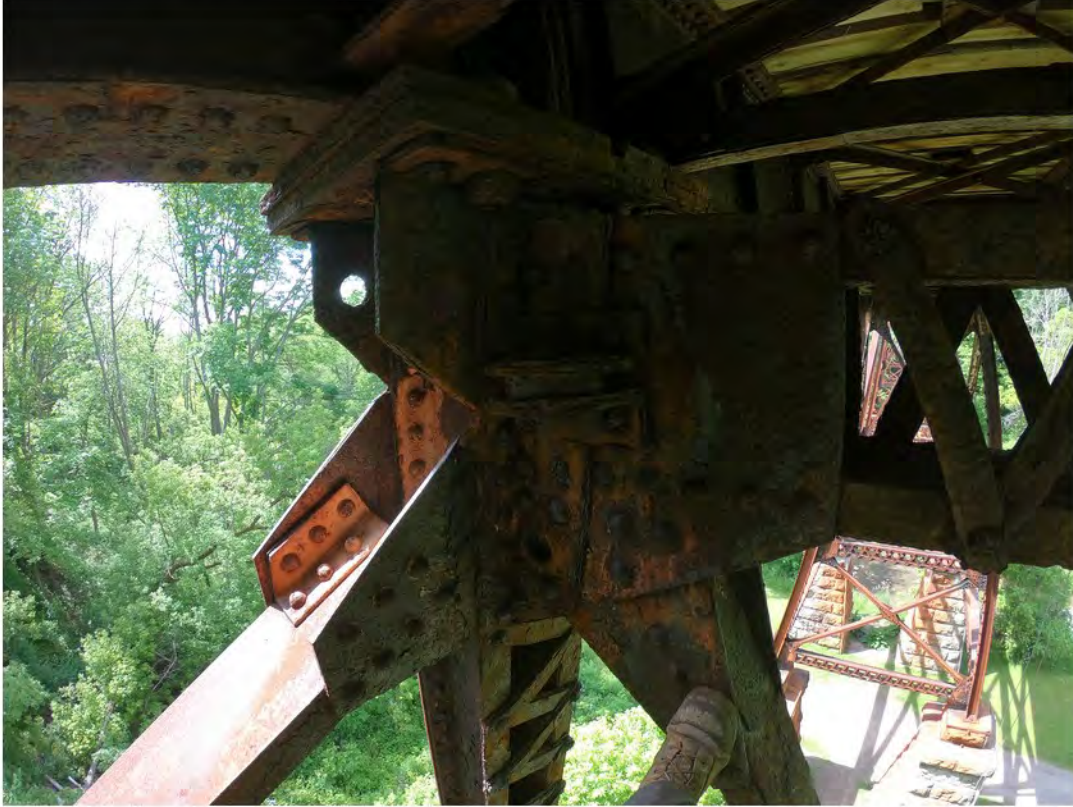
37. Very Severe Corrosion and Delamination at Column Connection to Girder; Separation of Bracing at Weld

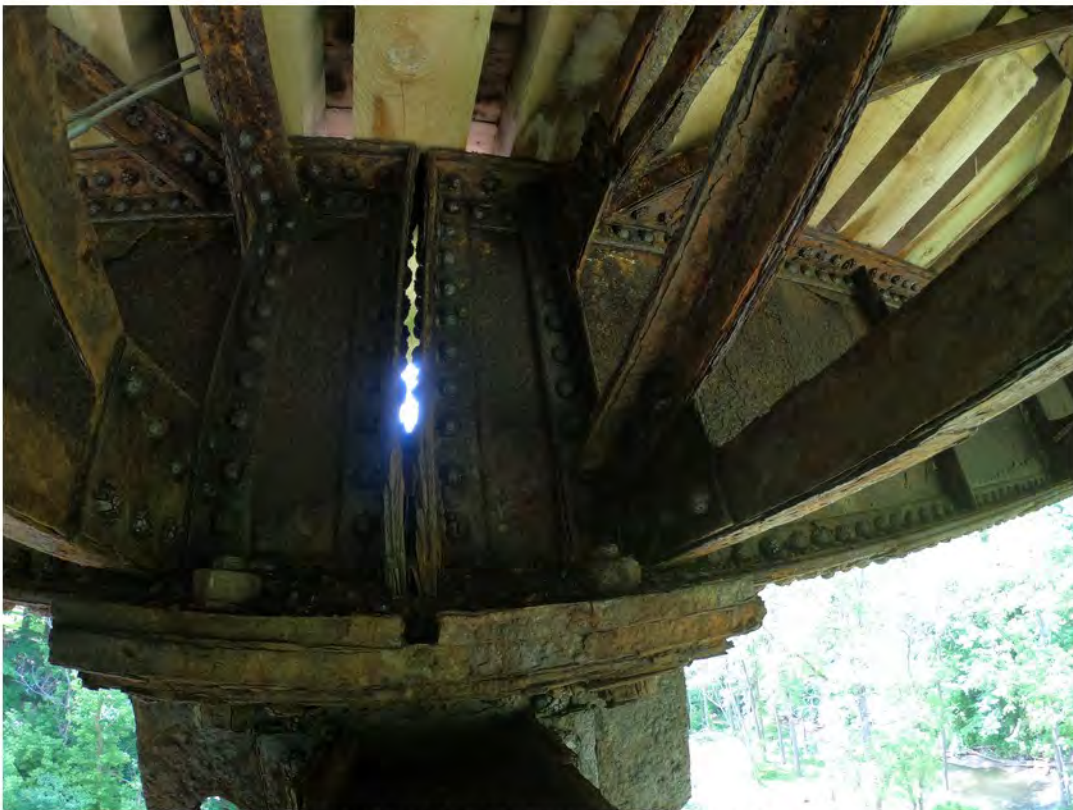
38. Severe Corrosion and Delamination of Diaphragm; Medium Corrosion and Delamination of Girder and Bearing Plate

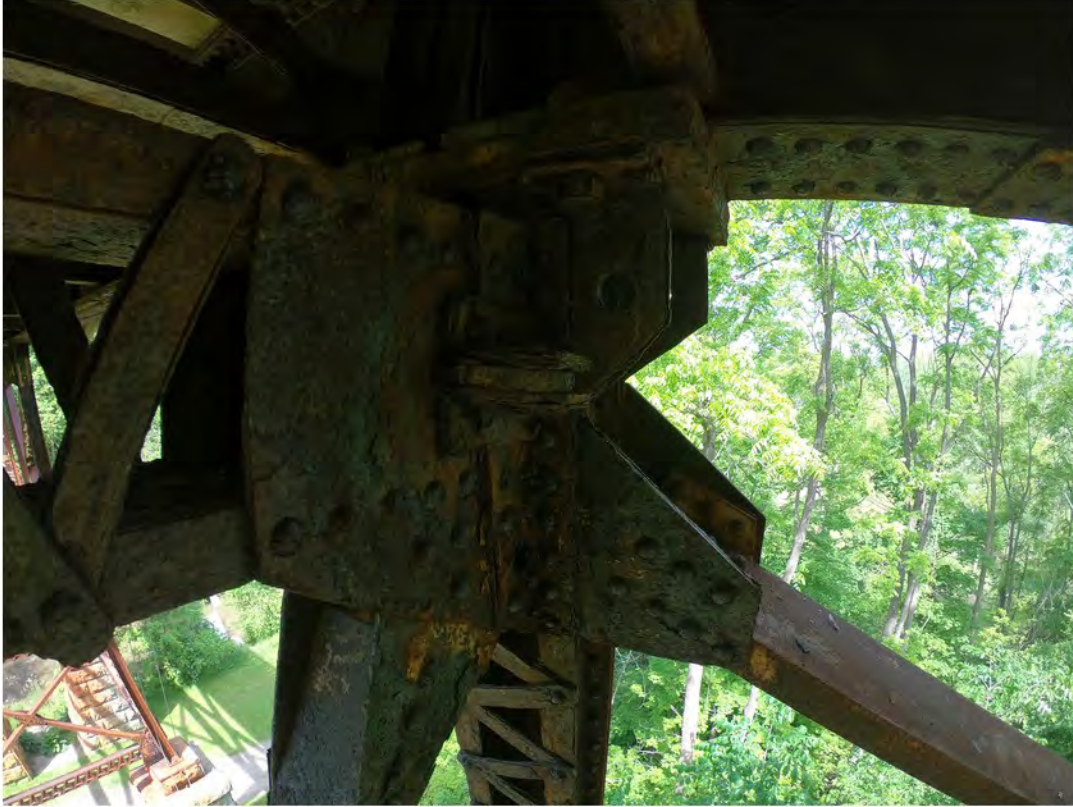
39. Severe Deterioration and Delamination at Connection of Girder, Column, and Diagonal Bracing

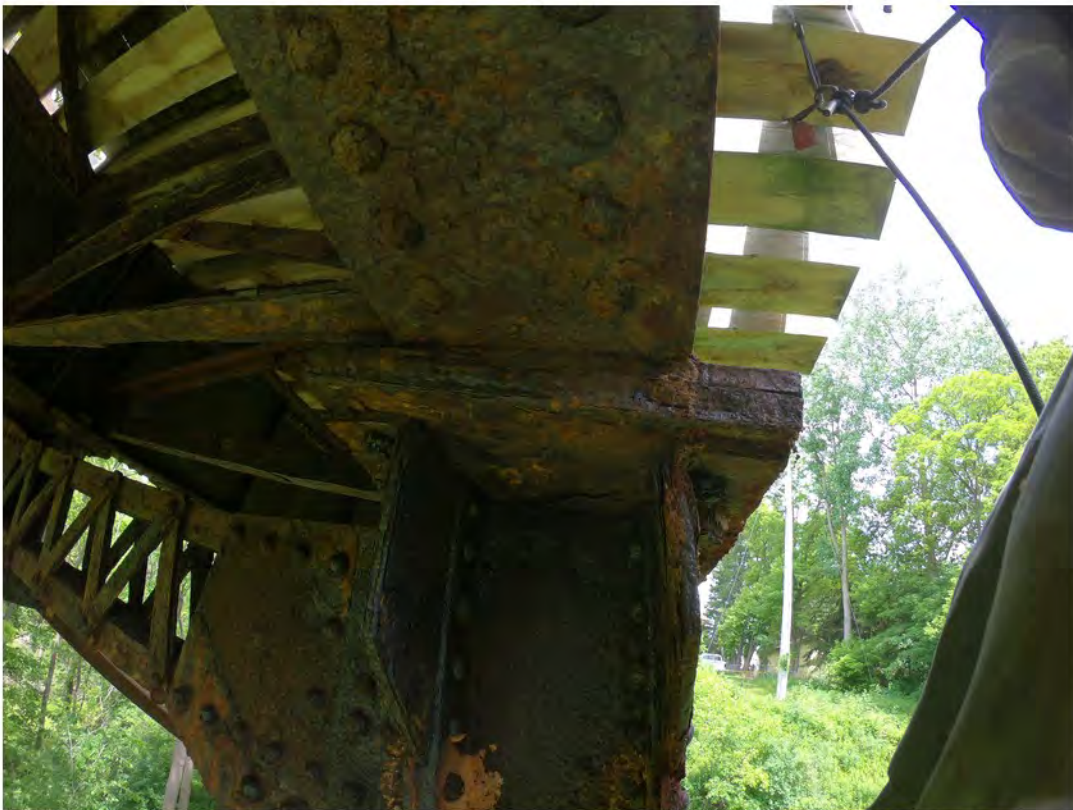
40. Medium Corrosion and Delamination of Bearing Plate at Girder; Medium Corrosion and Delamination on Bottom Flange of Girder

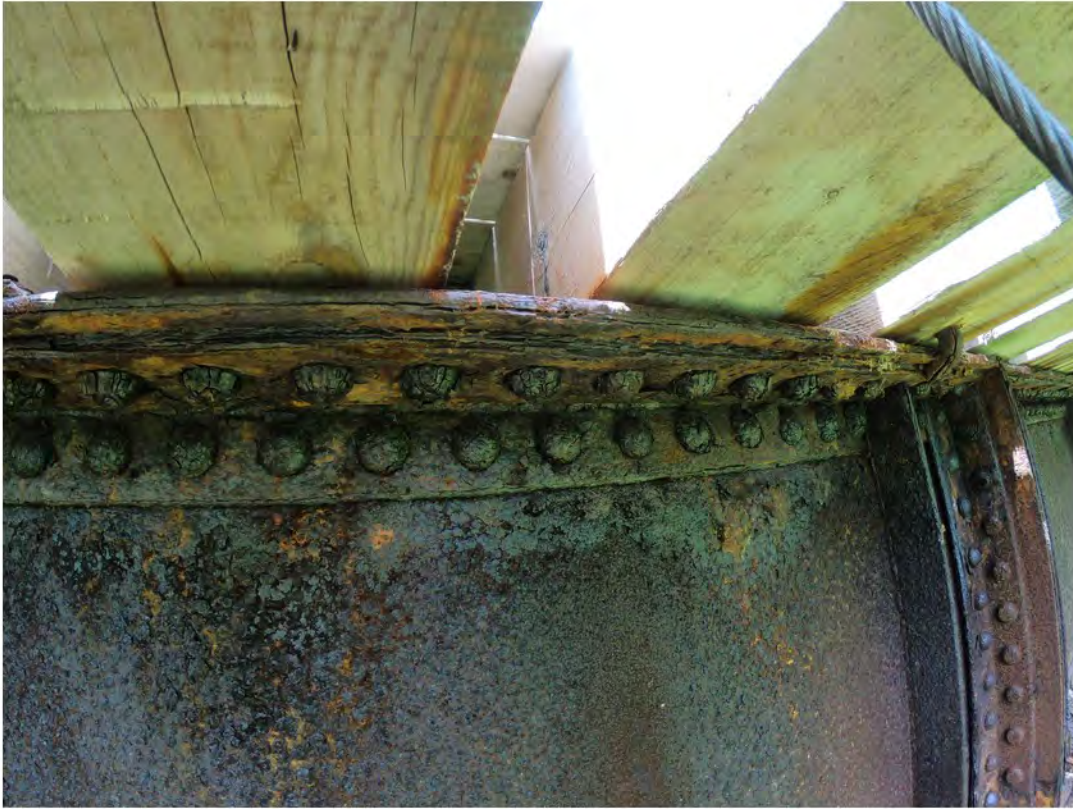
41. Severe Corrosion and Delamination on Top Flange of Girder

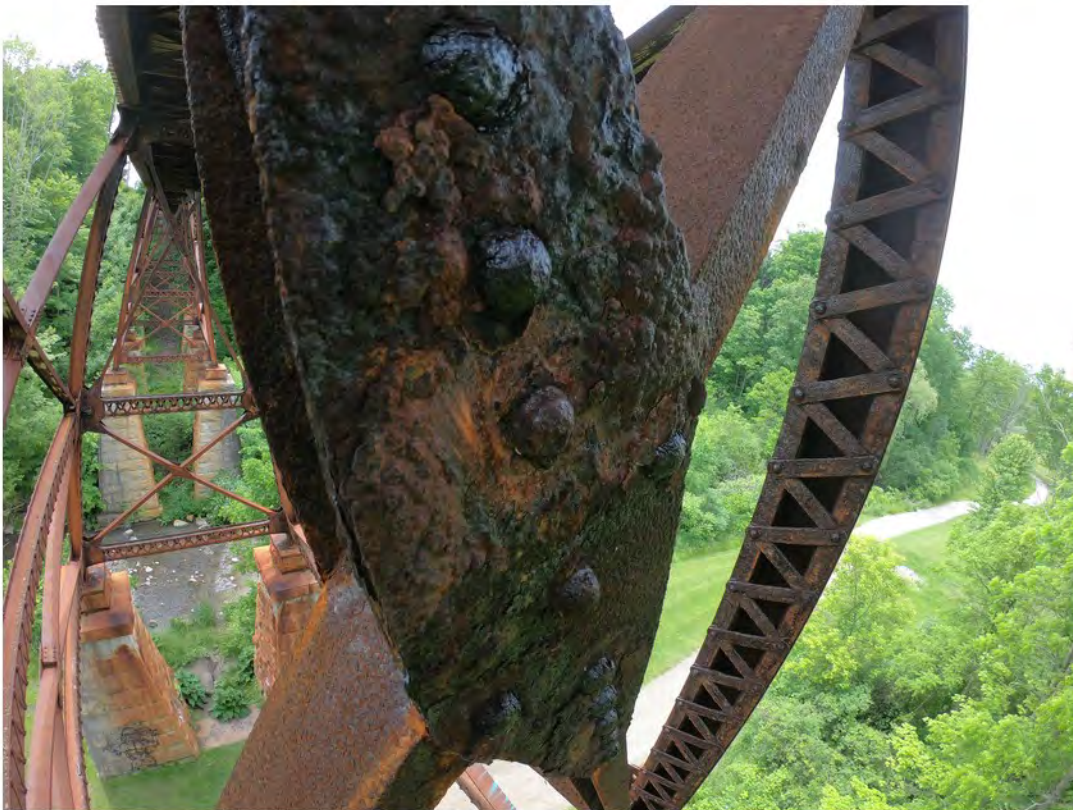
42. Very Severe Corrosion on Connection Plate Between Diagonal Lateral Bracing Members

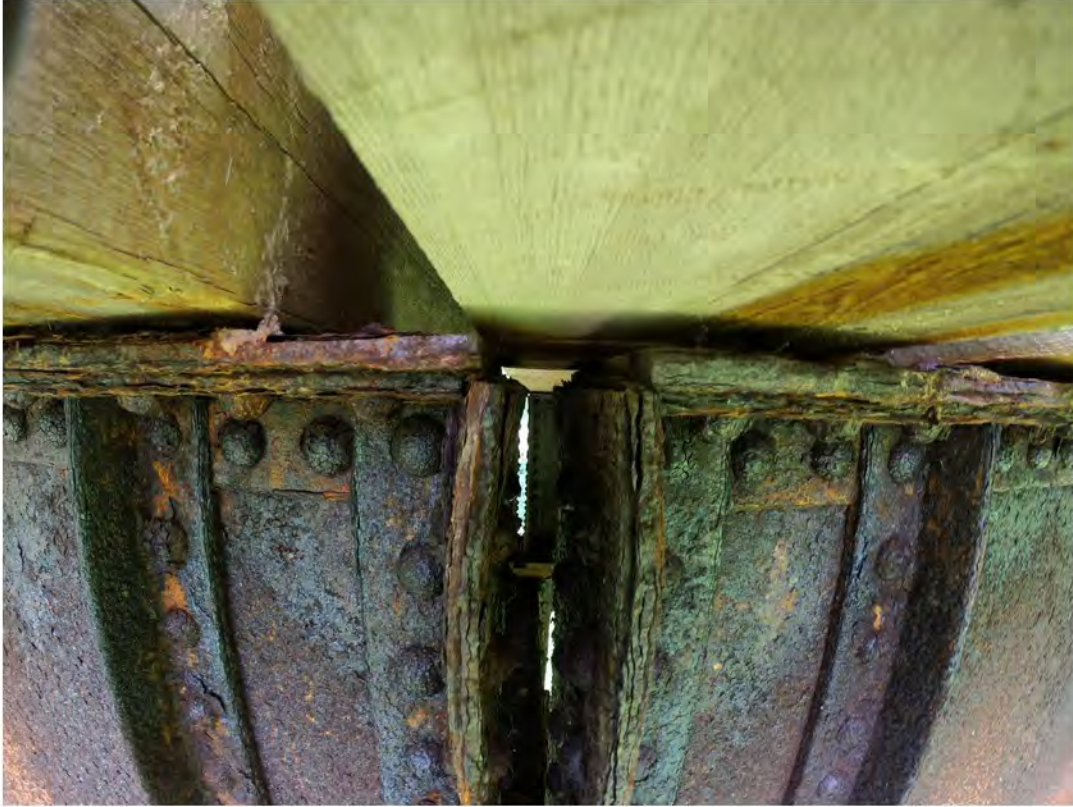
43. Very Severe Corrosion and Delamination at Ends of Girders Over Columns

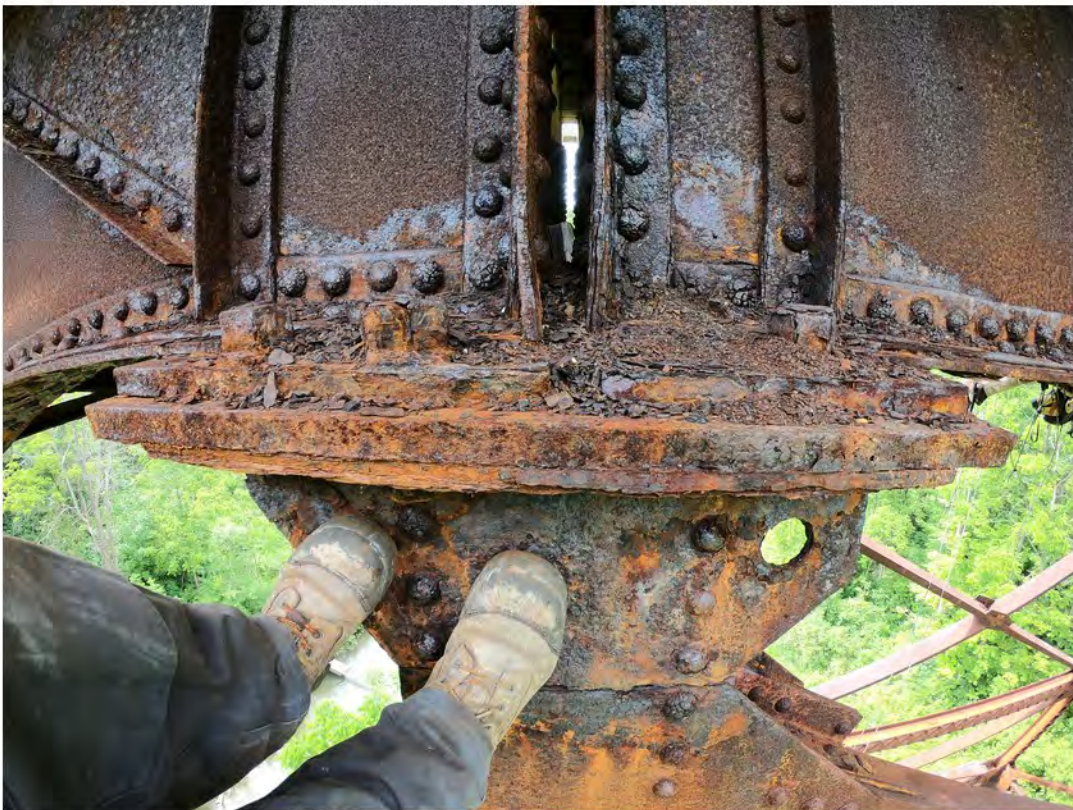
44. Severe Corrosion on Bottom Flange of Girder Resting on Bearing Plate; Medium Corrosion and Delamination of Bearing Plate

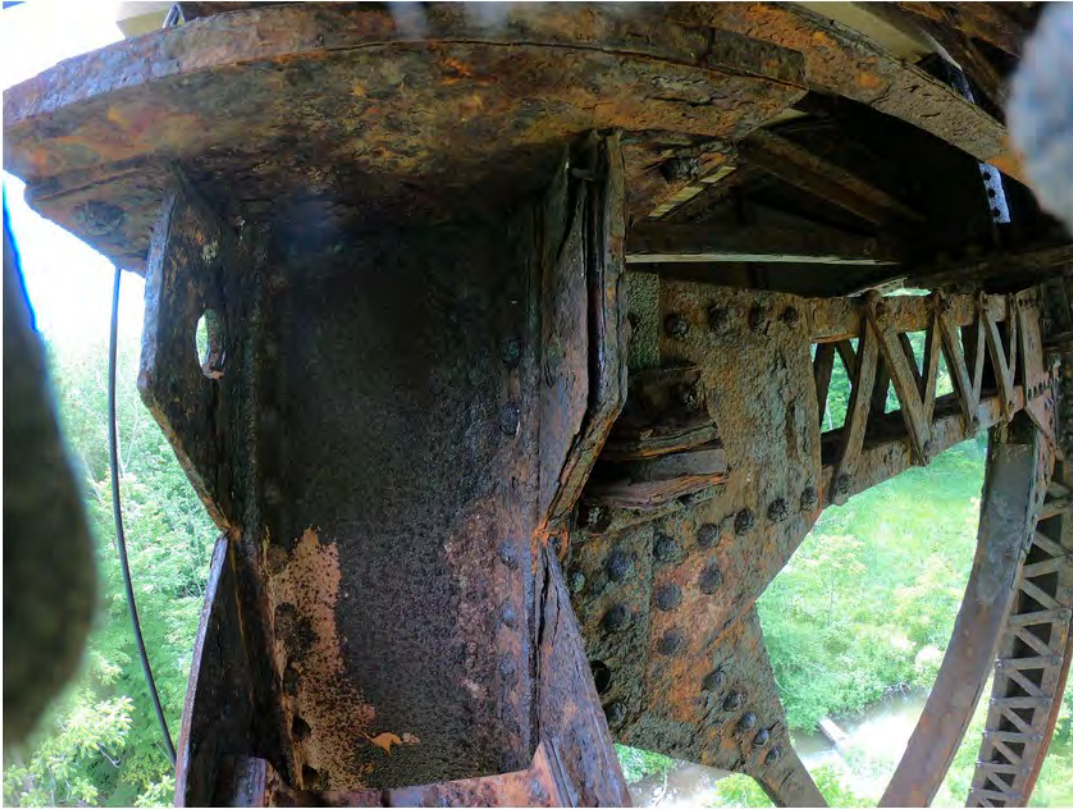
45. Very Severe Deterioration and Delamination of Bearing Seat at Top of Column

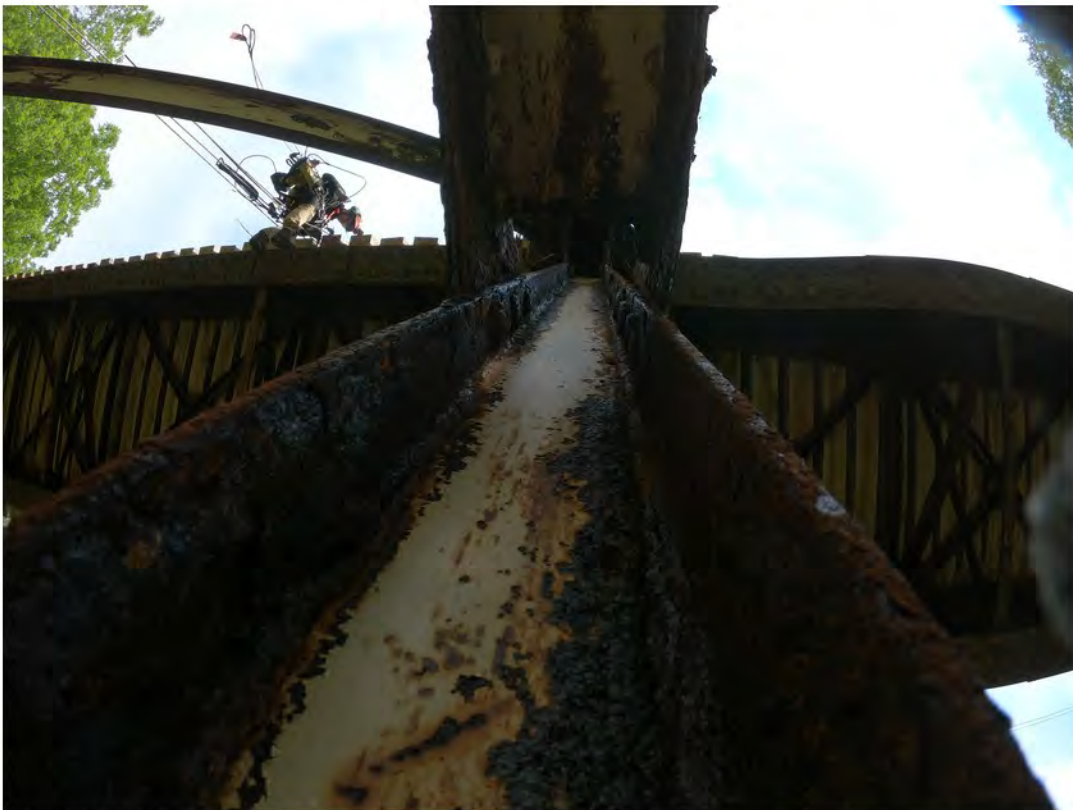
46. Severe Corrosion and Delamination on Both Flanges of Column

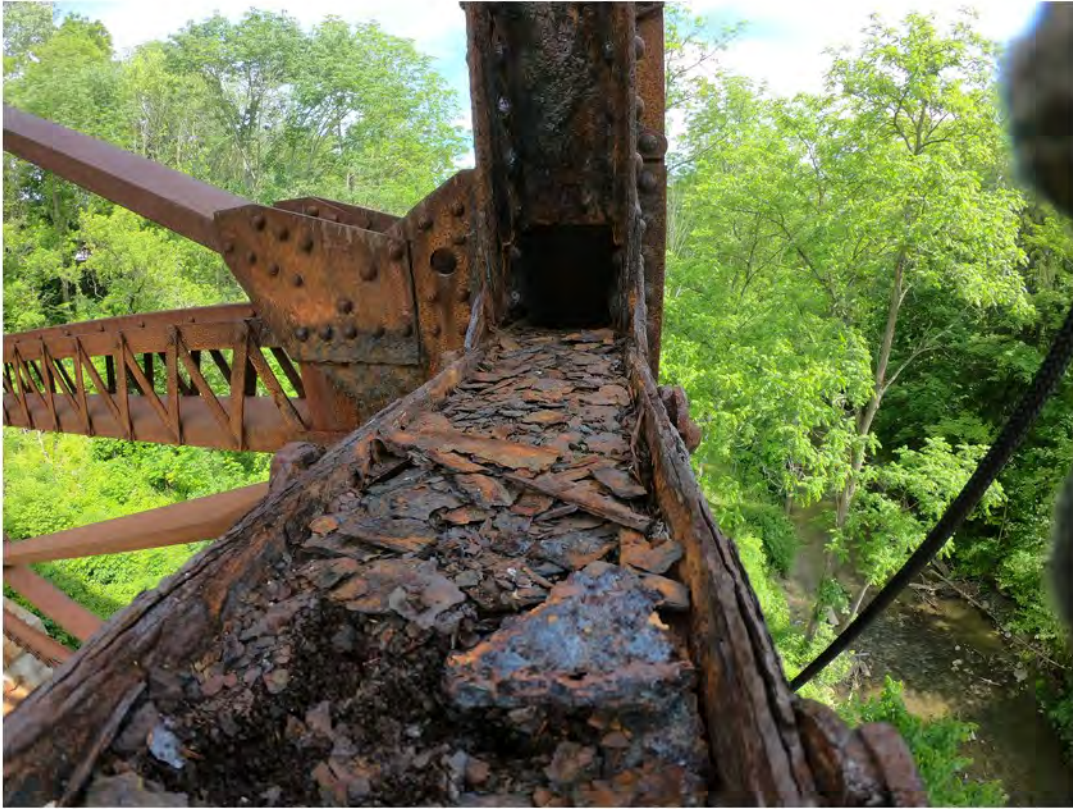
47. Very Severe Corrosion and Delamination of Horizontal Chord

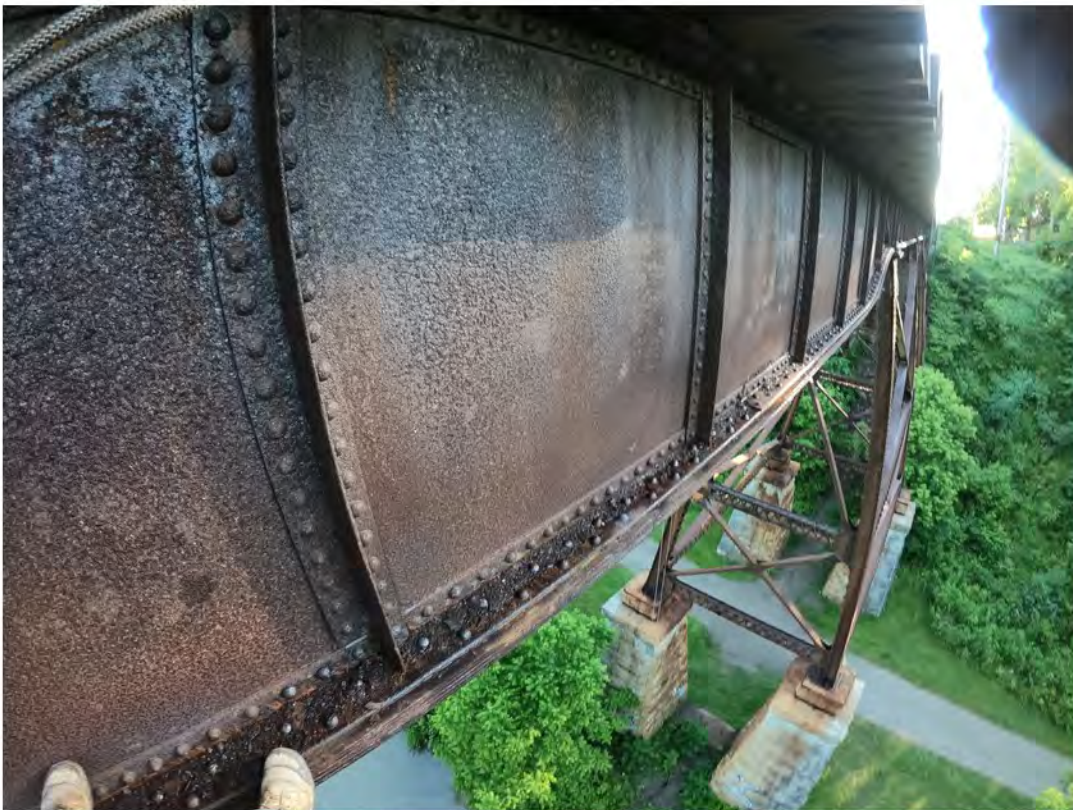
48. Medium Corrosion on Girder, Typical

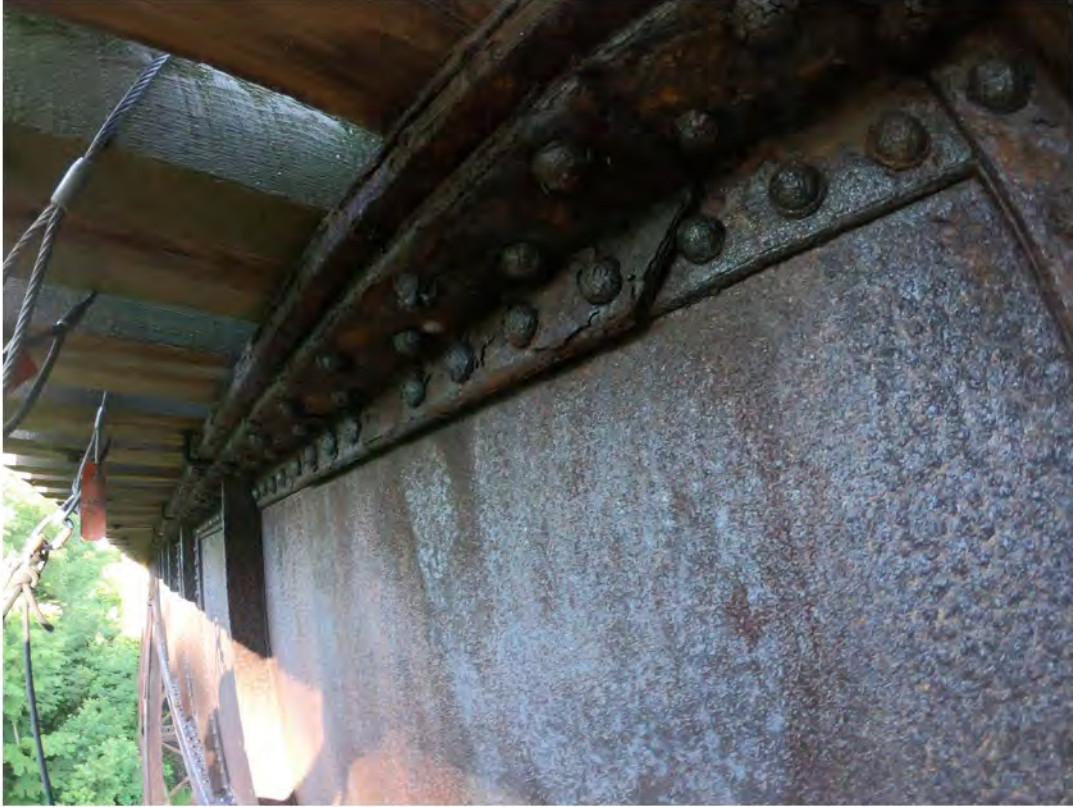
49. Severe Corrosion and Delamination of Angle Connections at the Top of Girder

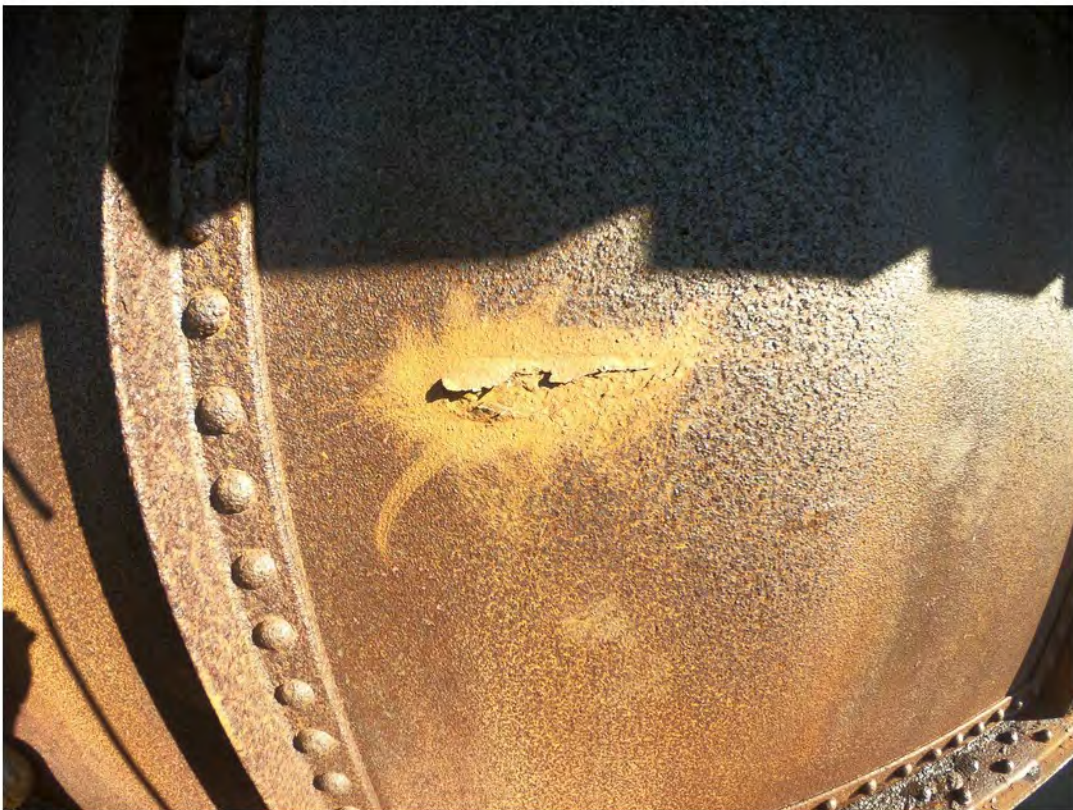
50. Localized Delamination on Exterior Face of Girder

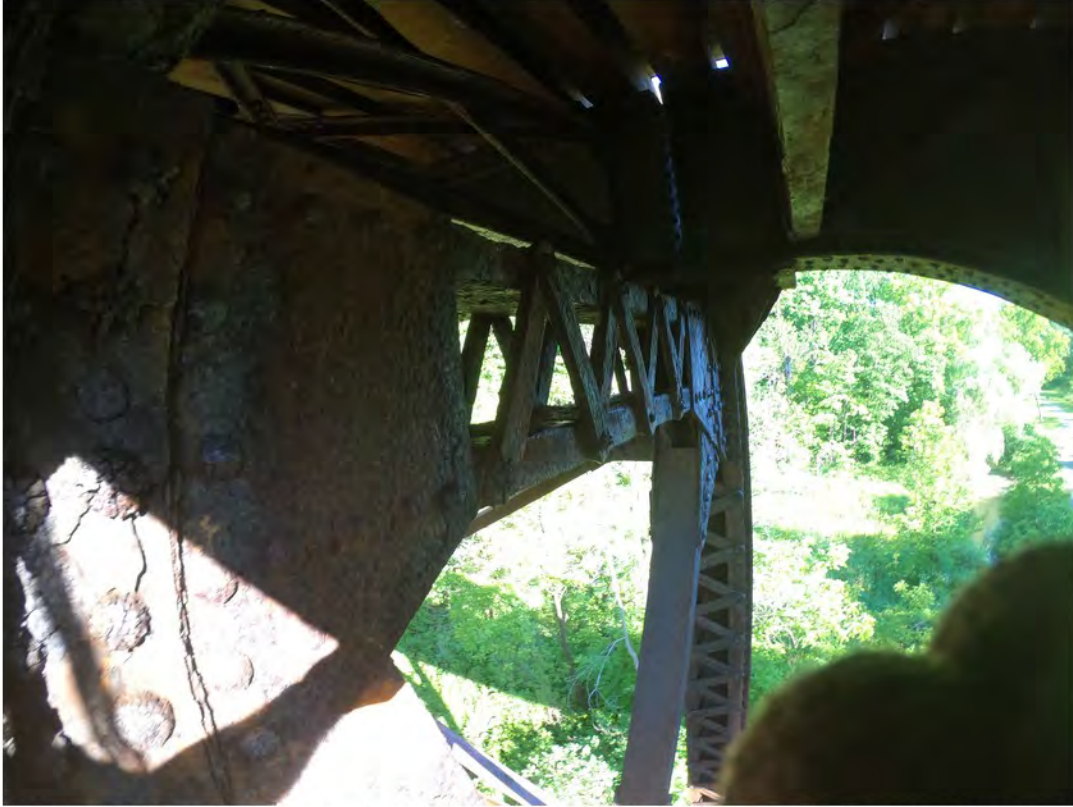
51. Severe Corrosion and Delamination of Connections and Cracking of Rivets at Lateral Support

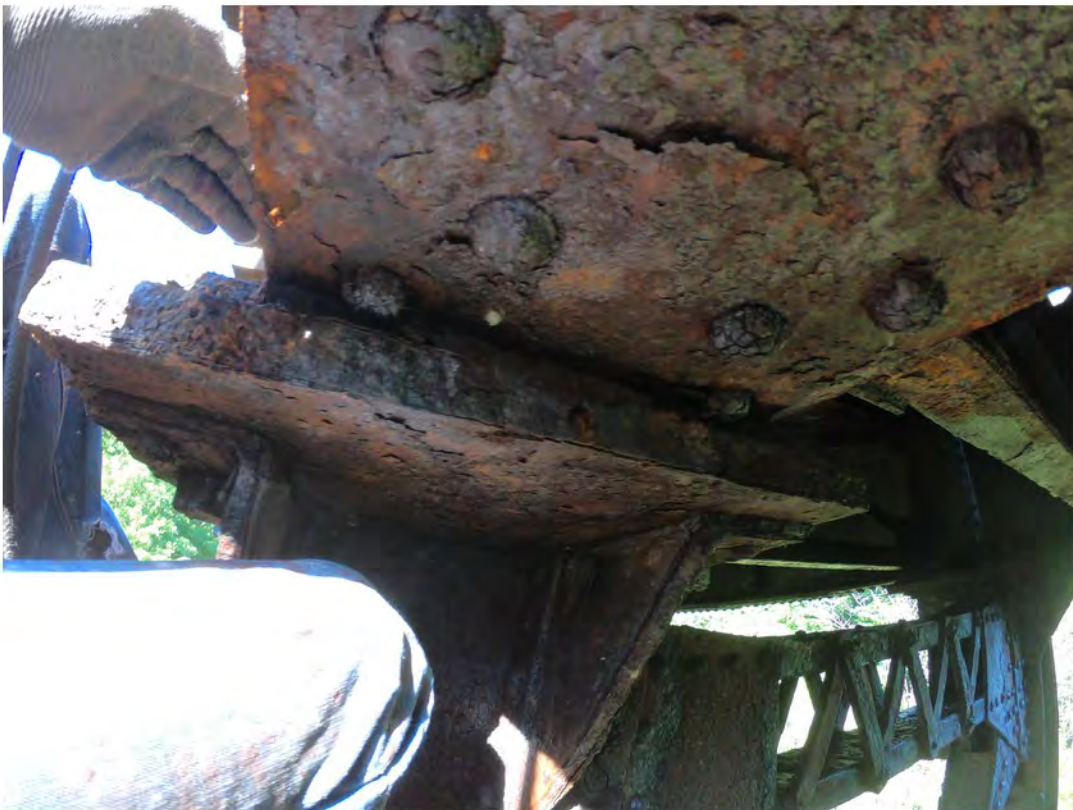
52. Severe Corrosion and Delamination on Bottom Flange of Girder at Column Connection

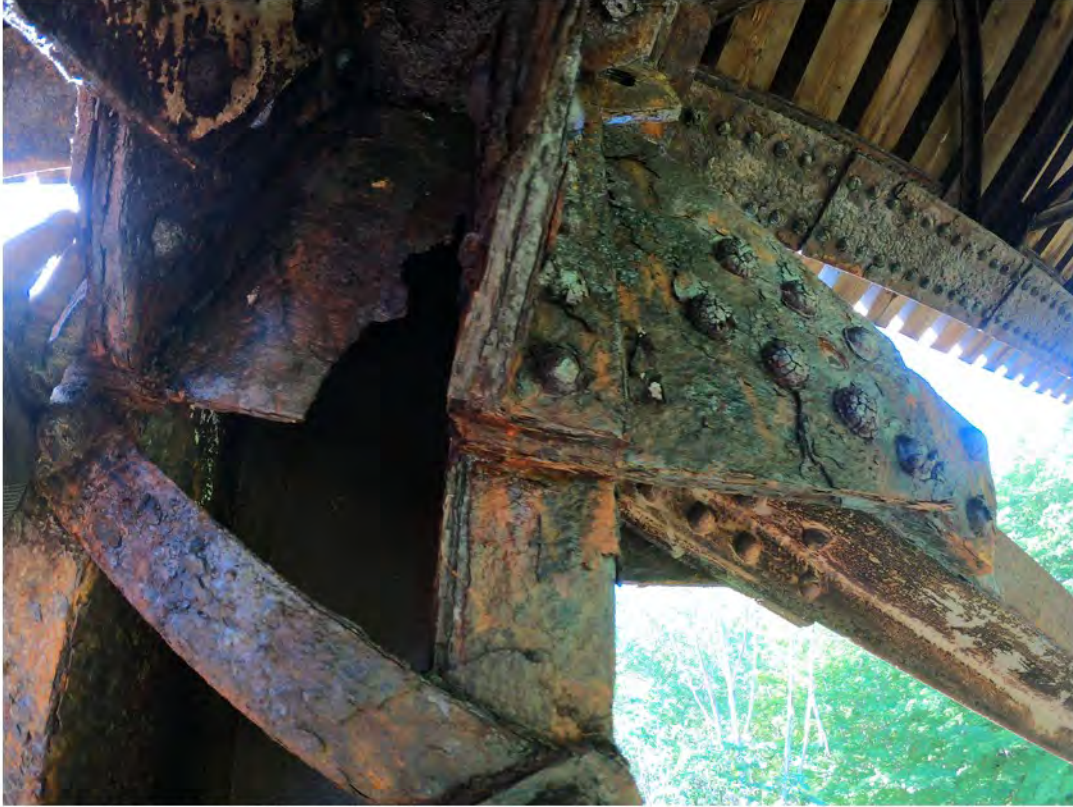
53. Very Severe Corrosion with Section Loss on Column Connection at South Column E

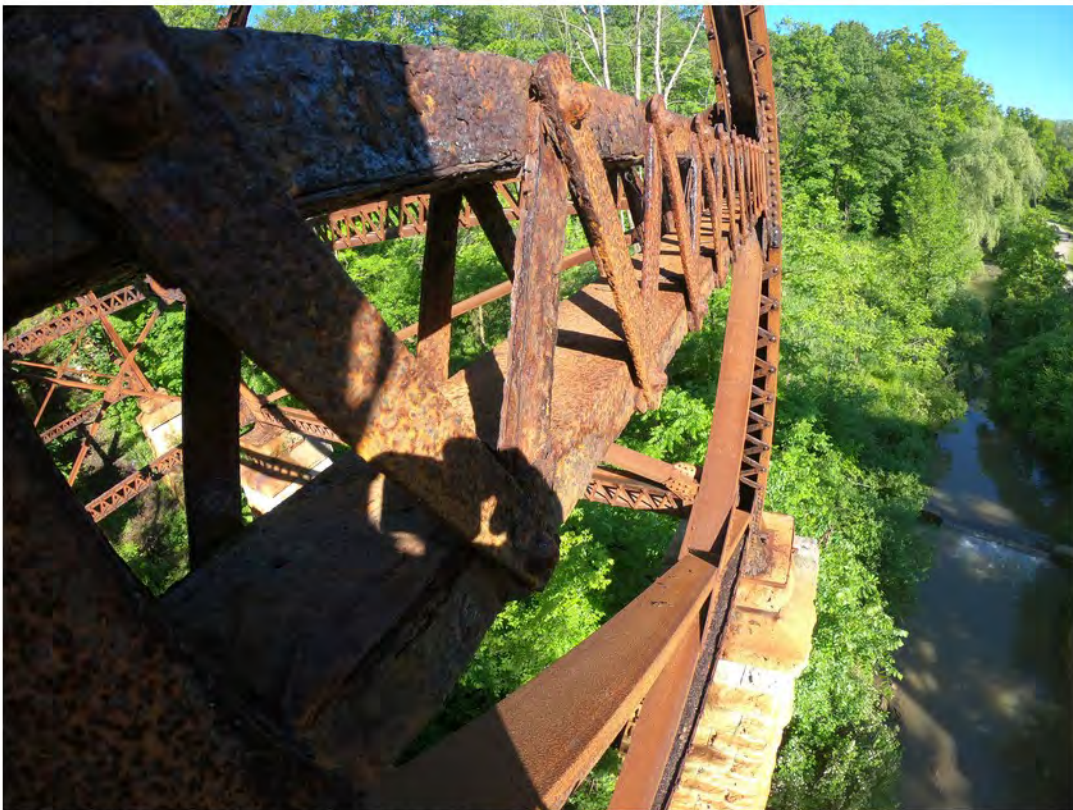
54. Severe Corrosion of Lateral Support and Lace Bracing at Centre of Columns, Typical

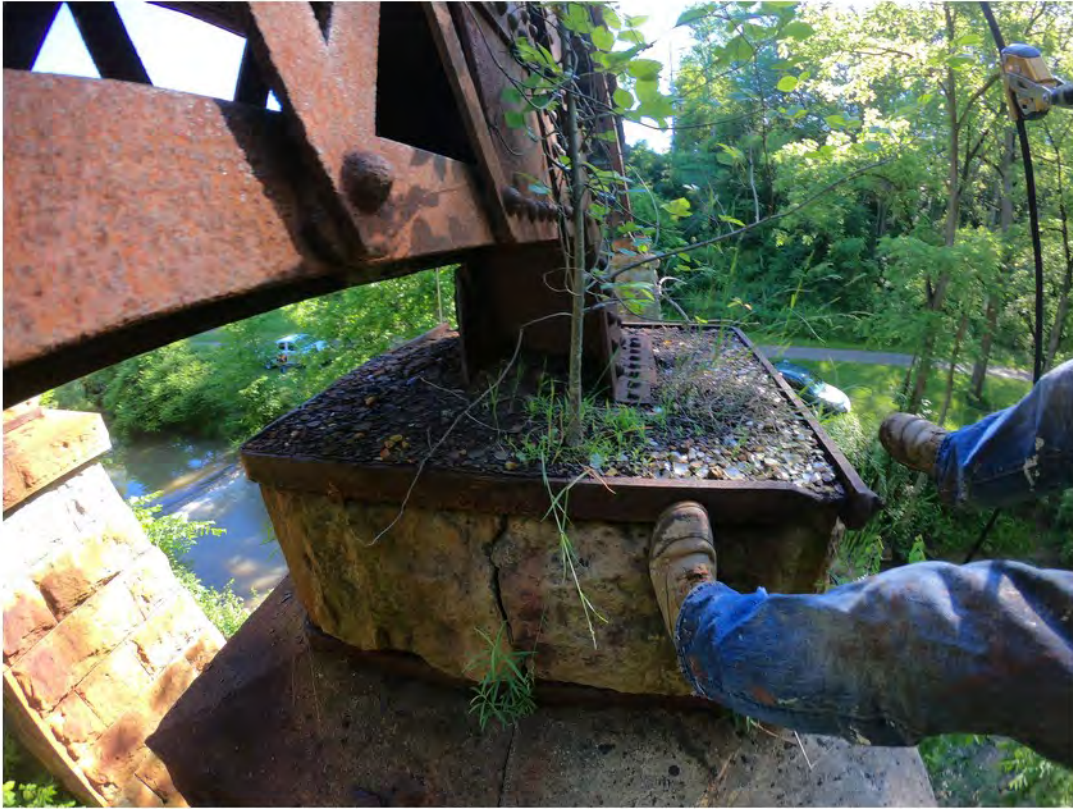
55. Medium Corrosion of Connection Between Column and Bearing Seat; Vertical Crack in Pier Cap

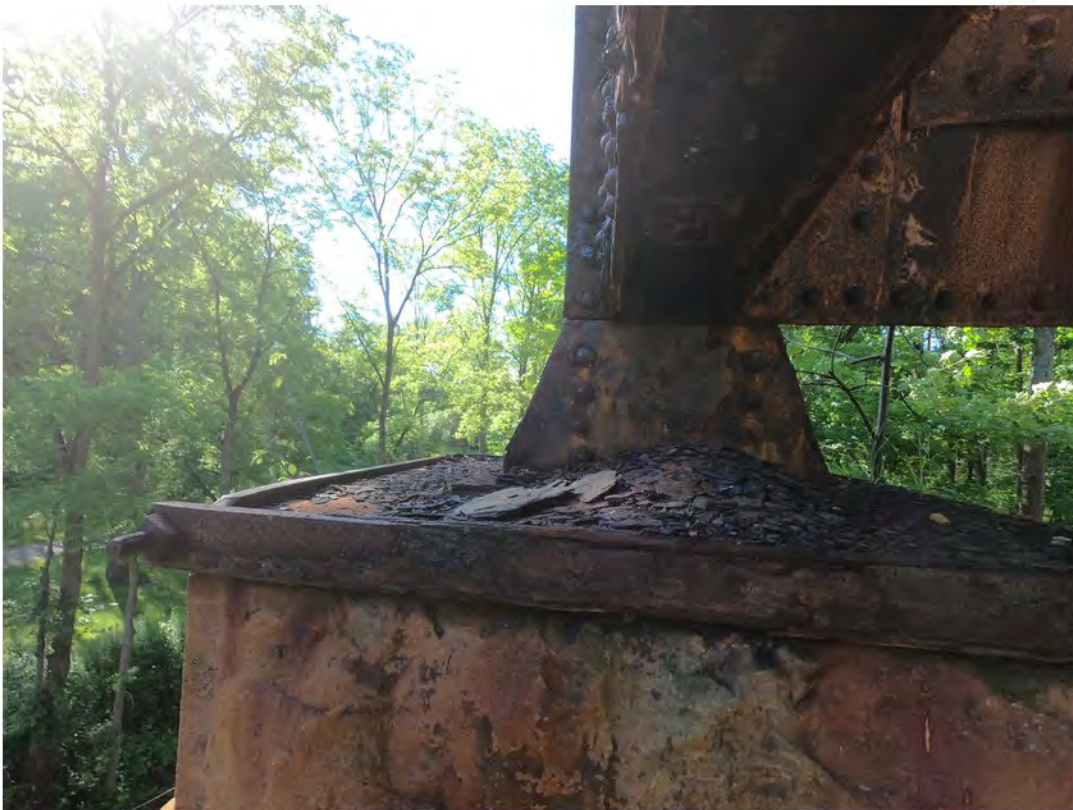
56. Severe Corrosion and Delamination of Column Bearing Connection

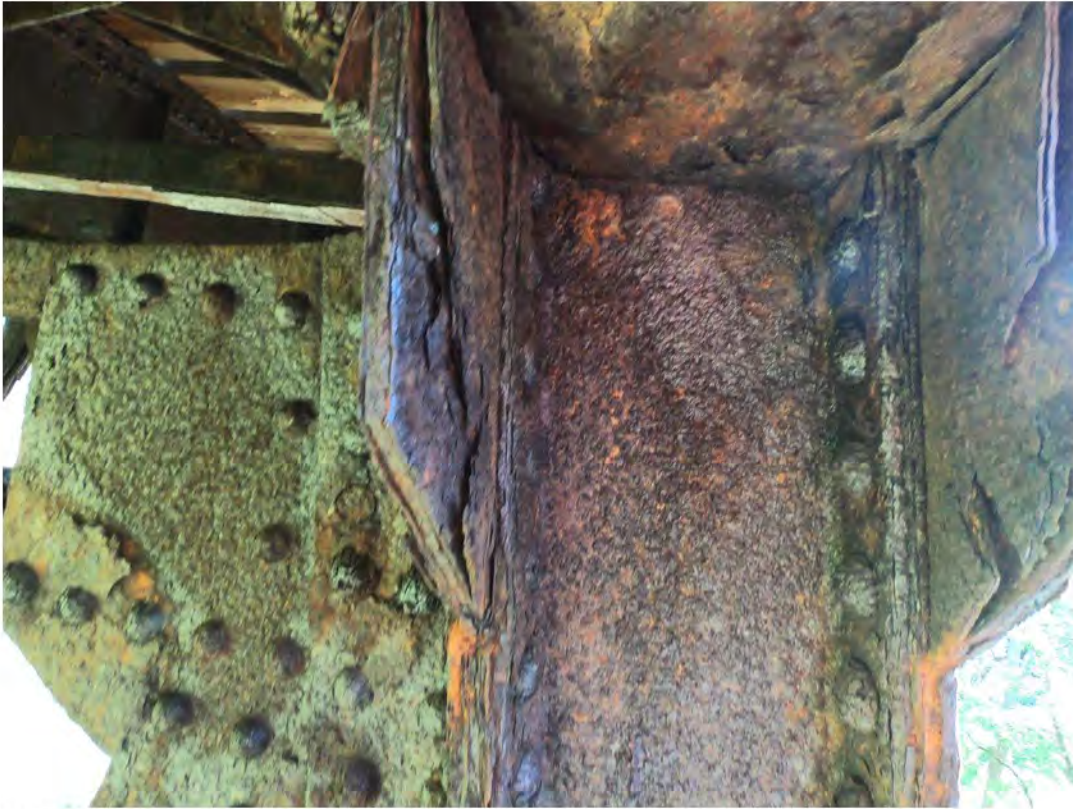
57. Severe Corrosion and Delamination at Connection of Column to Girder

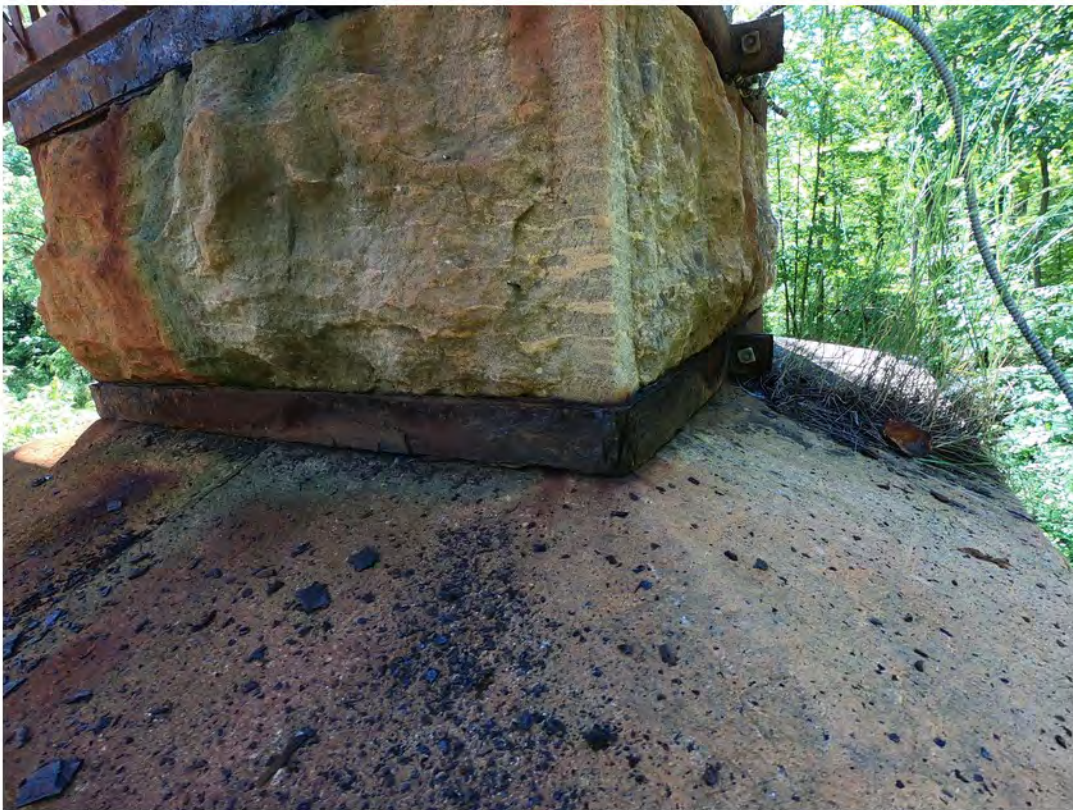
58. Medium Corrosion and Delamination of Steel Between Pier and Pier Cap
