KINSMEN PEDESTRIAN BRIDGE

EVALUATION REPORT

**ENHANCED OSIM INSPECTION,
LOAD LIMIT ANALYSIS,
& OPTIONS EVALUATION**

FOR
THE CORPORATION OF
THE TOWN OF TILLSONBURG

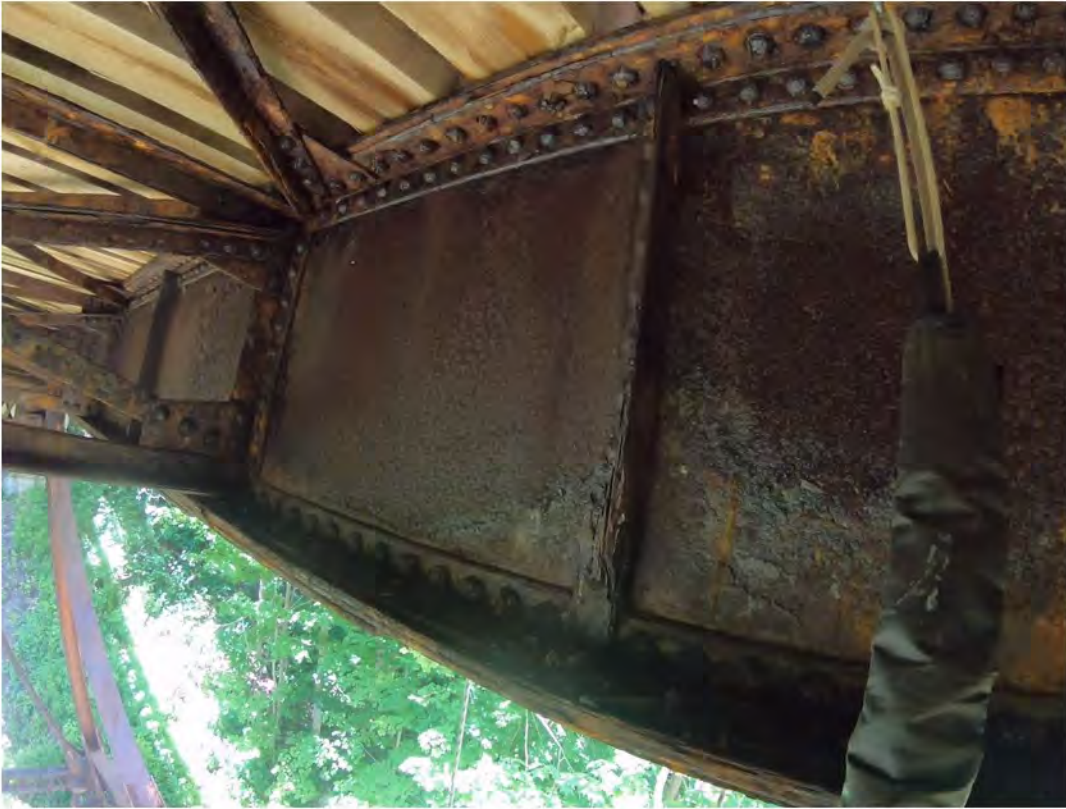
59. Very Severe Corrosion and Forty Percent Section Loss of Vertical Web Stiffener

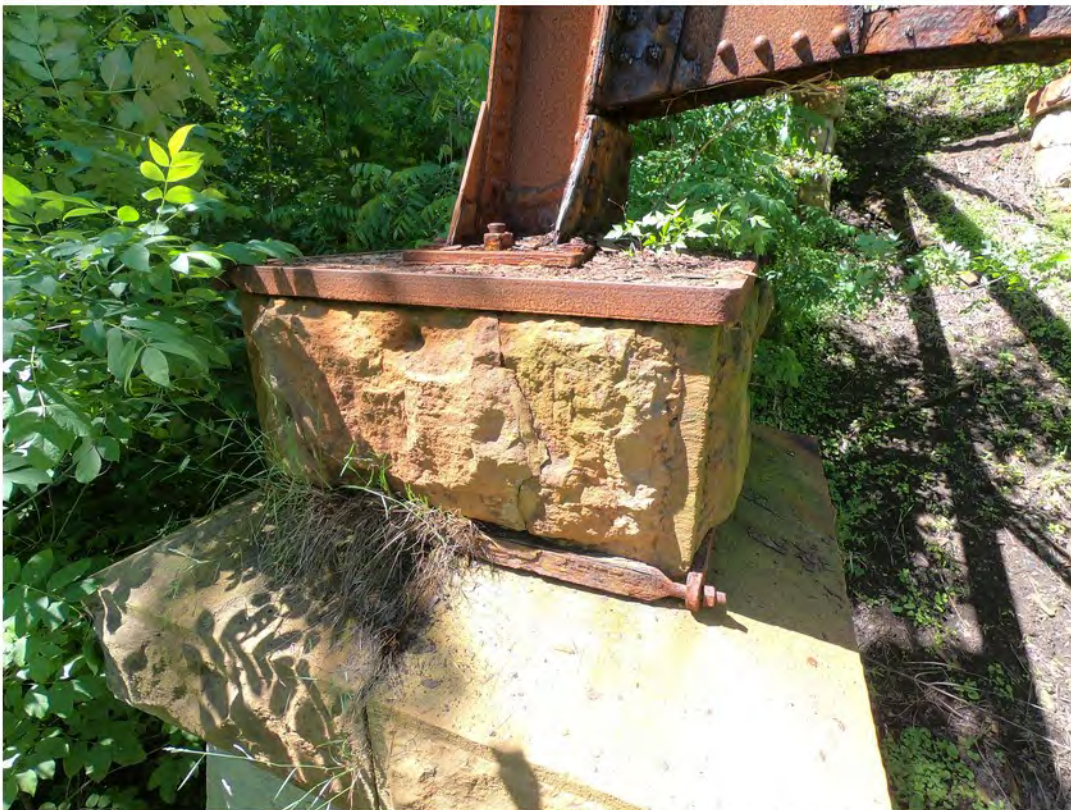
60. Severe Corrosion and Delamination of Steel at Bottom of Pier Cap; Vertical Crack in Pier Cap

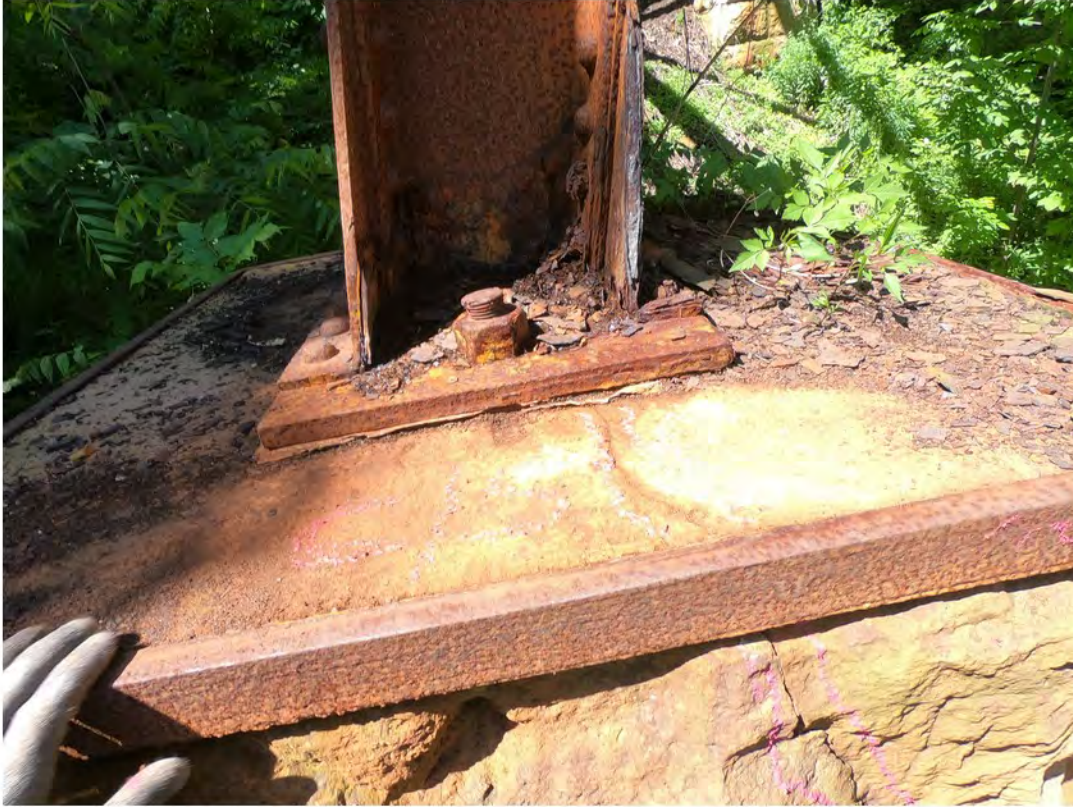
61. Vertical Crack in Bearing Block; Severe Corrosion of Column at Connection

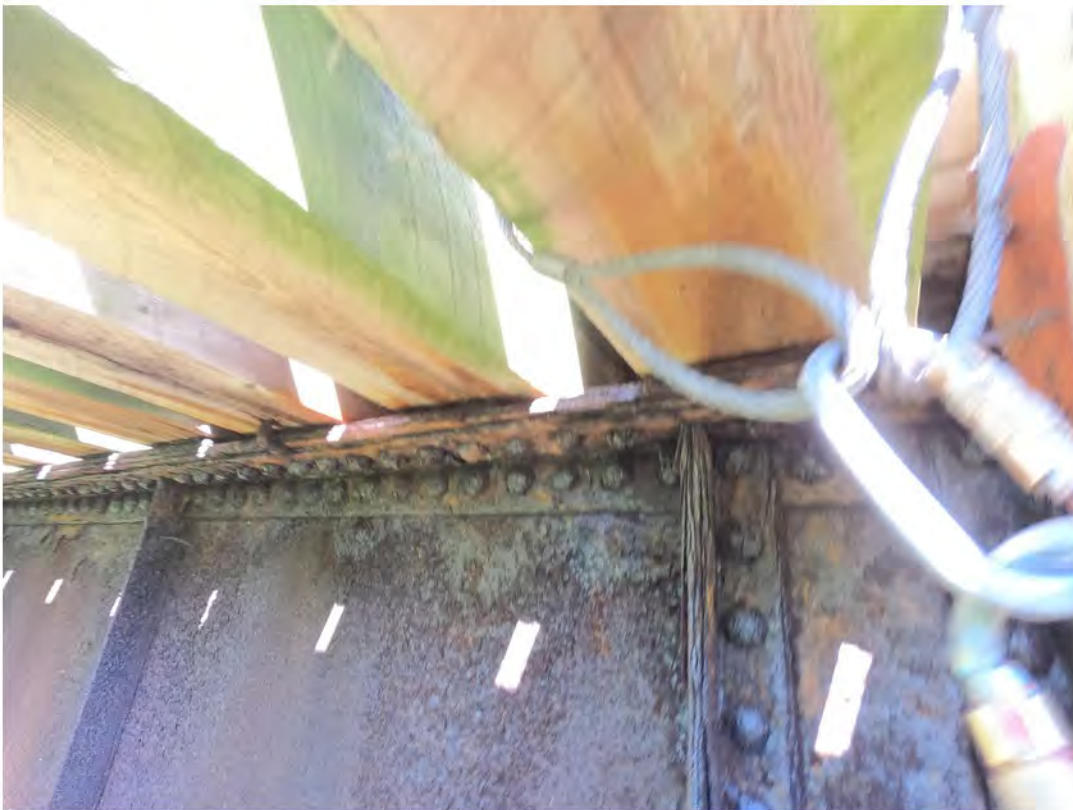
62. Severe Corrosion and Delamination of Web Stiffener

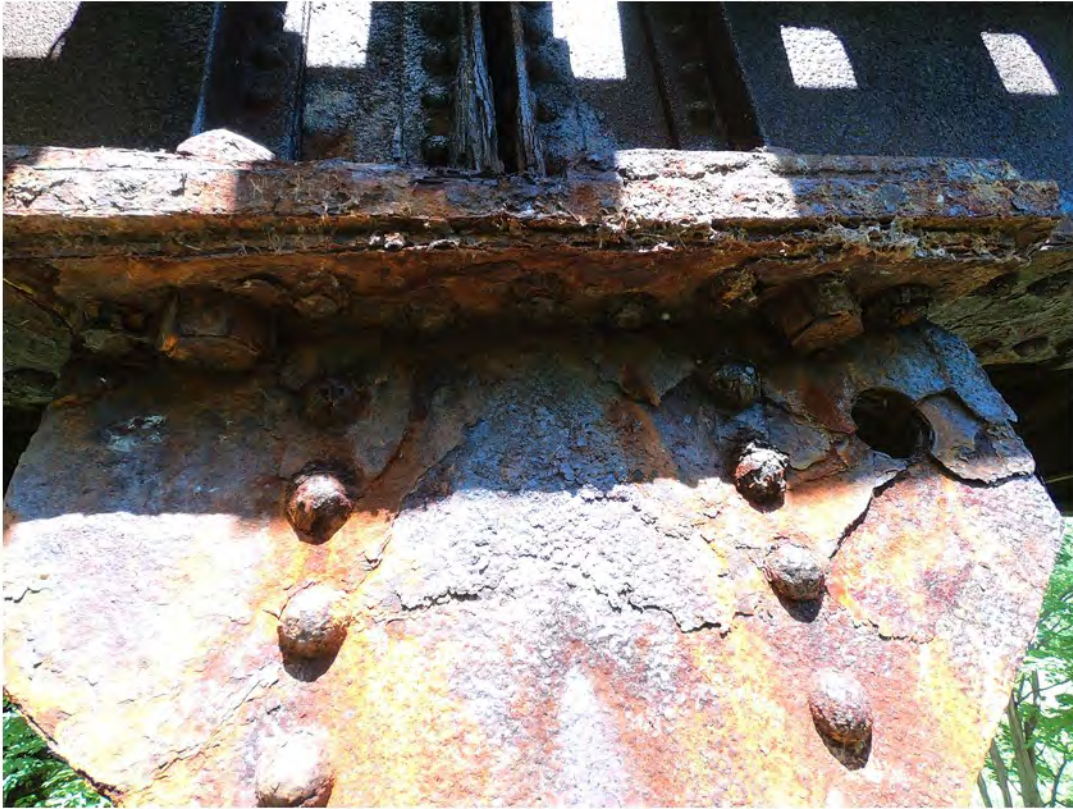
63. Severe Corrosion of Connection Plate and Bearing Plate at Connection Between Column and Girder

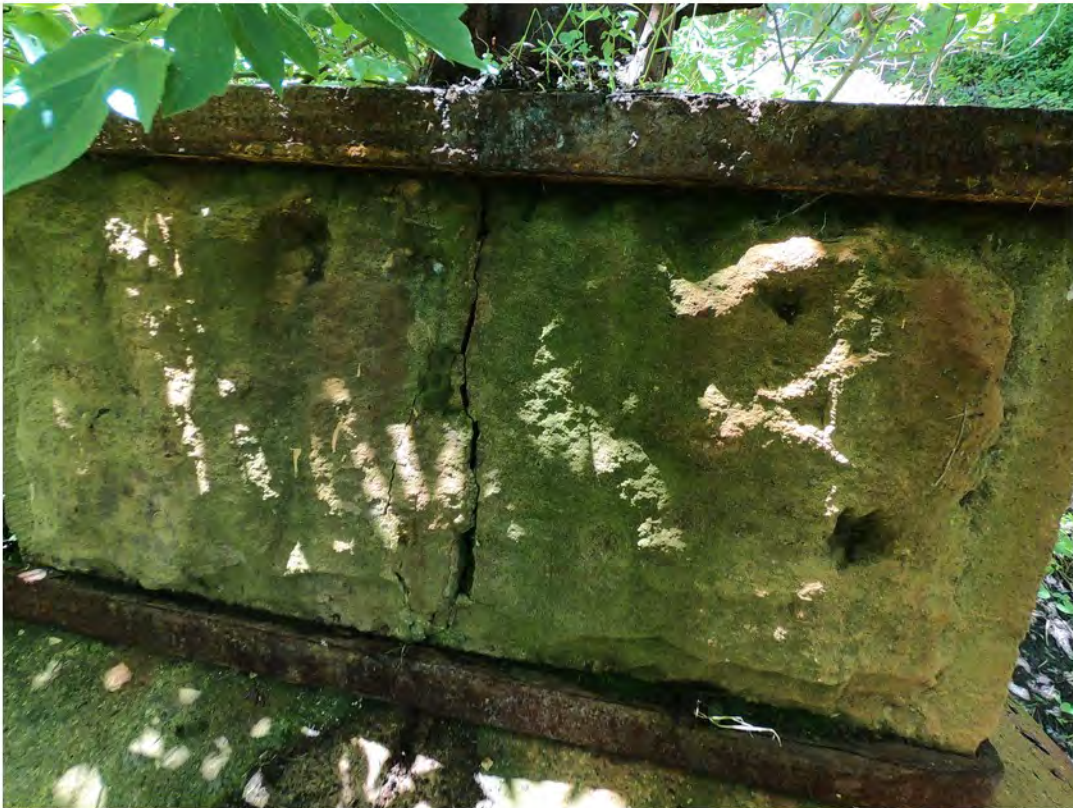
64. Vertical Cracking Through Pier Cap

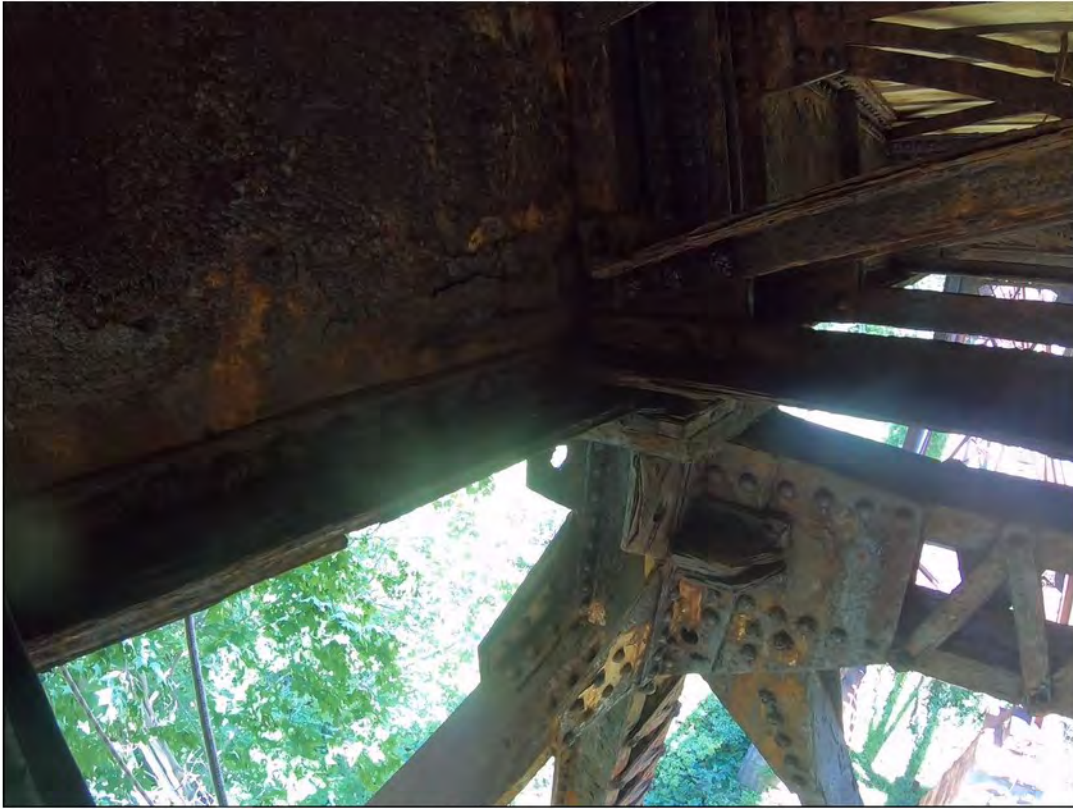
67. Very Severe Corrosion and Fifty Percent Section Loss of Bracket Under Bearing Seat

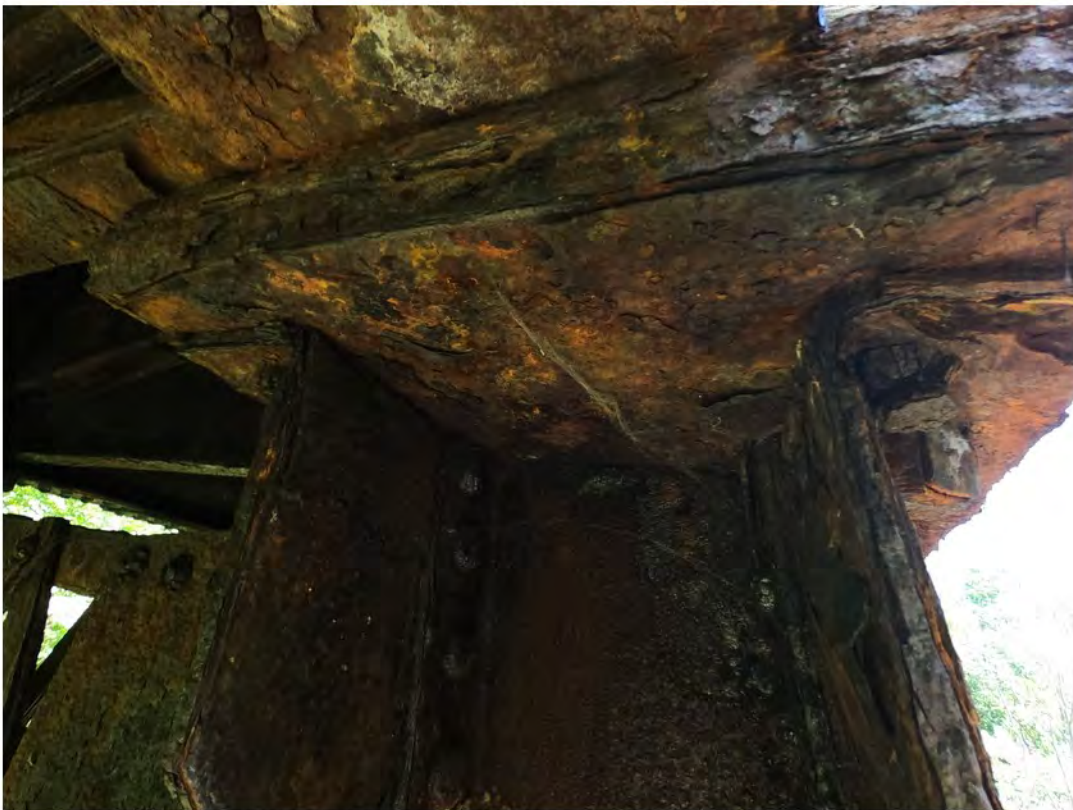
68. Severe Corrosion and Delamination at Connection Between Column and Girder

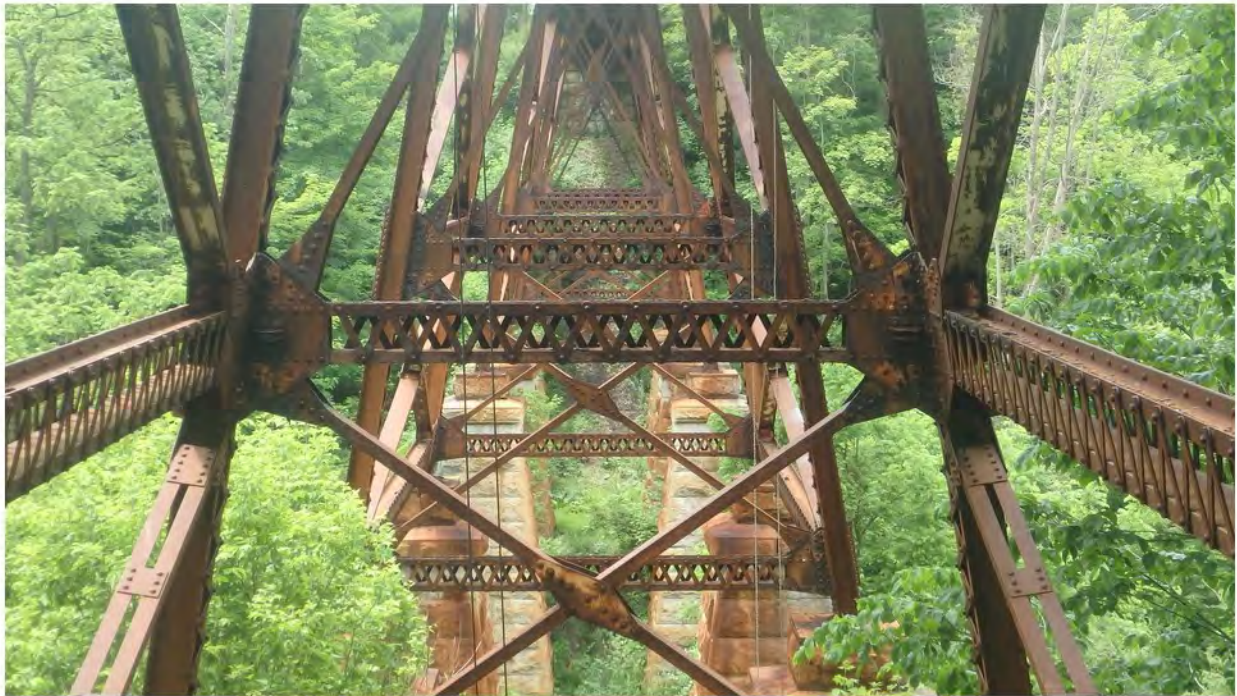
71. Medium to Severe Corrosion on Lateral Supports

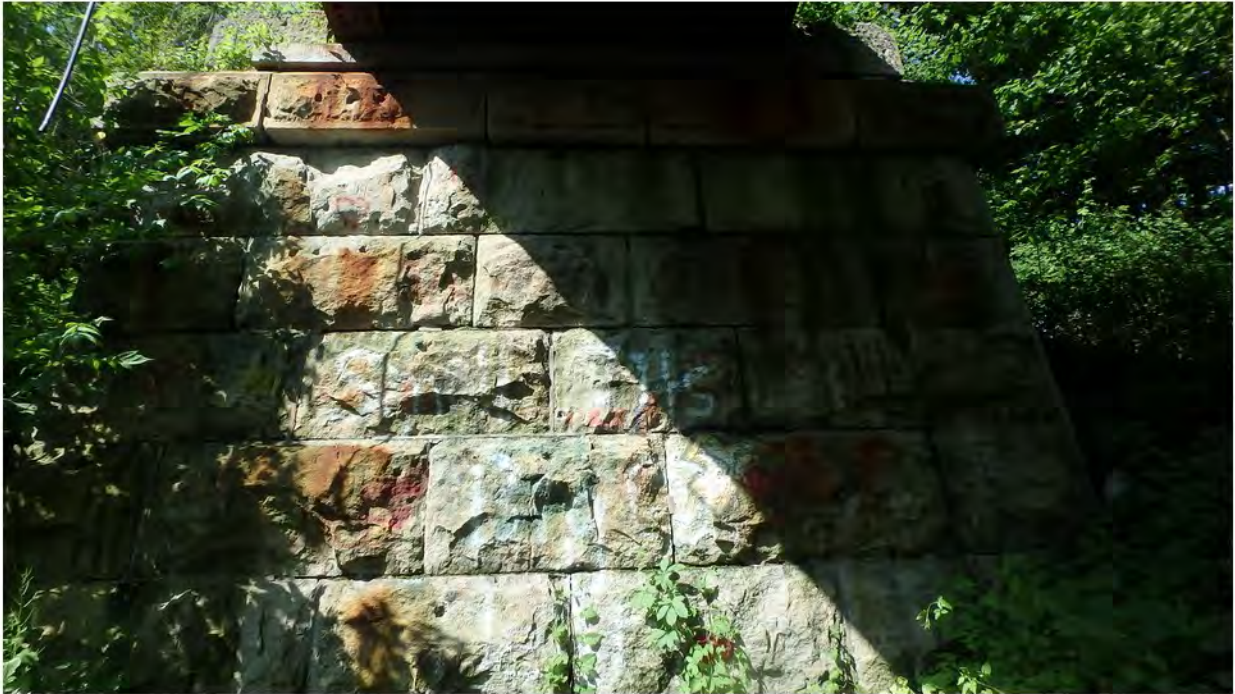
75. Minor Staining on West Abutment

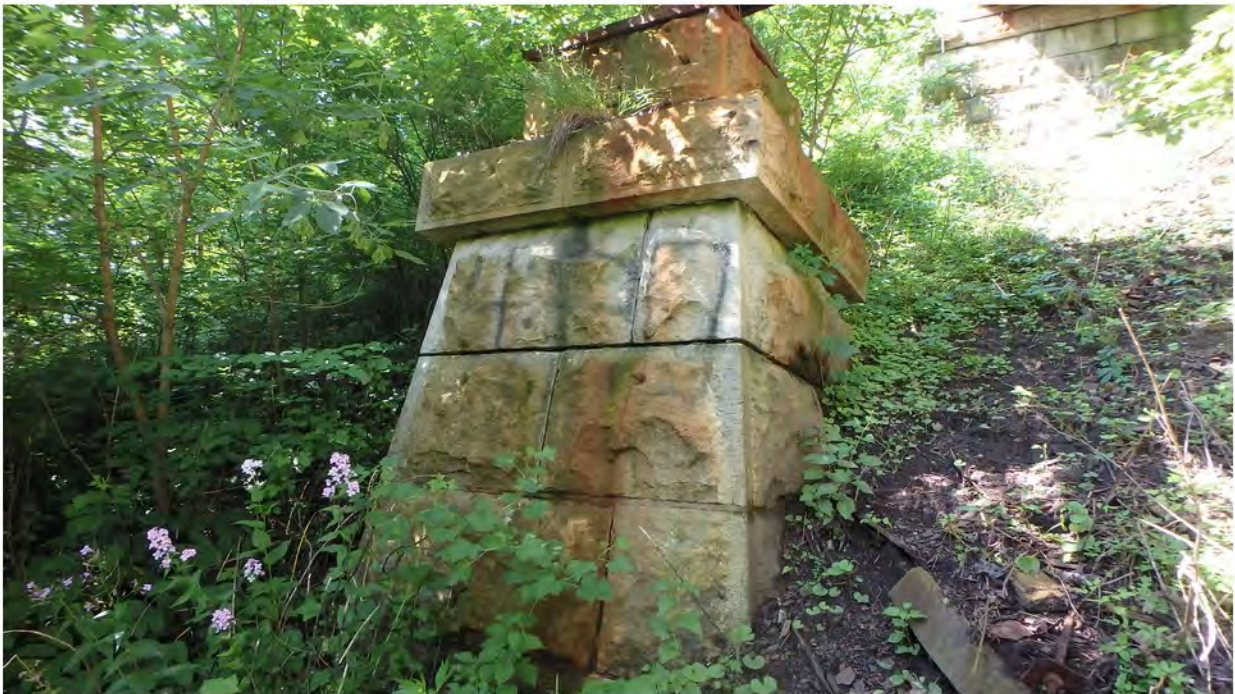
76. Vertical Cracking in Bearing Block; Separation of Concrete Blocks in South B Pier

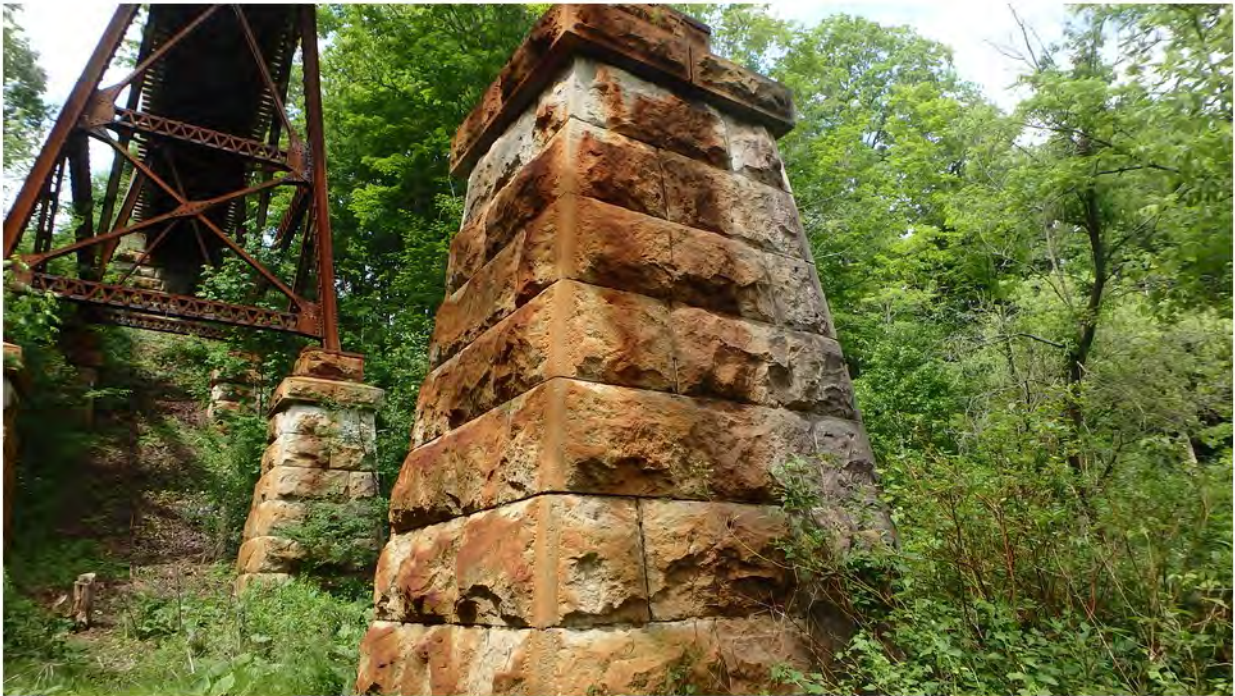
81. North D Pier; Staining Throughout

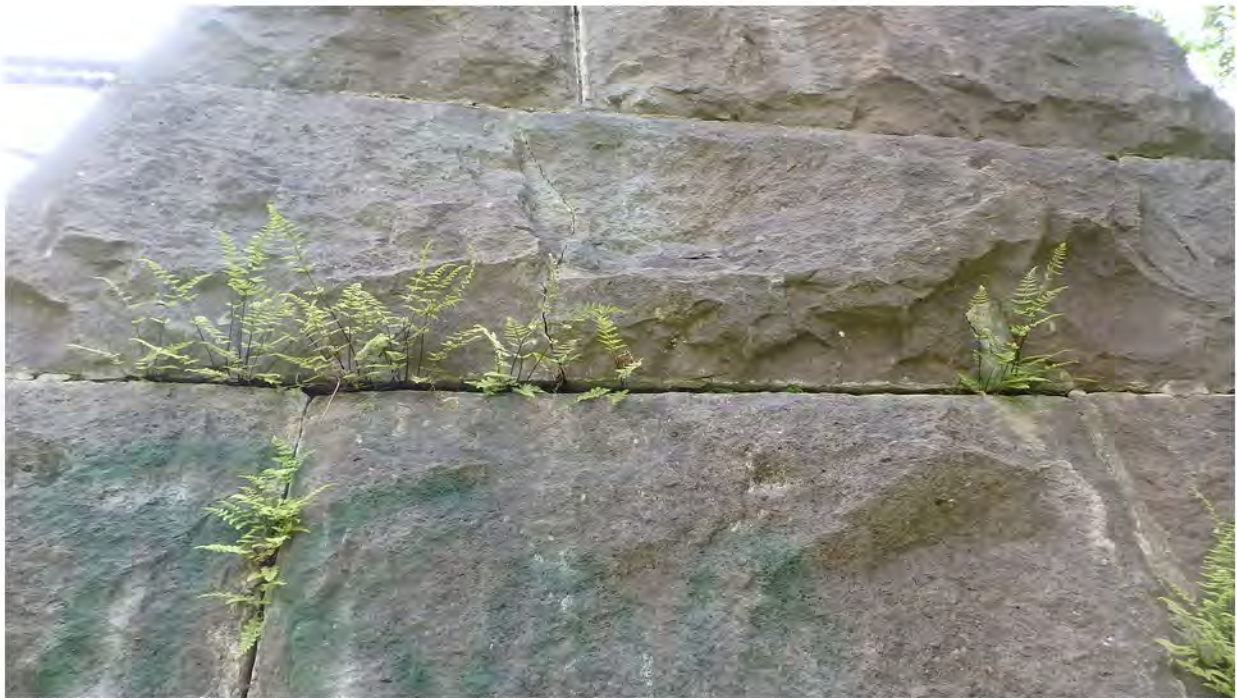
95. Cracking and Mortar Loss on Piers, Typical

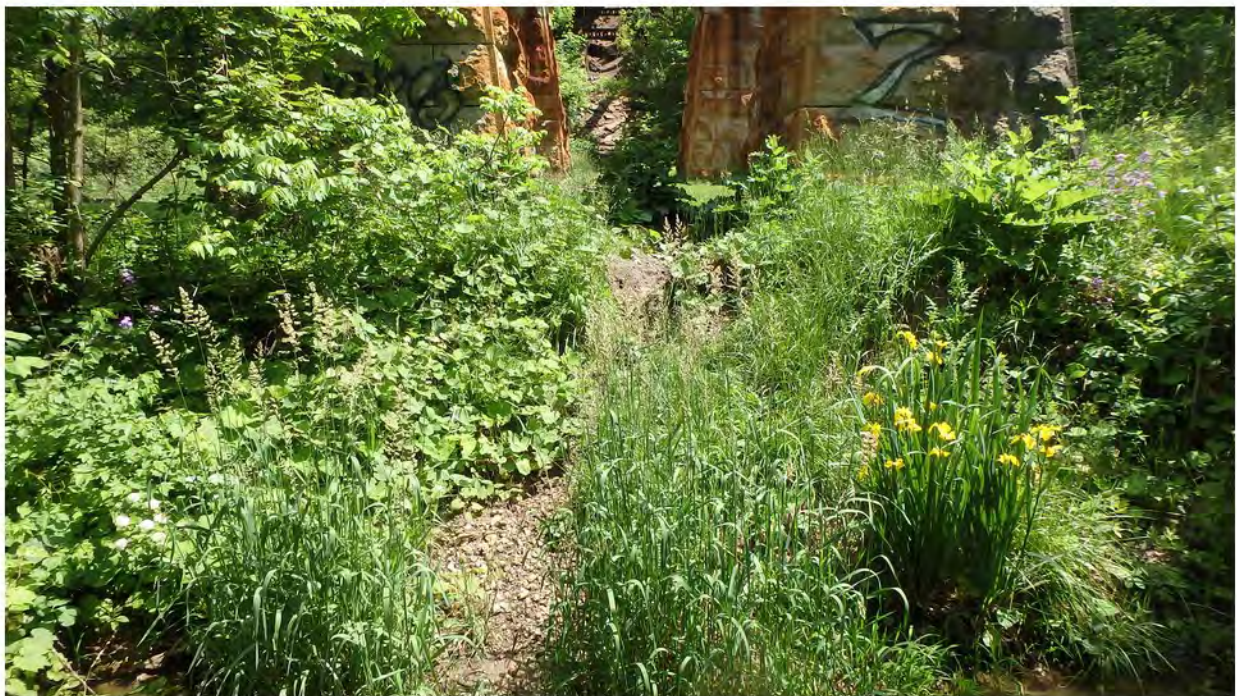
96. Erosion Between East Piers

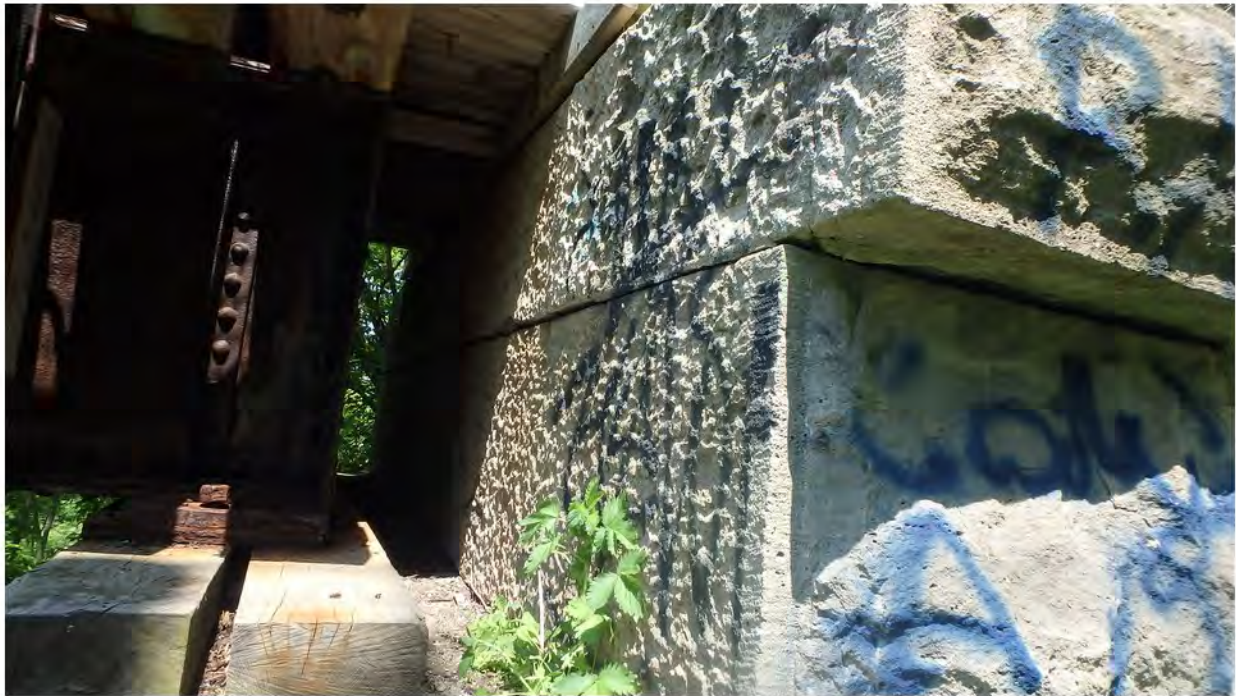
99. South East Bearing; Medium Corrosion and Delamination
