Subject: Kinsmen Pedestrian Bridge

Report Number: OPD 21-46

Kinsmen Pedestrian Bridge Preliminary Design Report

GMBP File: 521015-1

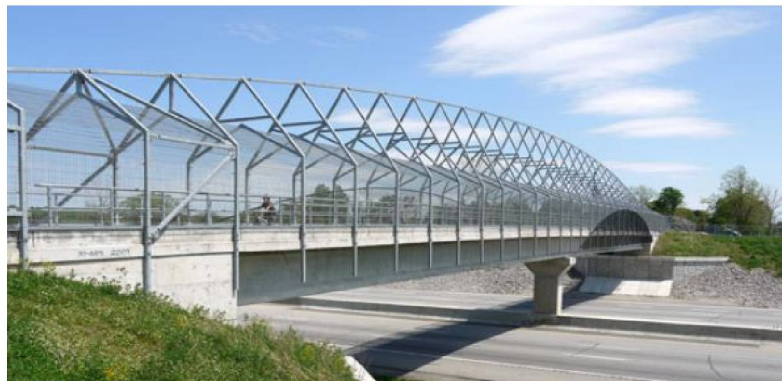
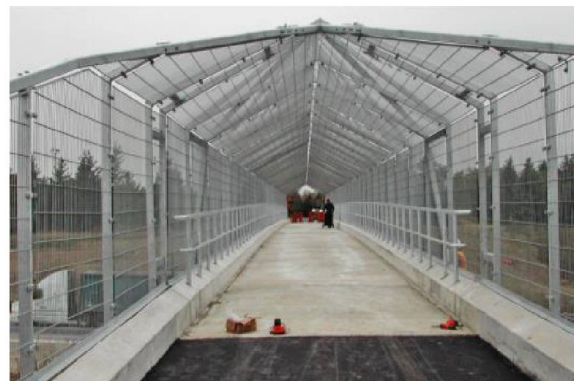
Figure 3 & 4: Mid Range Pedestrian (image provided by AMG Metals)

The option shown below represents a mid range pedestrian barrier that was selected for the Doon valley Pedestrian Bridge over Highway 401 in the Kitchener Area. The barrier is designed to eliminate climbing/falling hazards, prevent debris from being thrown on the traffic below and can be retrofitted with lighting to improve visibility and pedestrian safety at night. This barrier option can be included on each of the deck replacement options detailed above. The additional costs for a mid range pedestrian barrier are detailed further in **Appendix B**.

F 02 MID RANGE PEDESTRIAN BARRIER
1:25
