KINSMEN PEDESTRIAN BRIDGE

EVALUATION REPORT

**ENHANCED OSIM INSPECTION,
LOAD LIMIT ANALYSIS,
& OPTIONS EVALUATION**

FOR
THE CORPORATION OF
THE TOWN OF TILLSONBURG

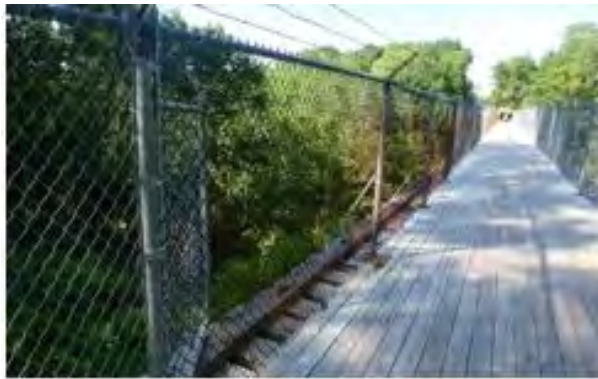
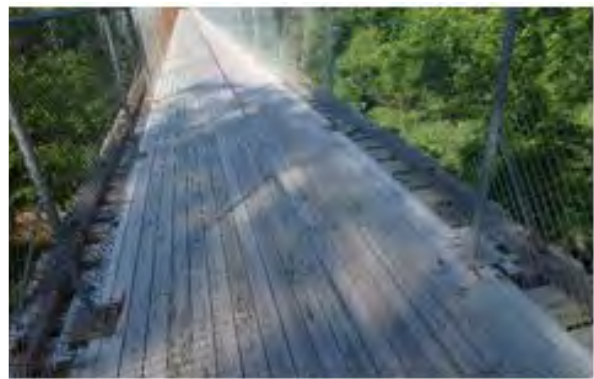
The current barrier is a steel chain-link fence with barbed wire along the top. The pedestrian barrier has medium surface corrosion and a loose wire at the bottom of the fence. Maintenance is recommended to be completed within one (1) year. Although the current design meets the

The existing wearing surface is wood plank decking attached to the wood deck ties beneath. The deck wearing surface was observed to be in 75% good condition, 24% fair condition and 1% poor condition. The deterioration noted during the inspection included light to medium weathering and minor checking and splitting. Two boards were also noted to be warped upwards. Maintenance to remove and replace the warped deck boards is recommended. Maintenance of this deck surface will be an ongoing task, given the nature of how it was constructed. This wearing surface was reinstalled following the 2010 wood deck tie replacement project for budgetary reasons. Deck replacement options will be reviewed since the deck surface has been identified as a safety concern due to the slippery conditions in wet weather and winter months. The method of nailing the deck boards directly into the wood tie-beams without an air gap will also cause premature deterioration of the wood deck ties. Alternative deck surface options are considered in the Options Evaluation under Section 3 of this report.

Figure 1 & 2: Existing Barrier and Deck Wearing Surface

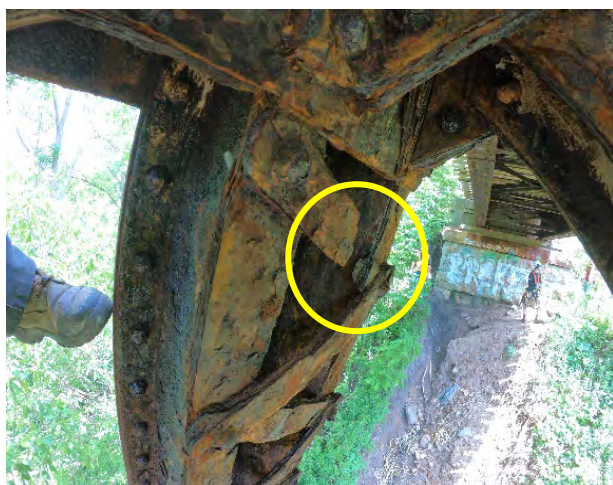
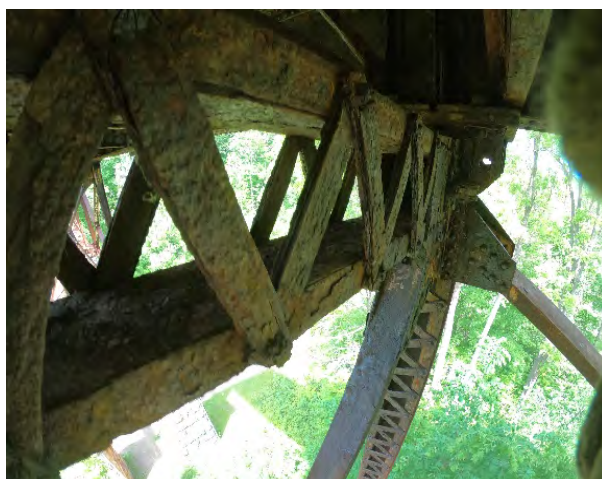
The diaphragm cross-braces, including the horizontal and diagonal components, are generally in fair to poor condition. Like most of the steel components on the bridge, the deficiencies include severe corrosion with flaking of delaminated steel causing section loss. The horizontal components observed 10% - 25% section loss while the diagonal components were observed to have 10% - 20% section loss. The horizontal components are 60% fair condition and 40% poor condition with the diagonal components being 70% fair condition and 30% poor condition. The diaphragms are recommended to be replaced in 1-5 years. As a general observation, it was noted that smaller steel sections were in poorer condition than larger and thicker steel sections.

Figure 3 & 4: Severely Deteriorated Laces Bracing throughout, Note Broken Brace in Figure 3

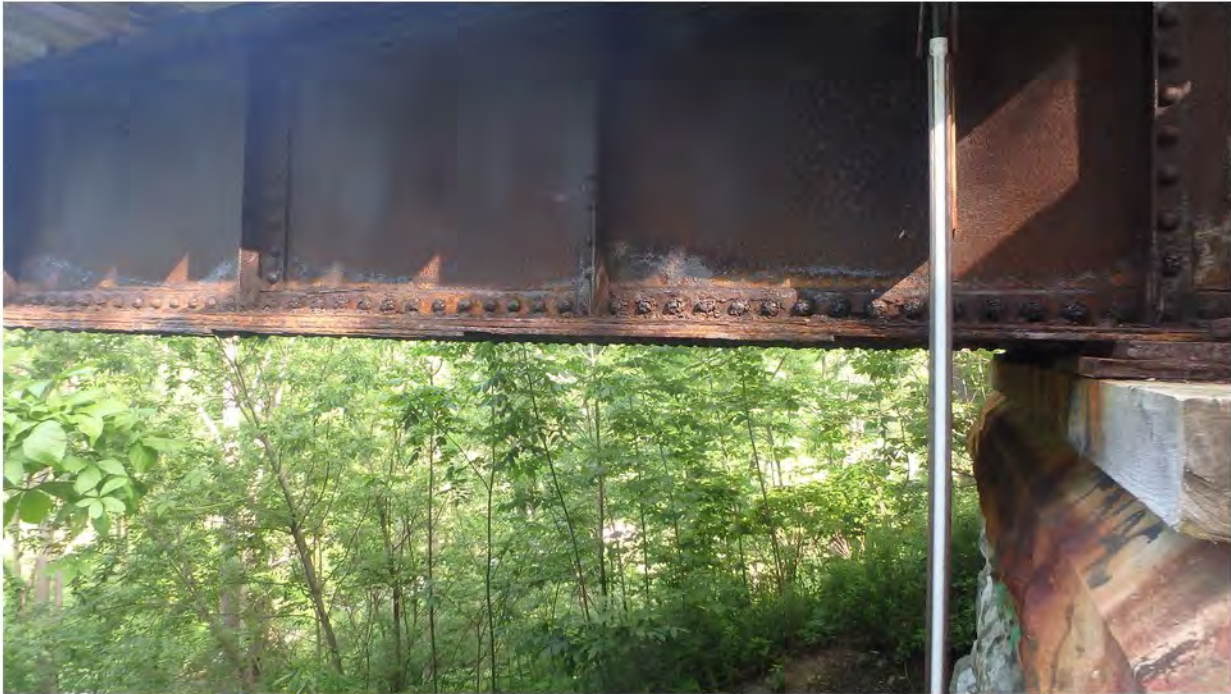
65. Severe Corrosion and Delamination of Angle at Bottom Flange of Girder

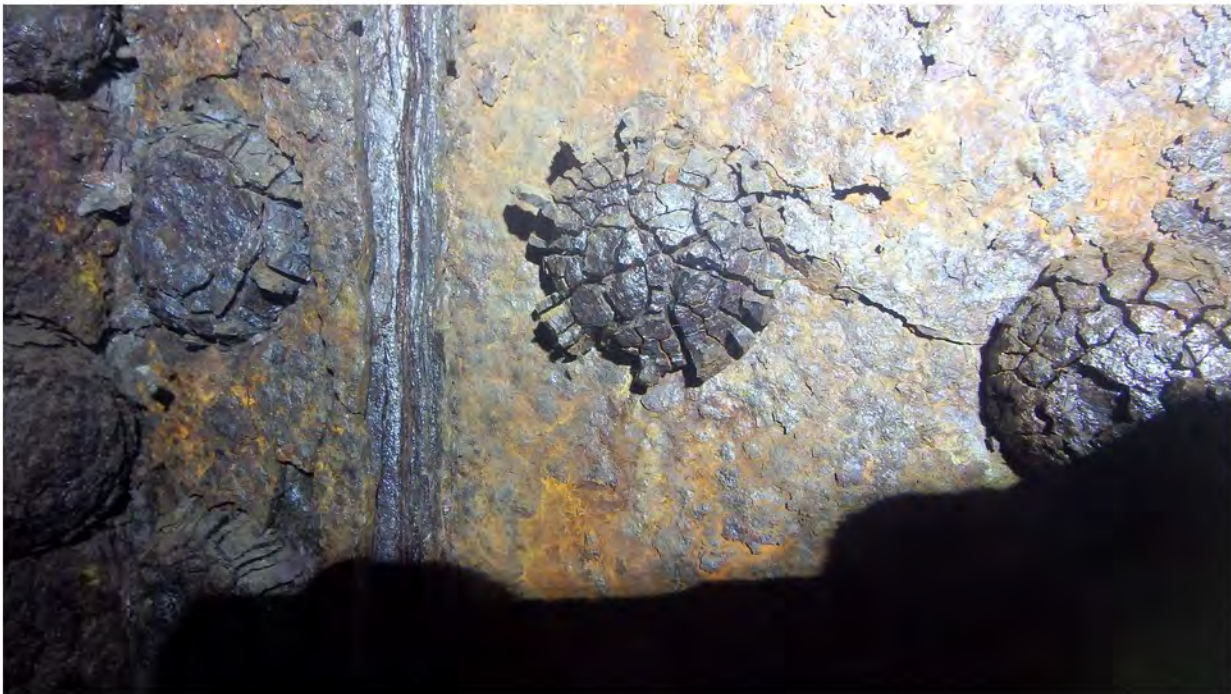
66. Rivet Cracking; Typical Throughout Structure

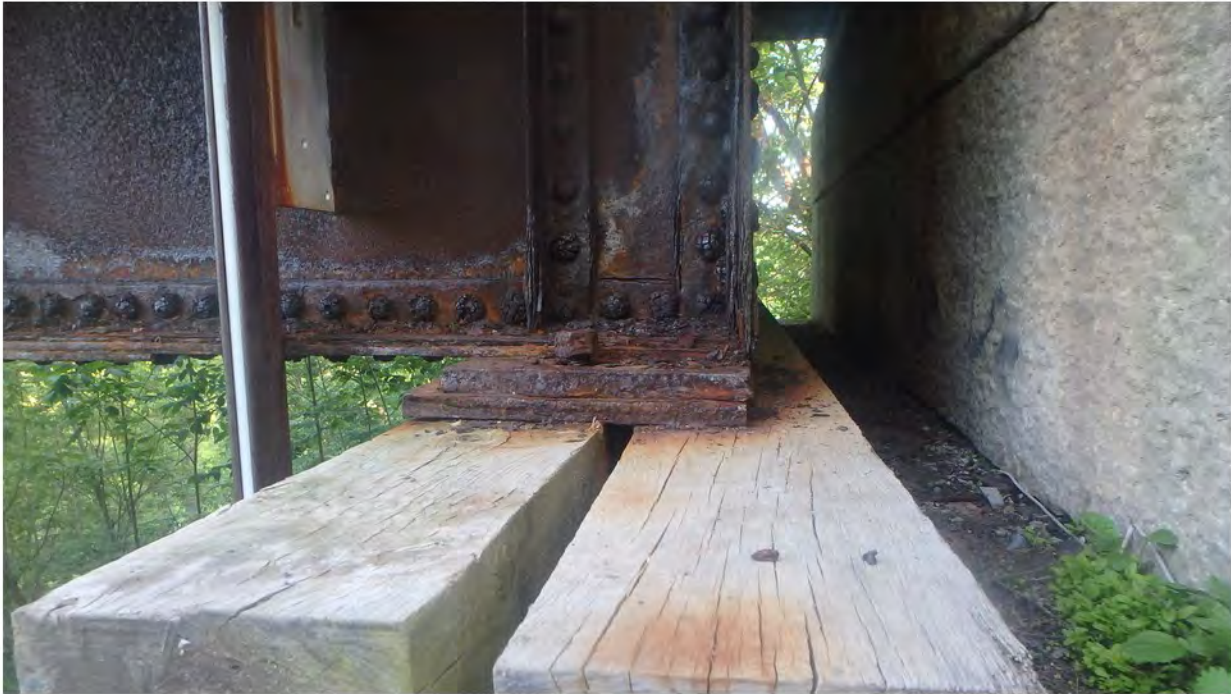
69. Medium Corrosion of Bearing Plate, and Severe Corrosion and Delamination of Girder End at East Abutment

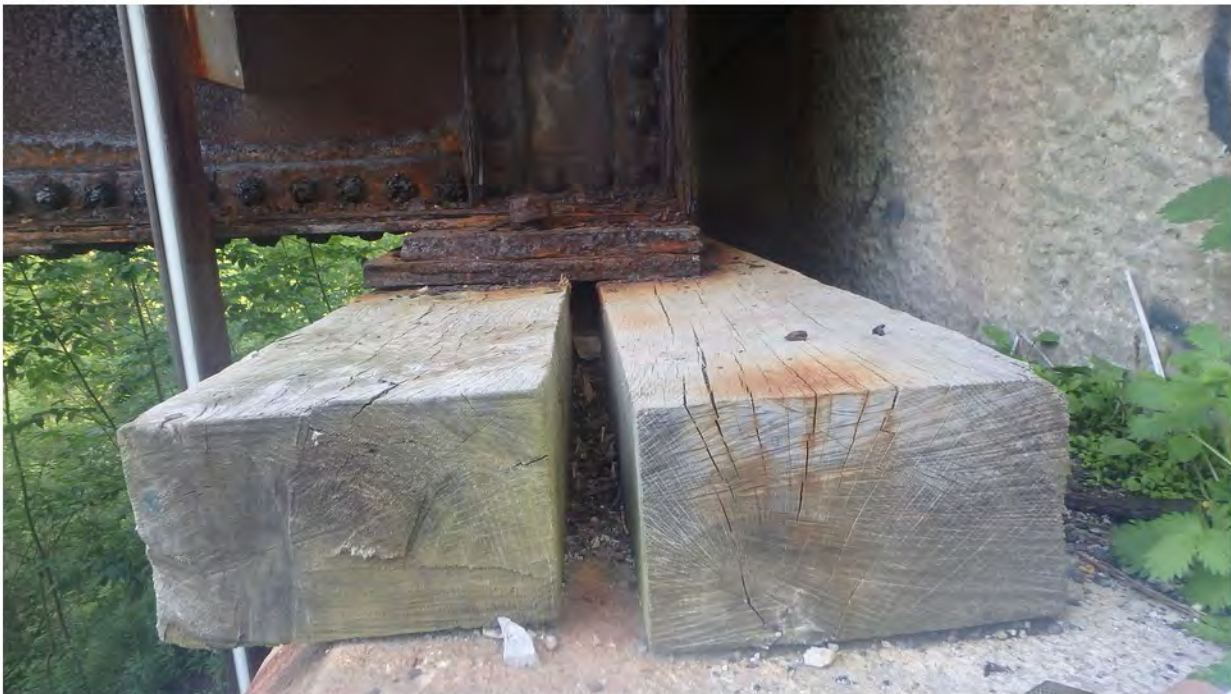
70. Minor Checks and Shakes in Wood at East Abutment

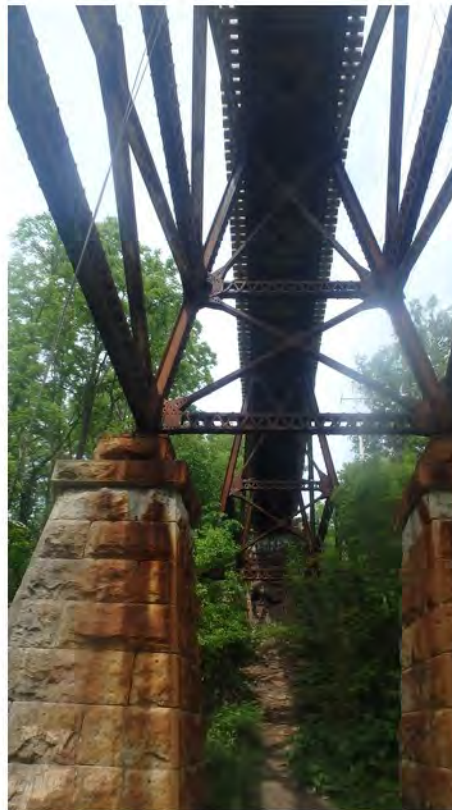
72. Soffit; Staining on Piers, Typical

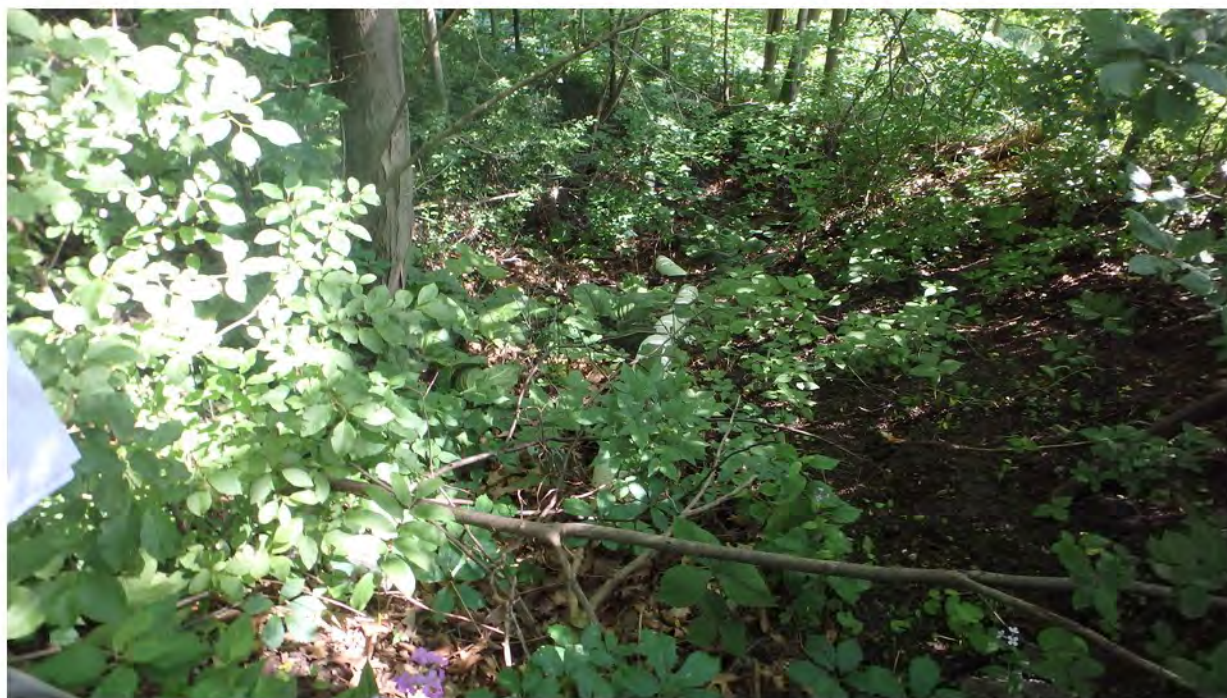
74. Erosion at Northeast Quadrant

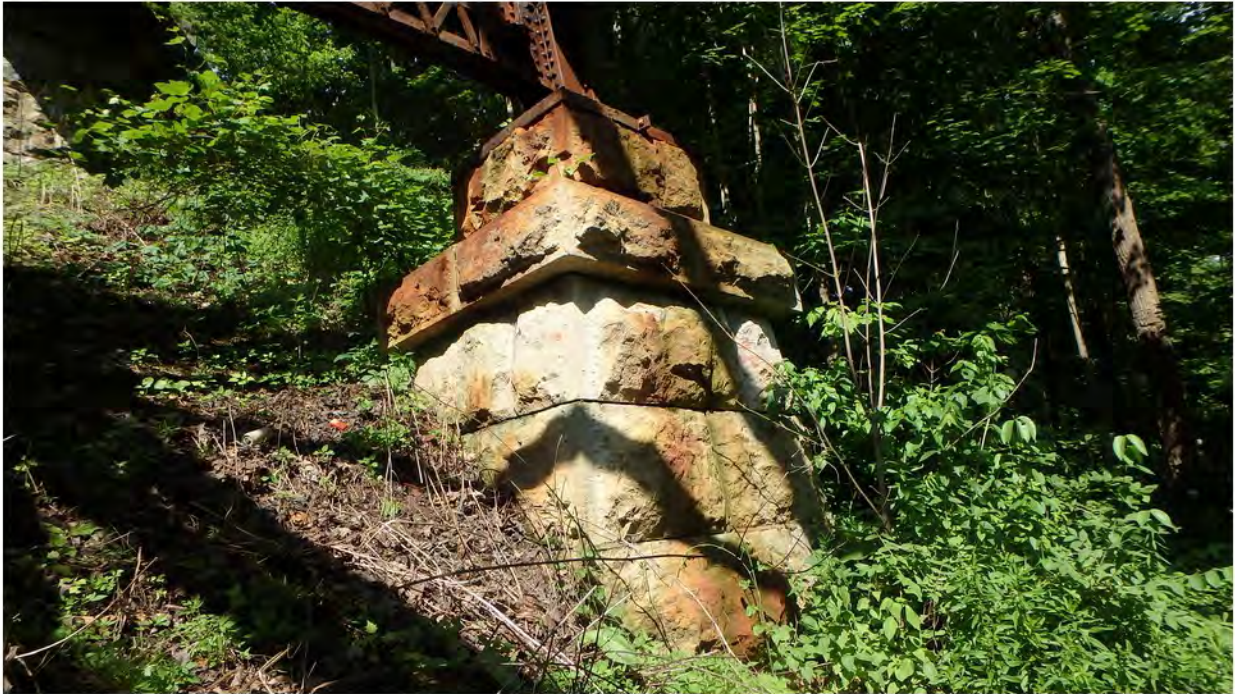
77. Staining and Vertical Cracking in Bearing Block; Staining in North B Pier

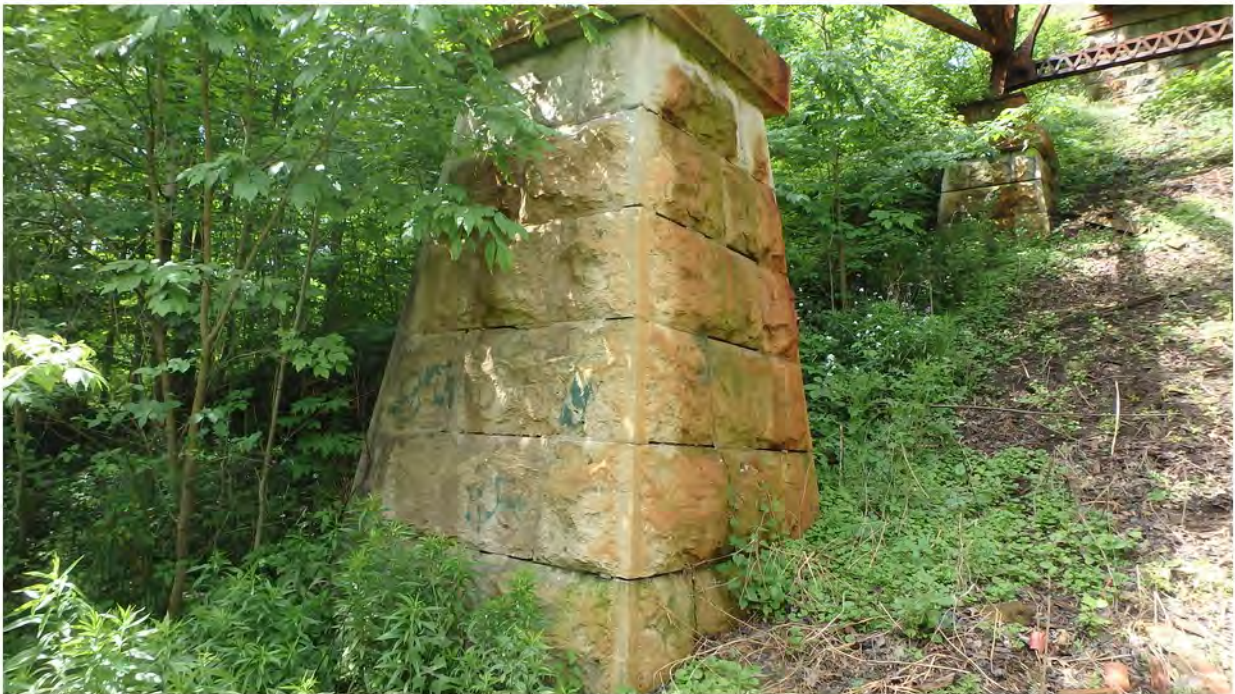
78. South C Pier; Staining Throughout

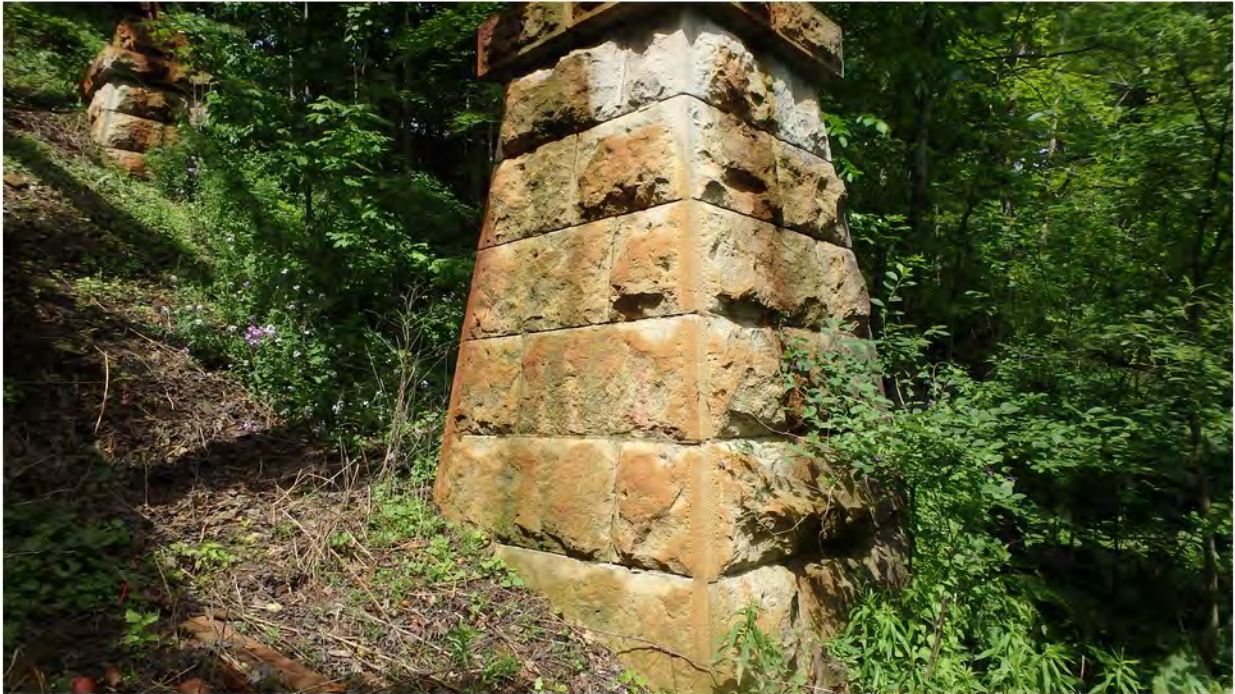
79. North C Pier; Staining Throughout

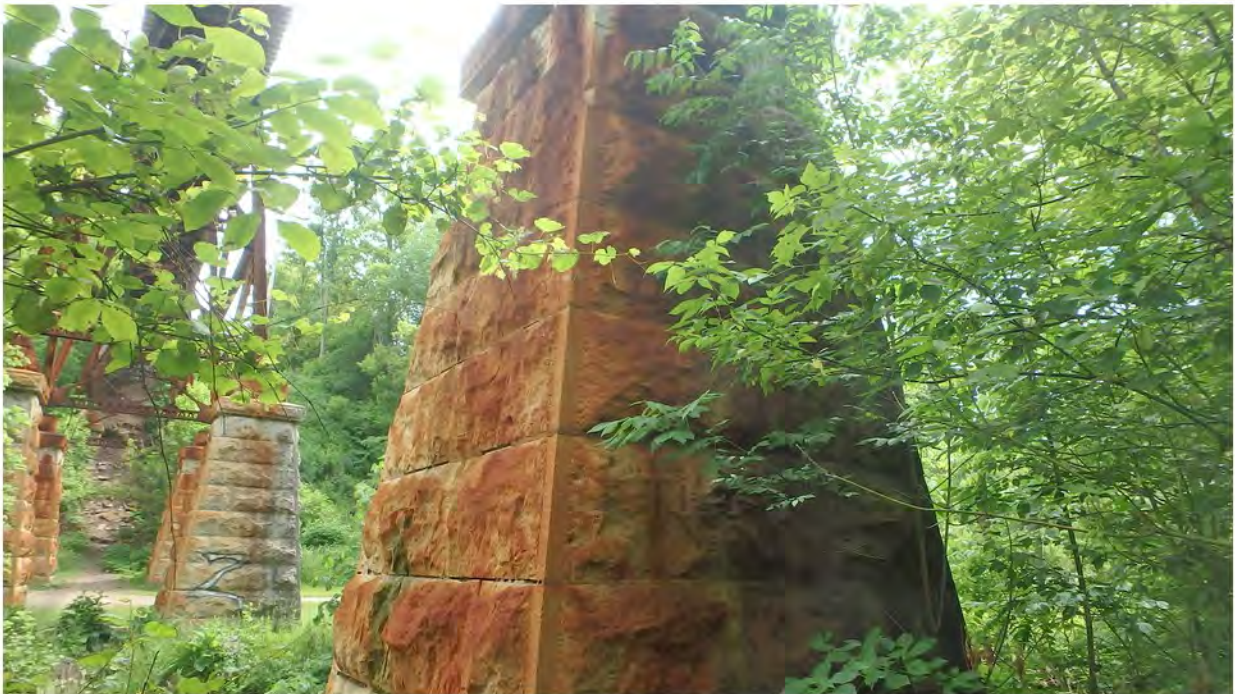
80. South D Pier; Staining Throughout

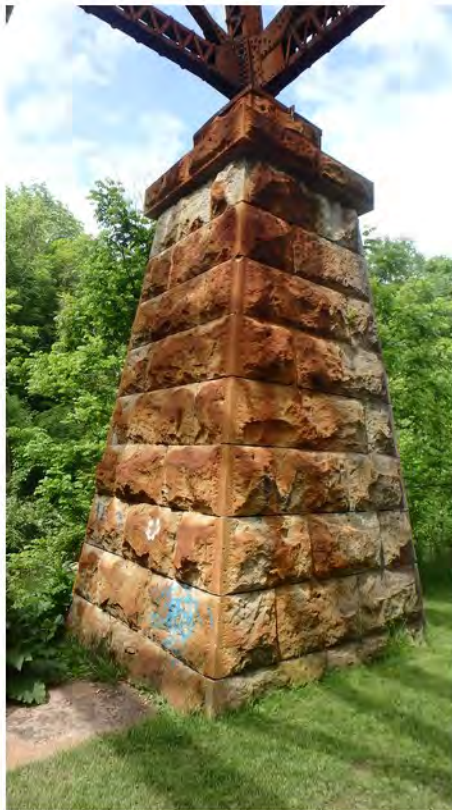
84. North F Pier; Staining Throughout

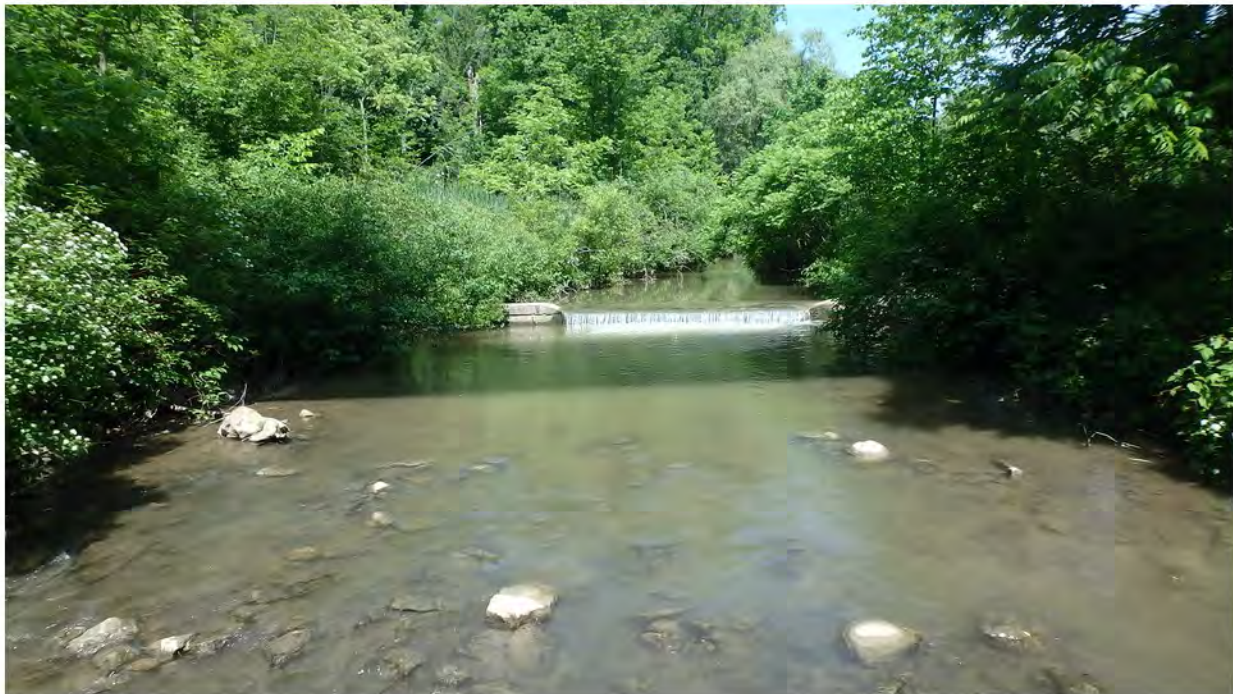
88. Upstream

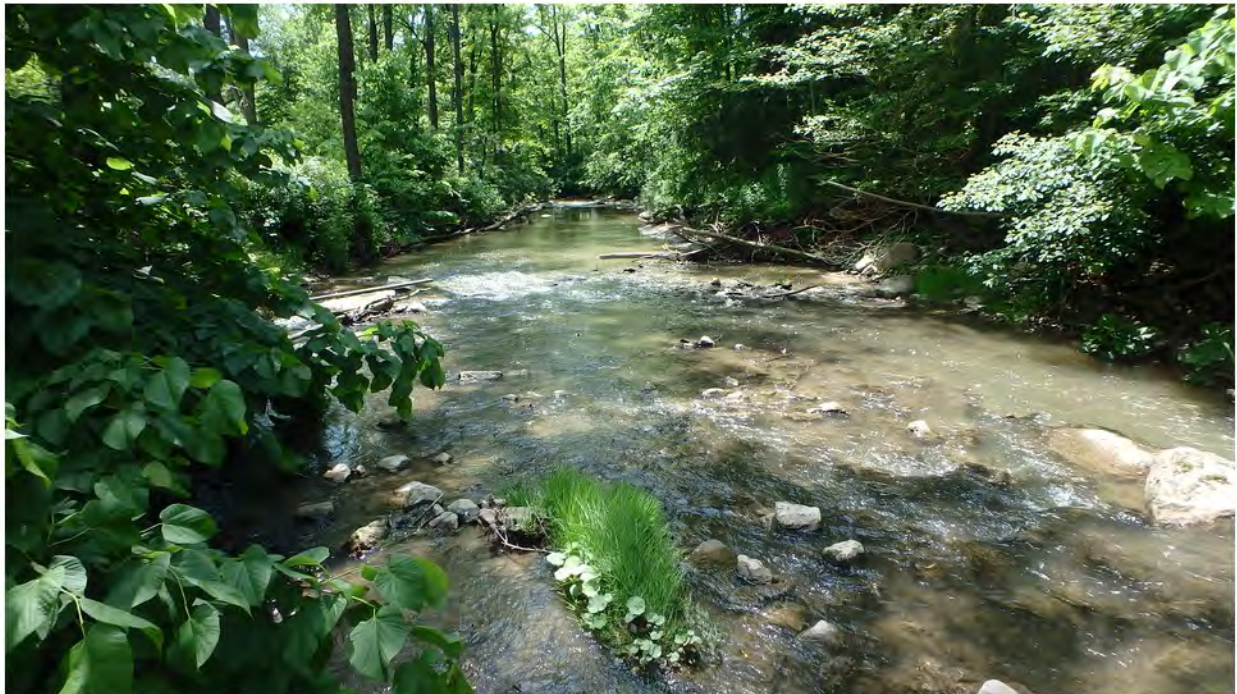
89. Downstream

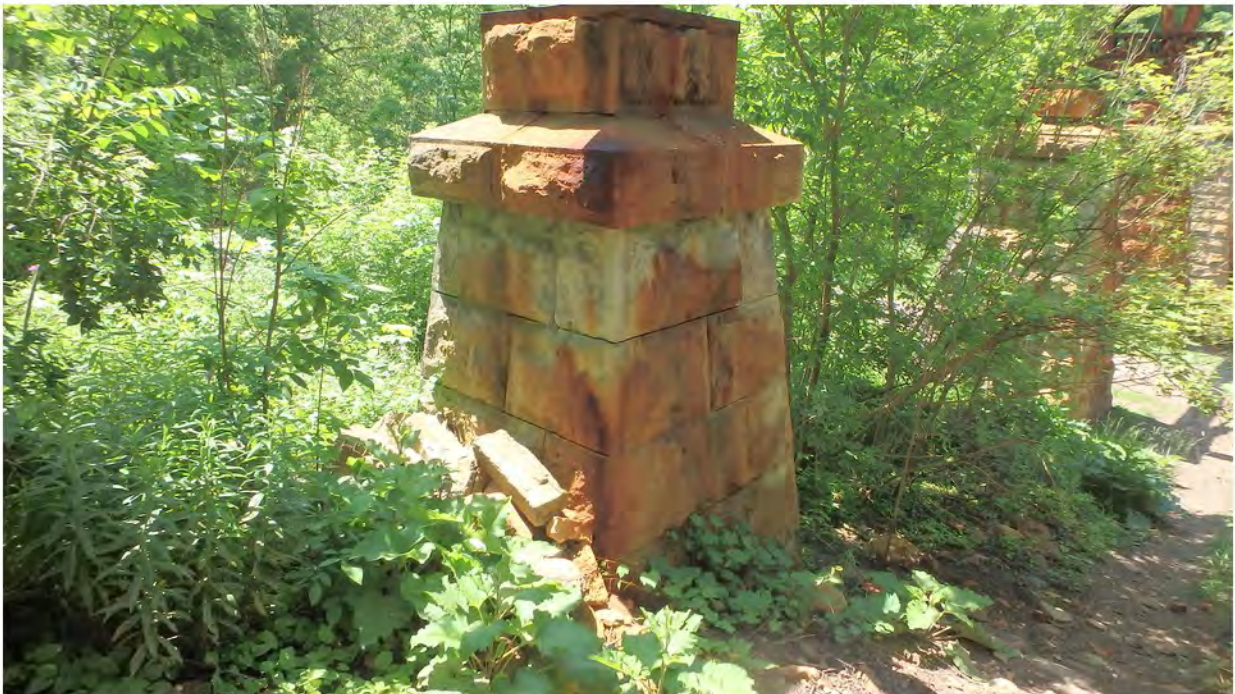
92. South H Pier; Staining Throughout

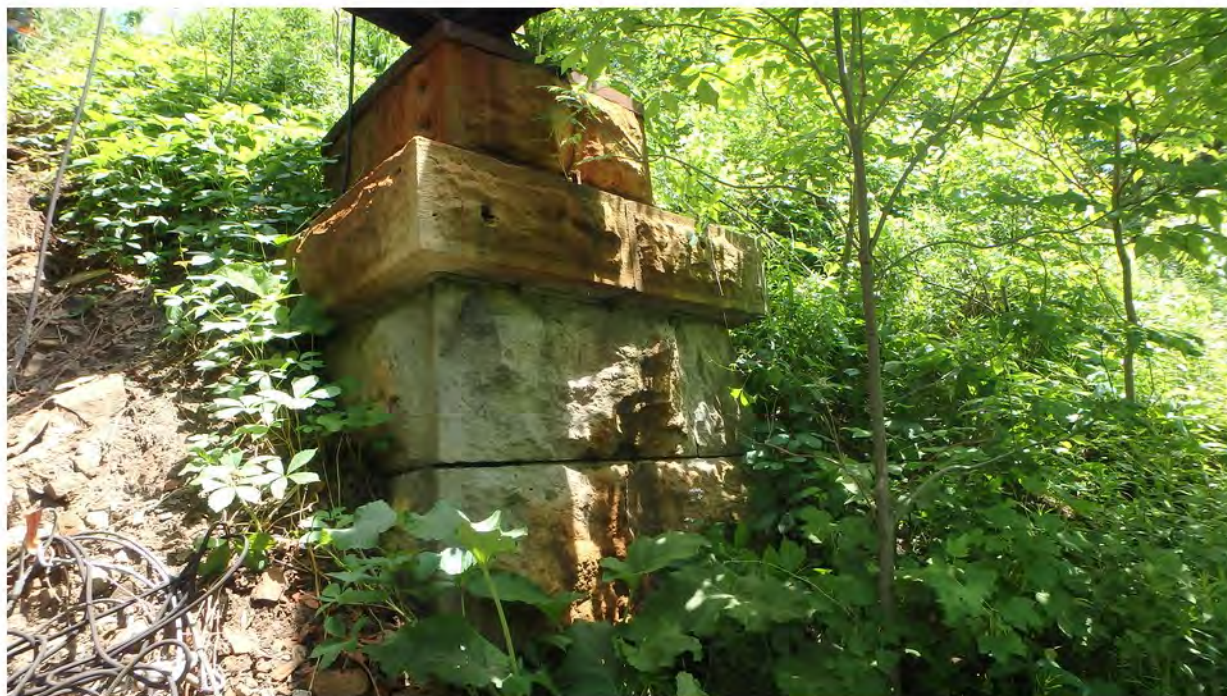
93. South I Pier; Staining Typical

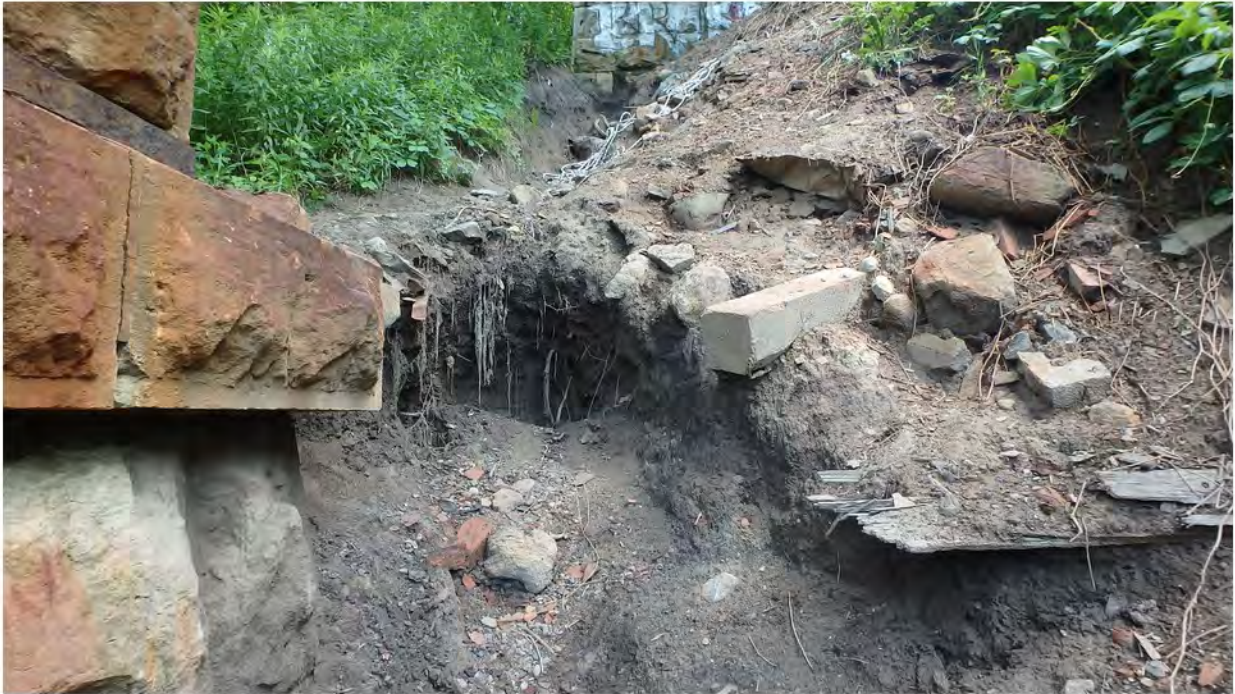
97. Severe Erosion From East Abutment Wall to North Pier

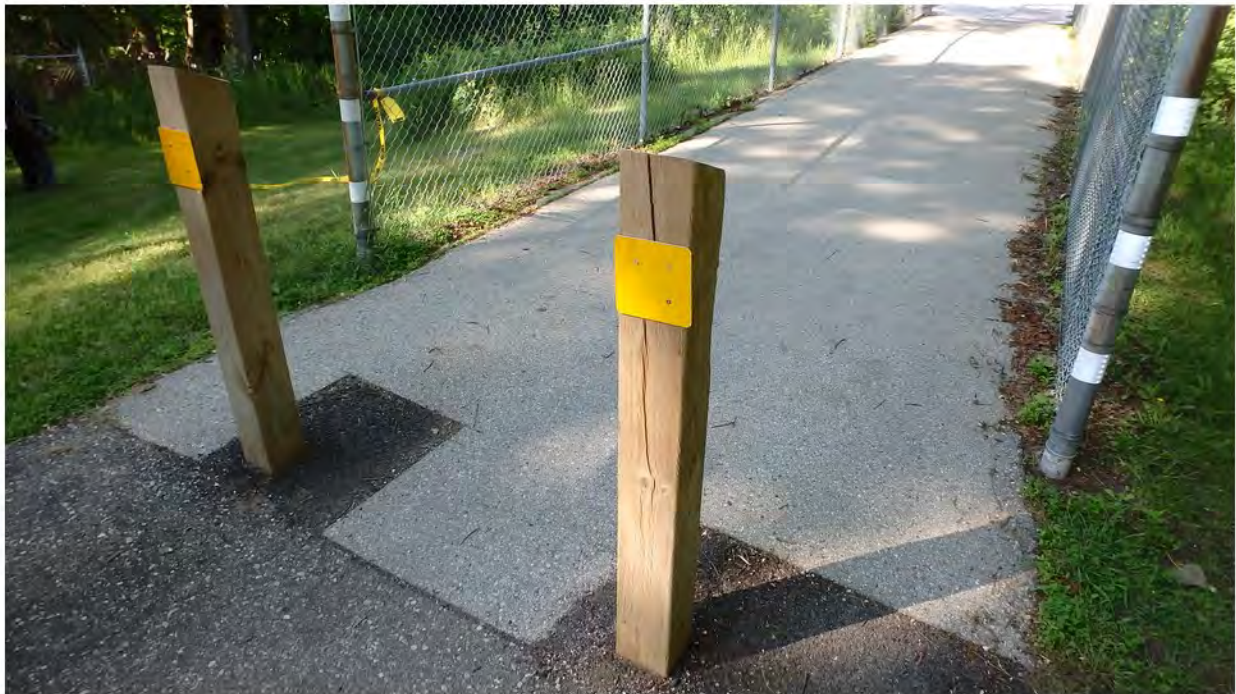
100. Wooden Posts at East Approach

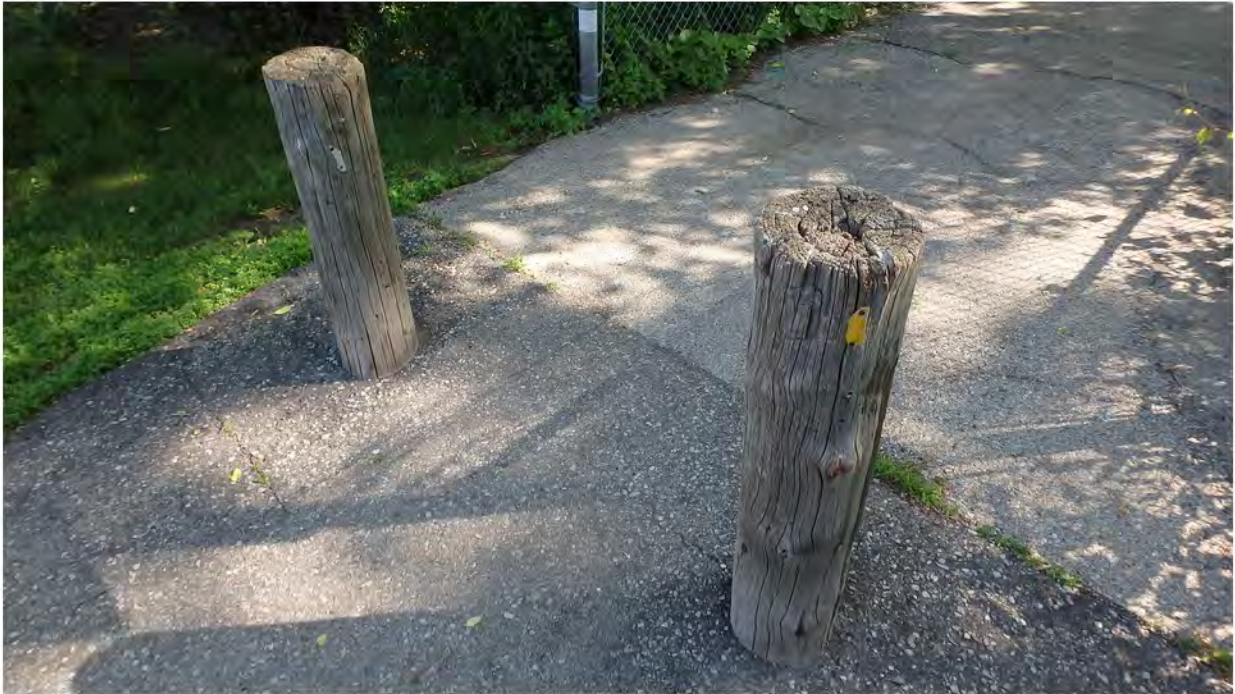
101. Checks and Splits in Wooden Posts at West Approach

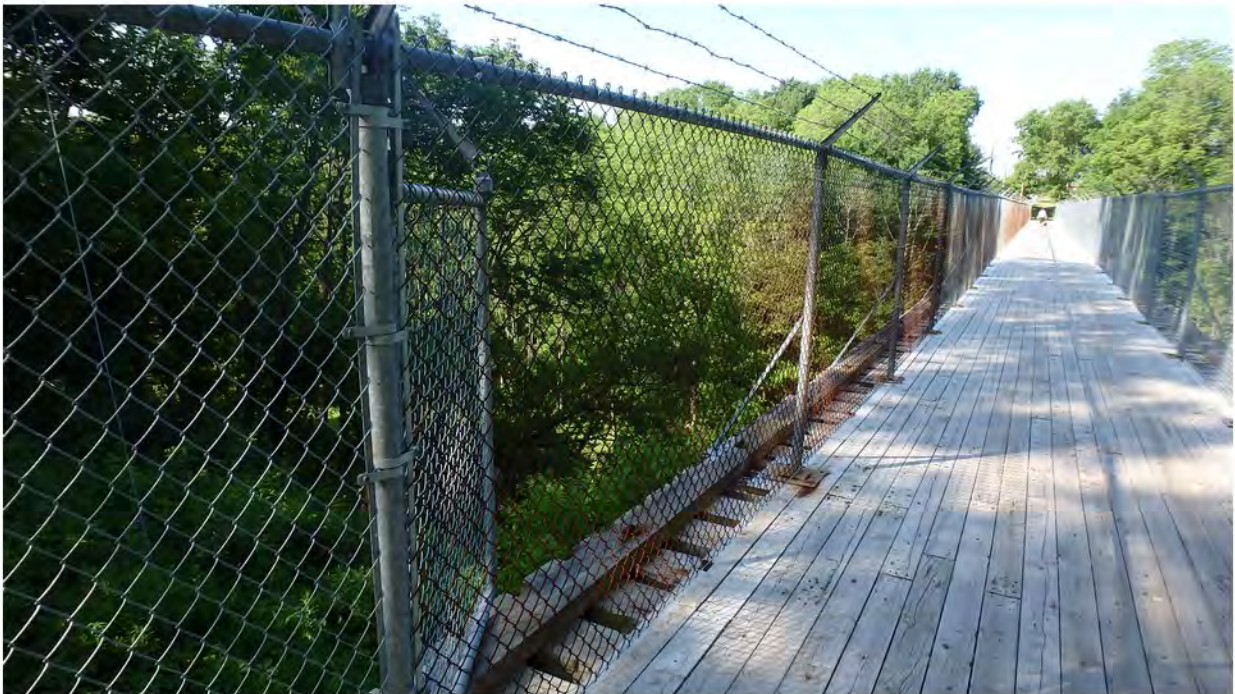
102. Light Corrosion on Fence at Both Sides of Deck, Typical

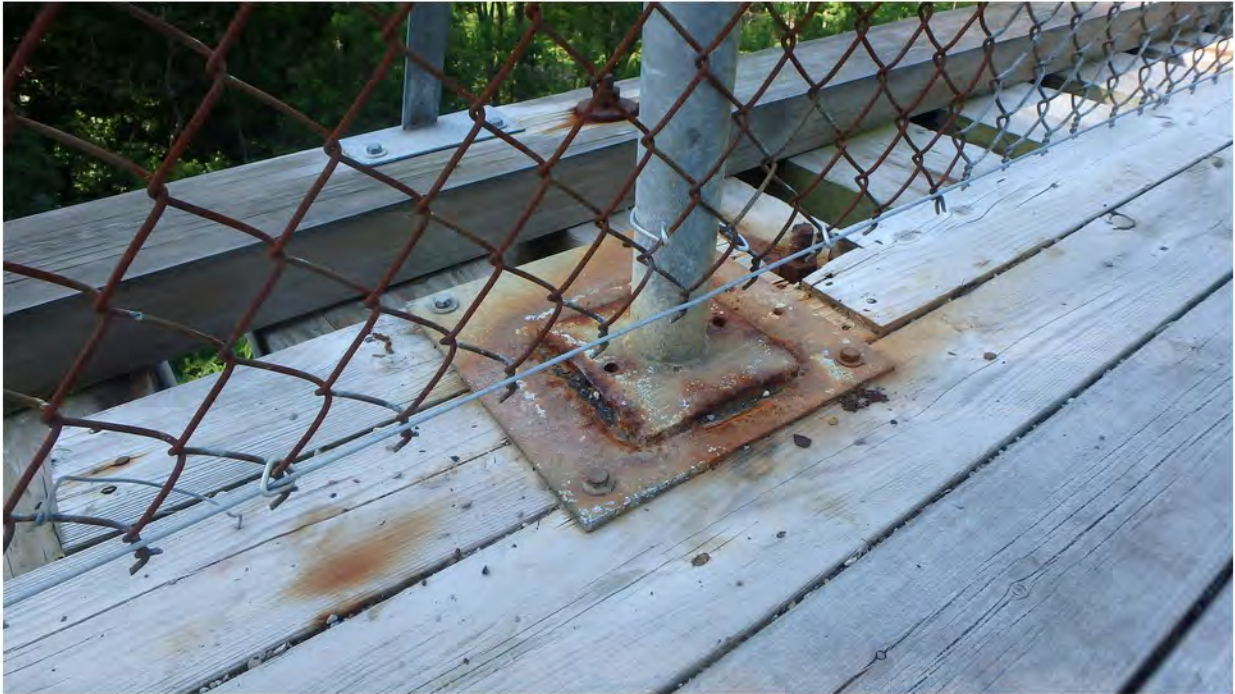
103. Medium Corrosion of Posts for Fencing on Bridge Deck

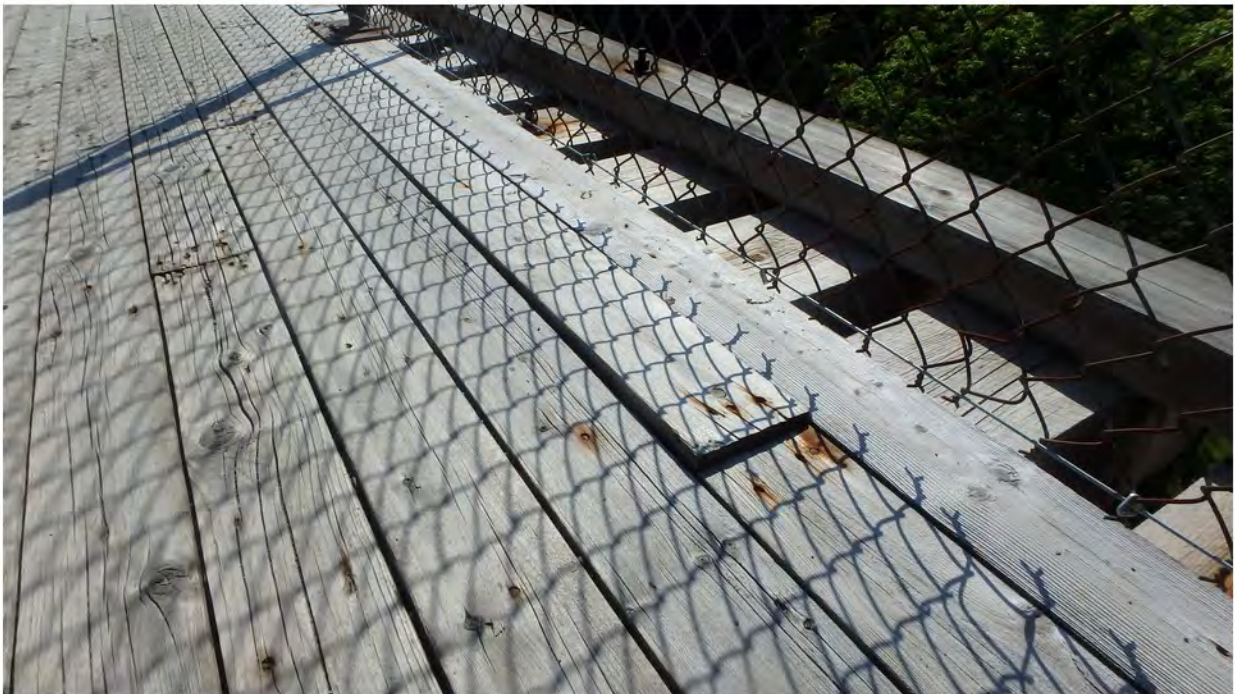
104. Lifting of Deck Boards Along Deck Wearing Surface
